**US Army Corps
of Engineers**

Beaver Lake

Final
U.S. Army Environmental Condition of
Property Report
Priority Area 1

August 30, 2021

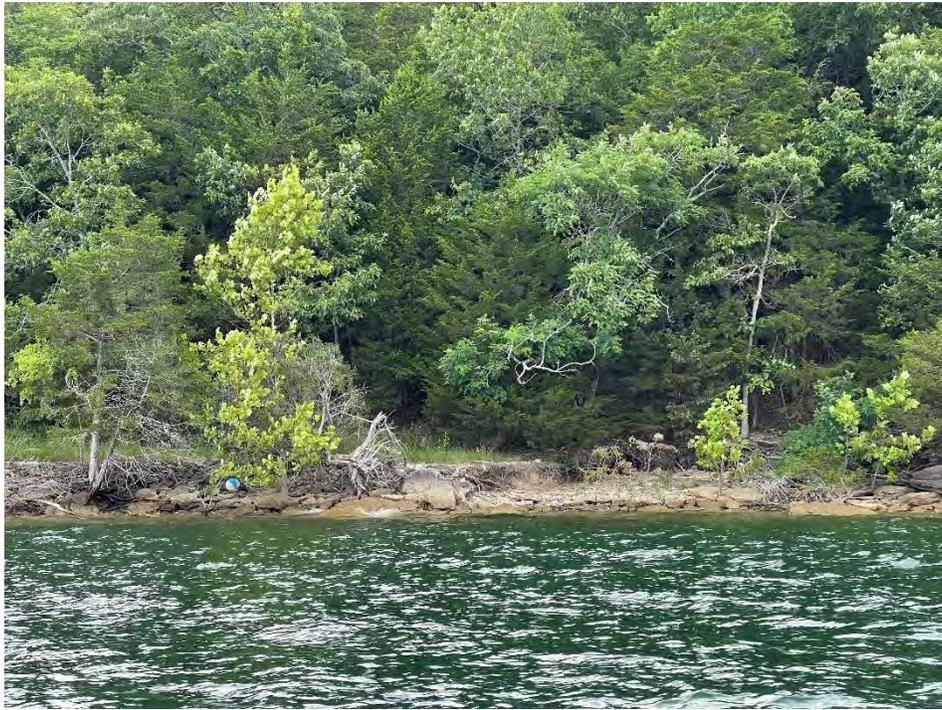
Priority Area 1A.1 – Minor debris visible

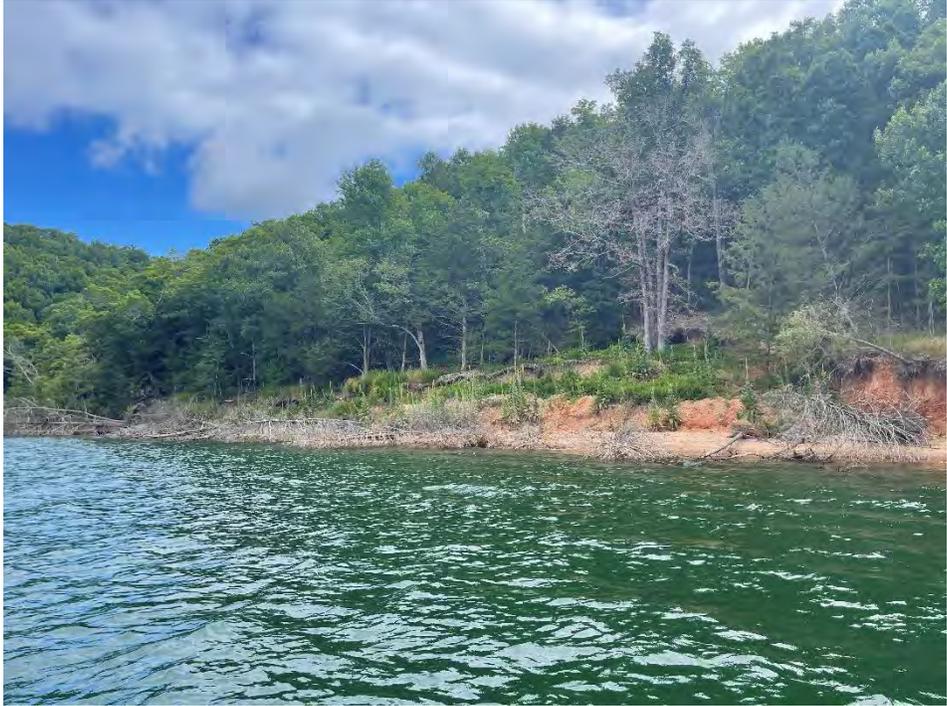
Priority Area 1A.1 – Shoreline view erosion visible

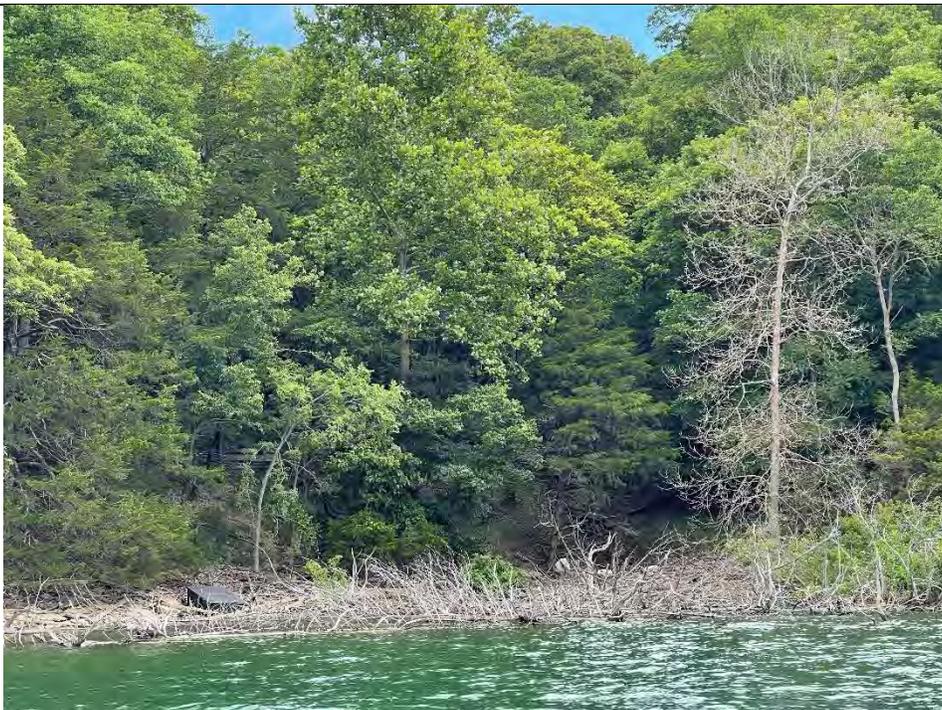
Priority Area 1A.1 – Shoreline view enclosed foam

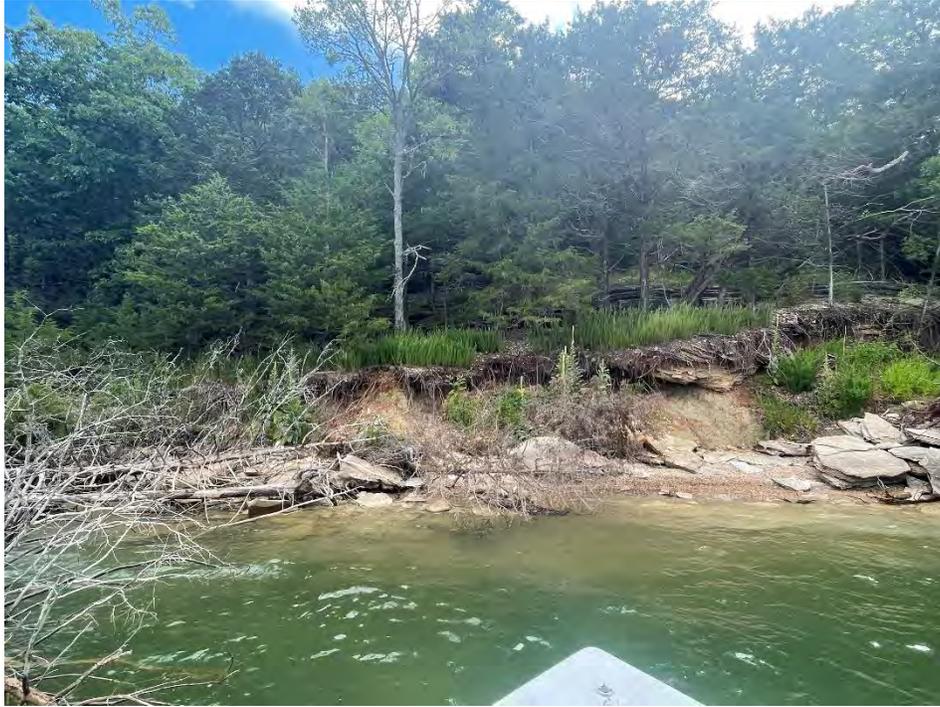
Priority Area 1A.2 – Shoreline view some erosion visible

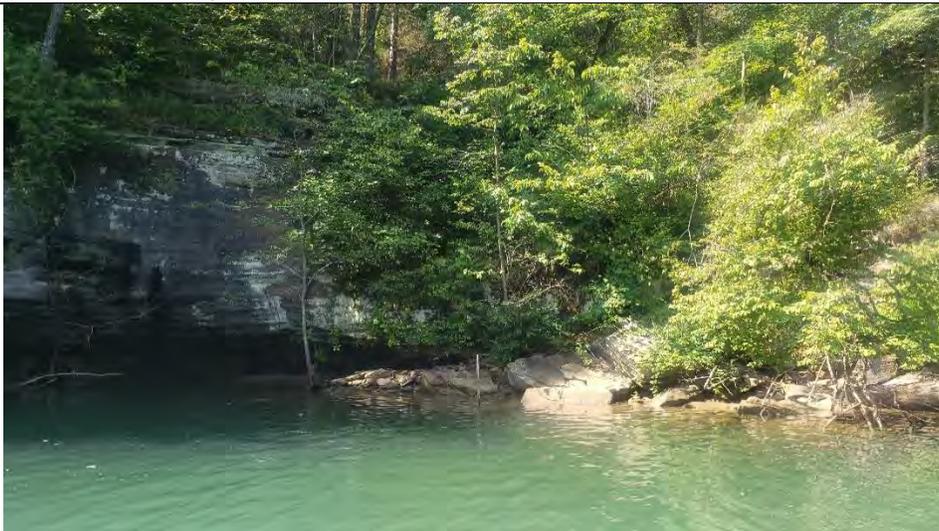
Priority Area 2 – Shoreline view with woody debris

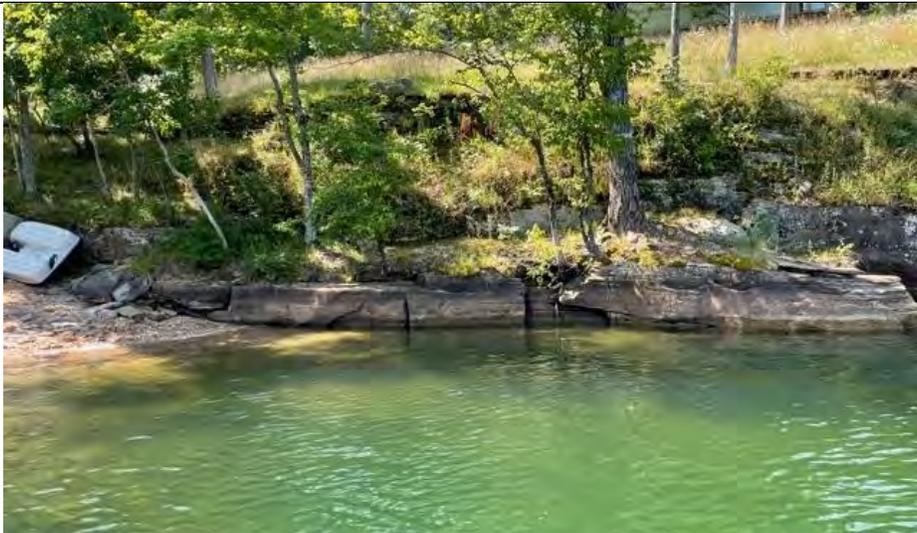
Priority Area 3.2 – Clarity and quality of water

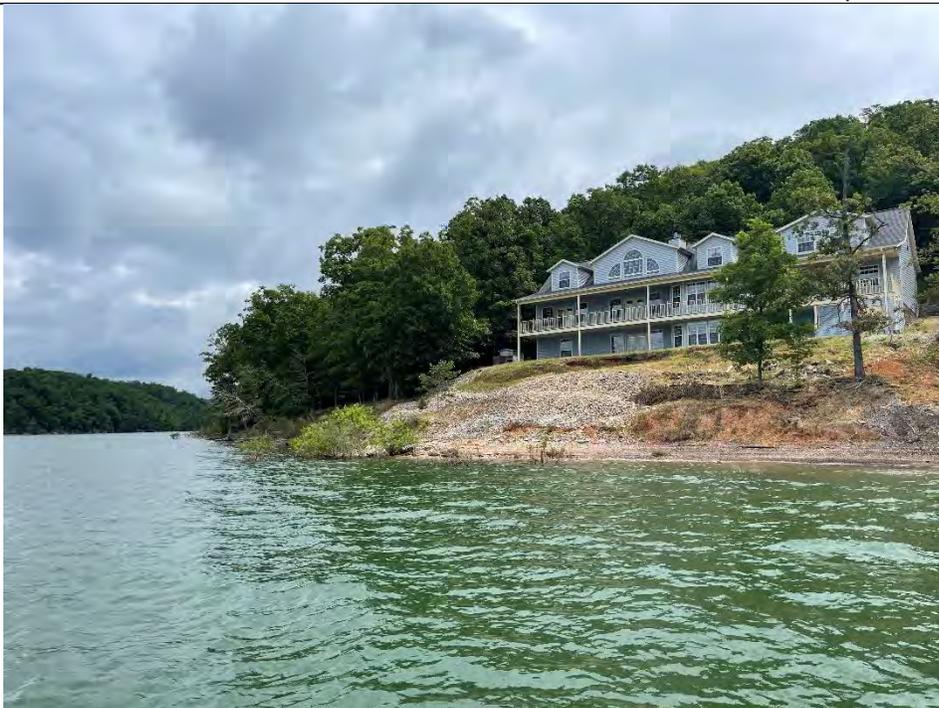
Priority Area 6 – Bank stabilization can be seen, USACE Beaver Lake Office erosion permit

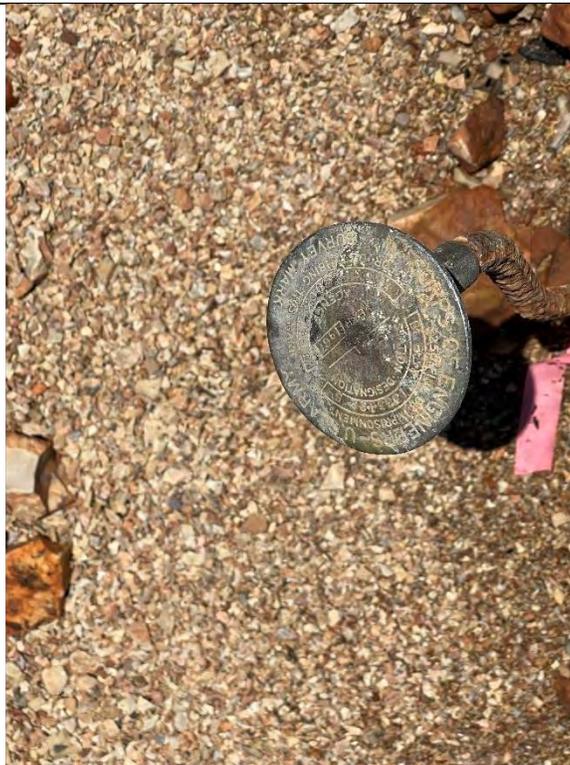
Priority Area 12 - USACE Marker on Priority Area property
