Three Rivers Southeast Arkansas Study

Appendix C: Engineering

**Report on Design and Construction Deficiencies in the Dale Bumpers White River
National Wildlife Refuge, Arkansas**

SUBJECT: Site Visit to Inspect MKARNS Construction Deficiencies of Mitigation Structures
Dale Bumpers White River National Wildlife Refuge (WRNWR), Arkansas

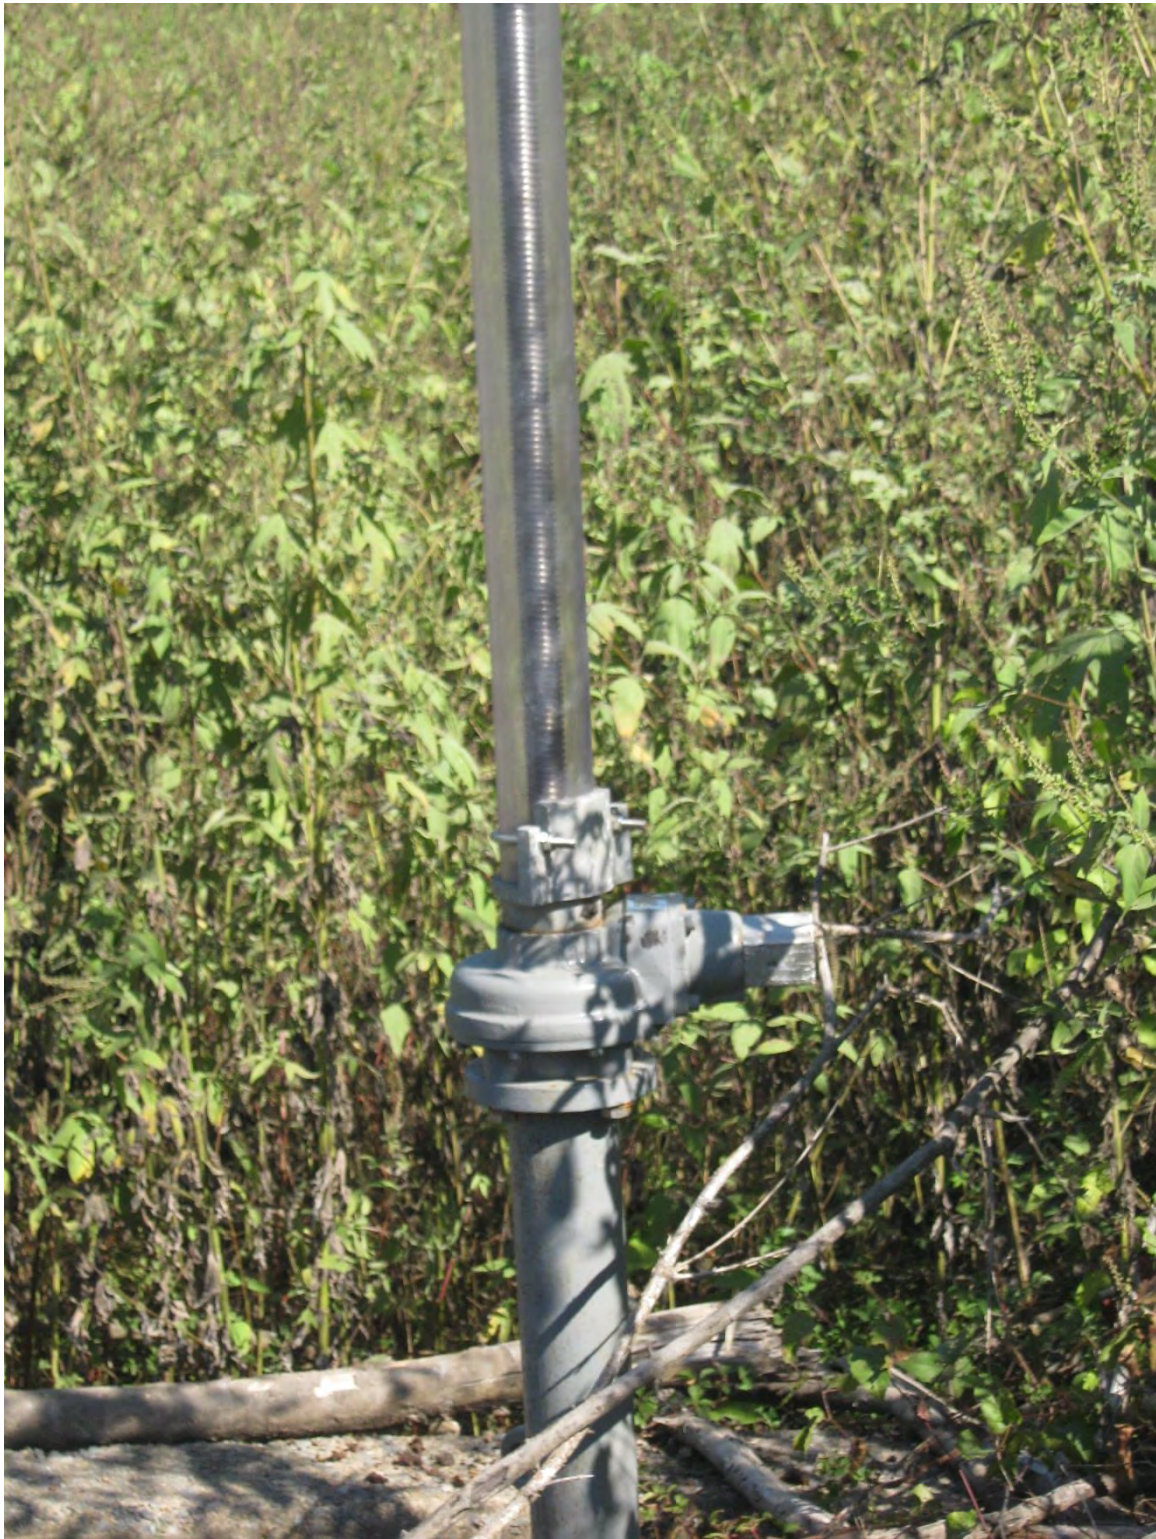
The north slide gate has been replaced by Ducks Unlimited under contract with the USFWS. A "Hydrogate", Model IB5, with a 4:1 lift ratio was used to replace the original sluice gate. See Figure 1.

Figure 1 - Area 1, New Gate Mechanism installed by USFWS in 2003.

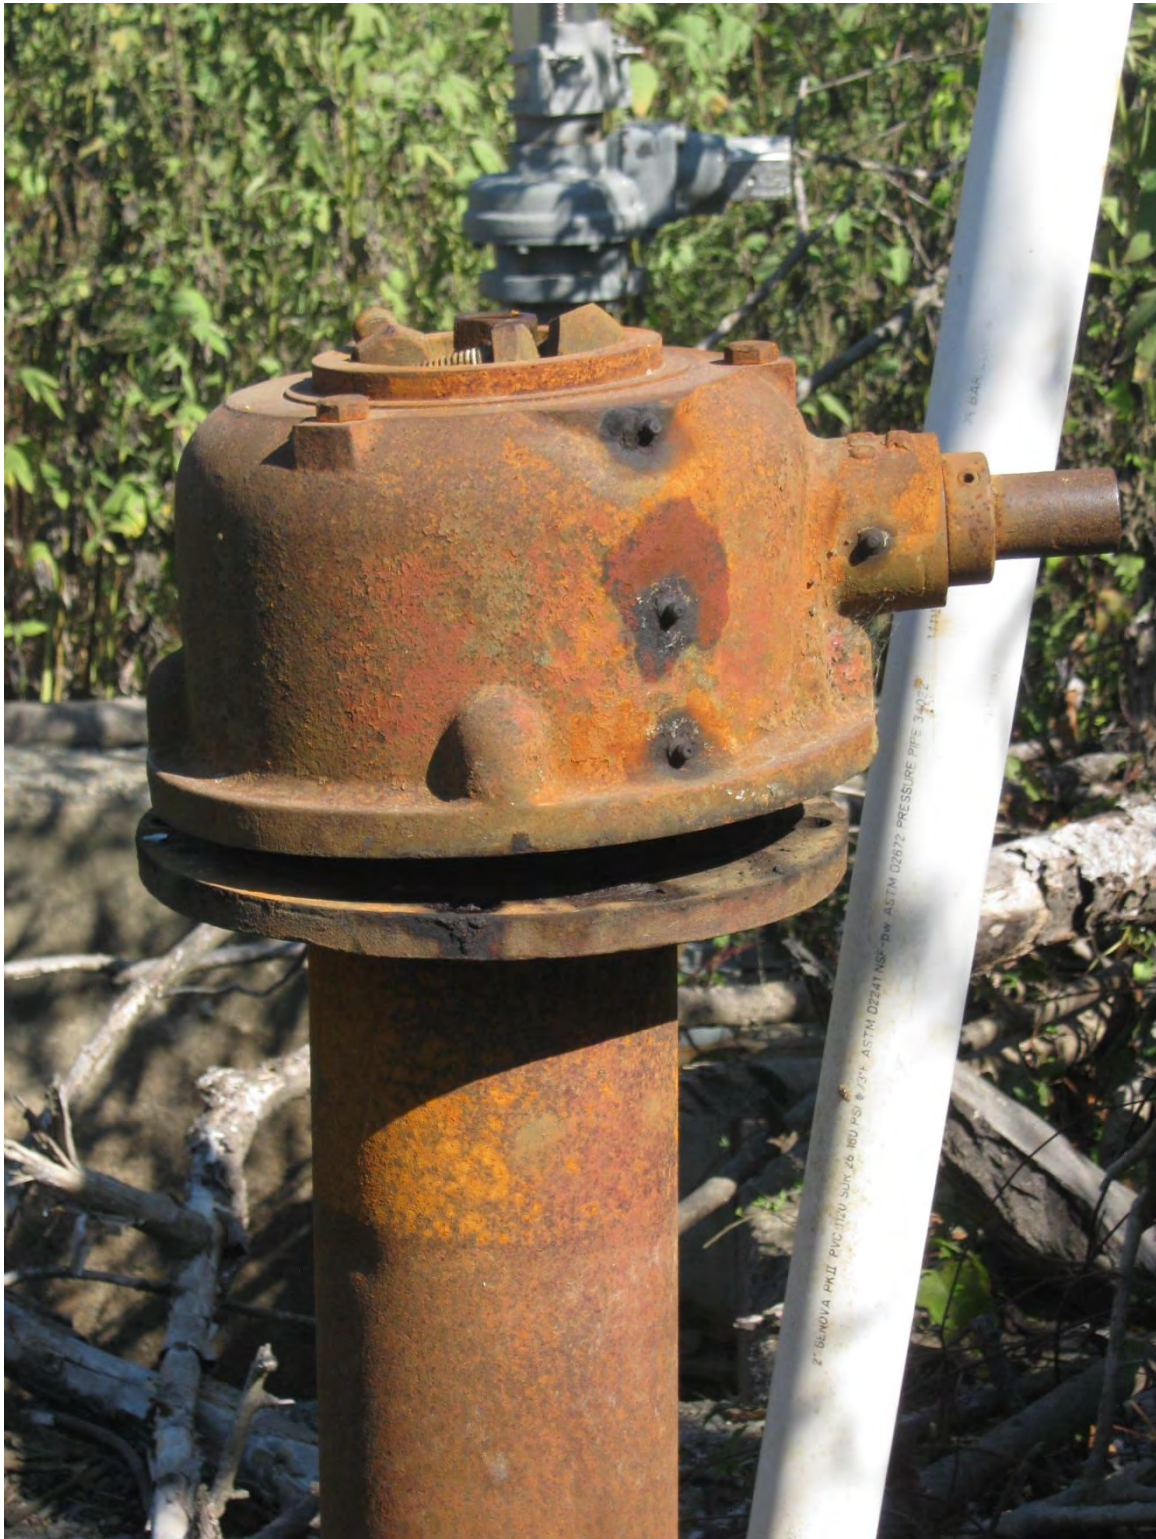
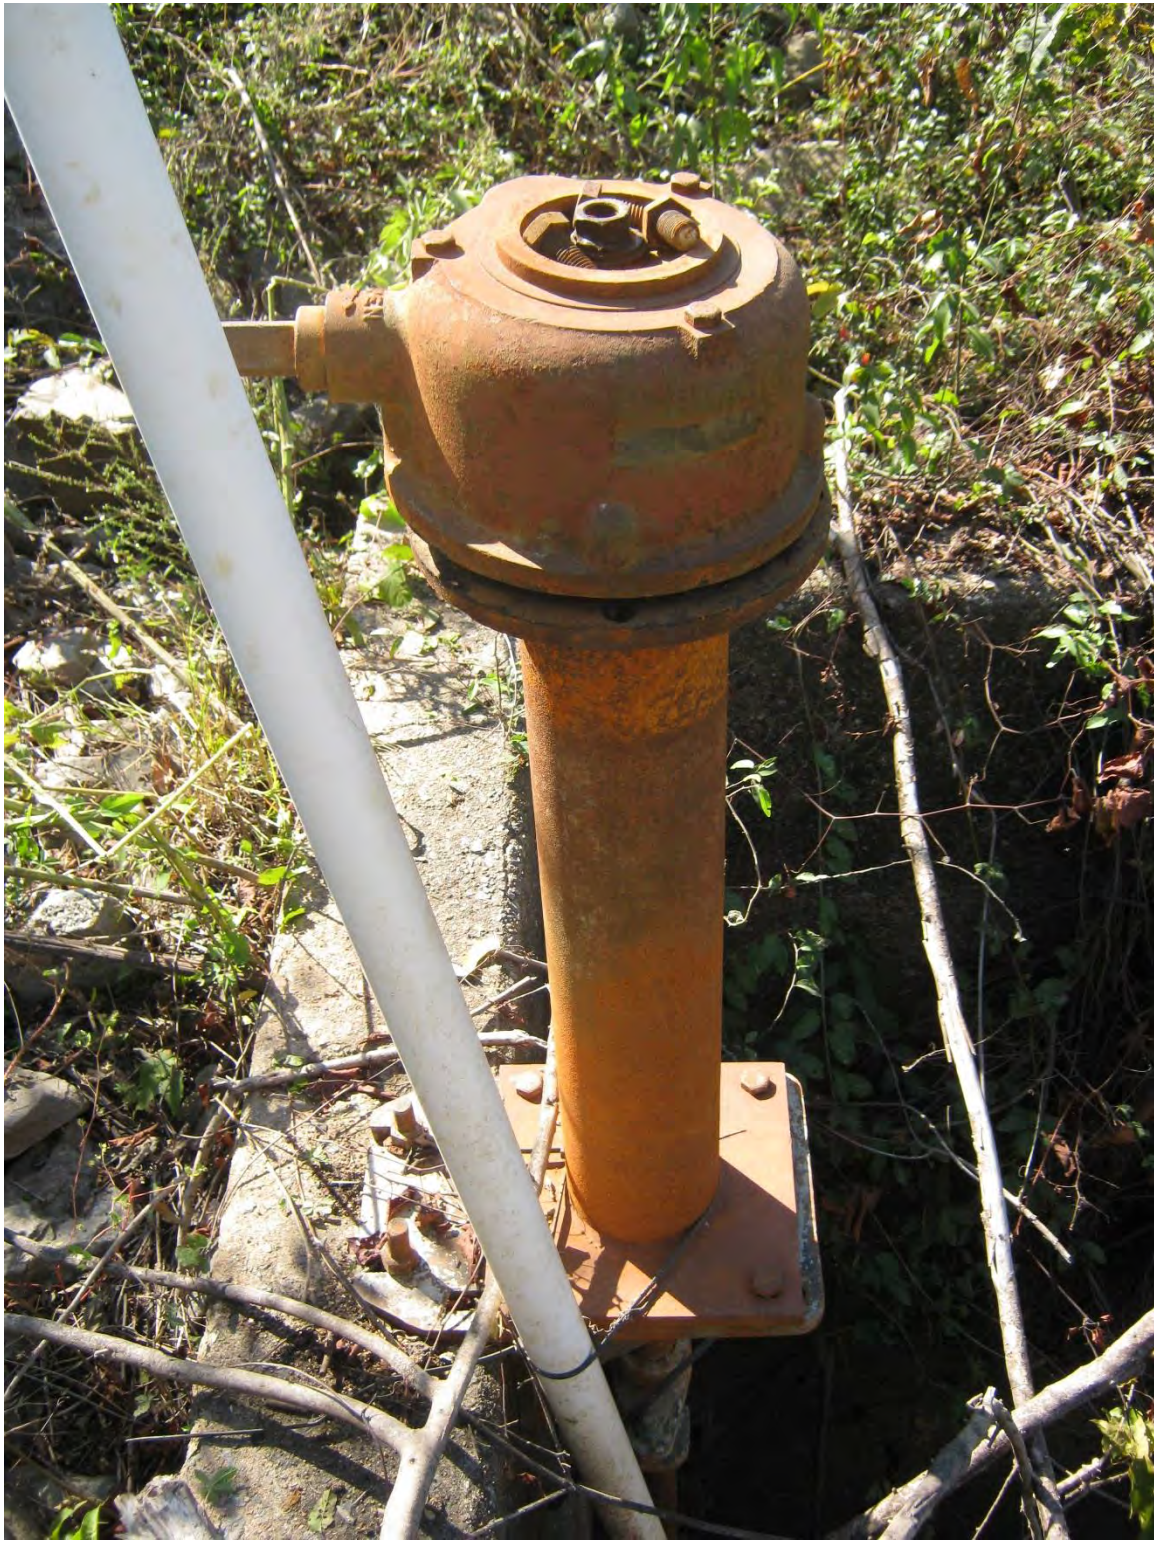
The south slide gate is still the original one installed. It has been partially disassembled and is currently inoperable. See Figures 2 and 3. In addition, the gate's guide brackets are not anchored to the concrete wall due to corrosion of the existing anchor bolts. See Figure 4. An attempt to re-anchor the guide brackets was never completed.

Figure 2 - Area 1, Existing Gate Mechanism (Note that it has been disassembled.)

Figure 3 - Area 1, Existing Gate Mechanism (Note that it has been disassembled.)

Recommendation: The south slide gate should be repaired or replaced to restore its operability. Where missing, the steel guide channel and concrete should be repaired. Both slide gates should be re-anchored to the concrete wall. All vegetative and earthen debris should be removed to insure successful operation of the entire structure as designed.

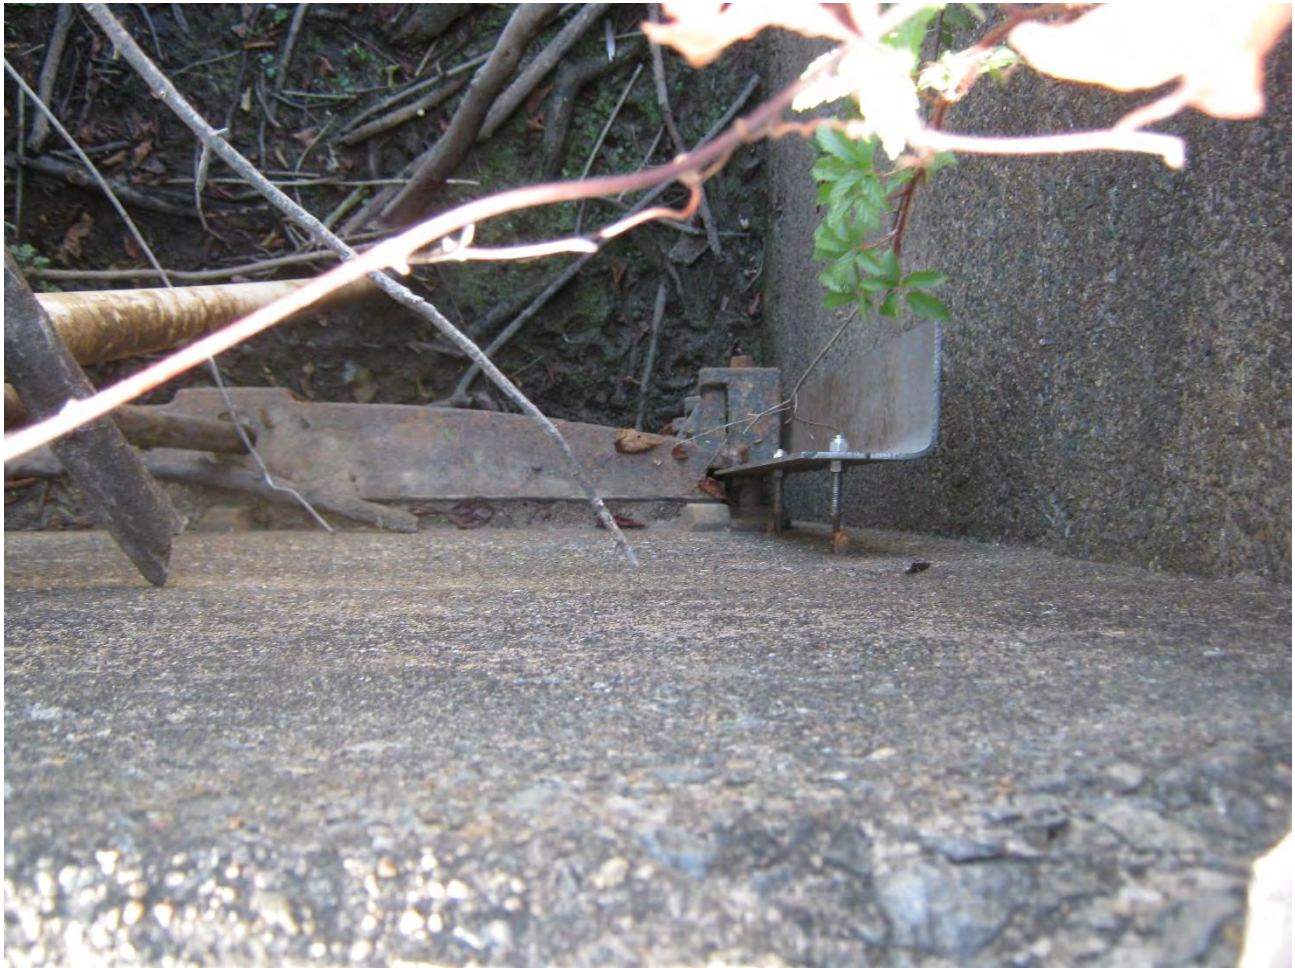
Figure 4 - Area 1 - Existing southern slide gate. Note that the anchor bolts are not connected.

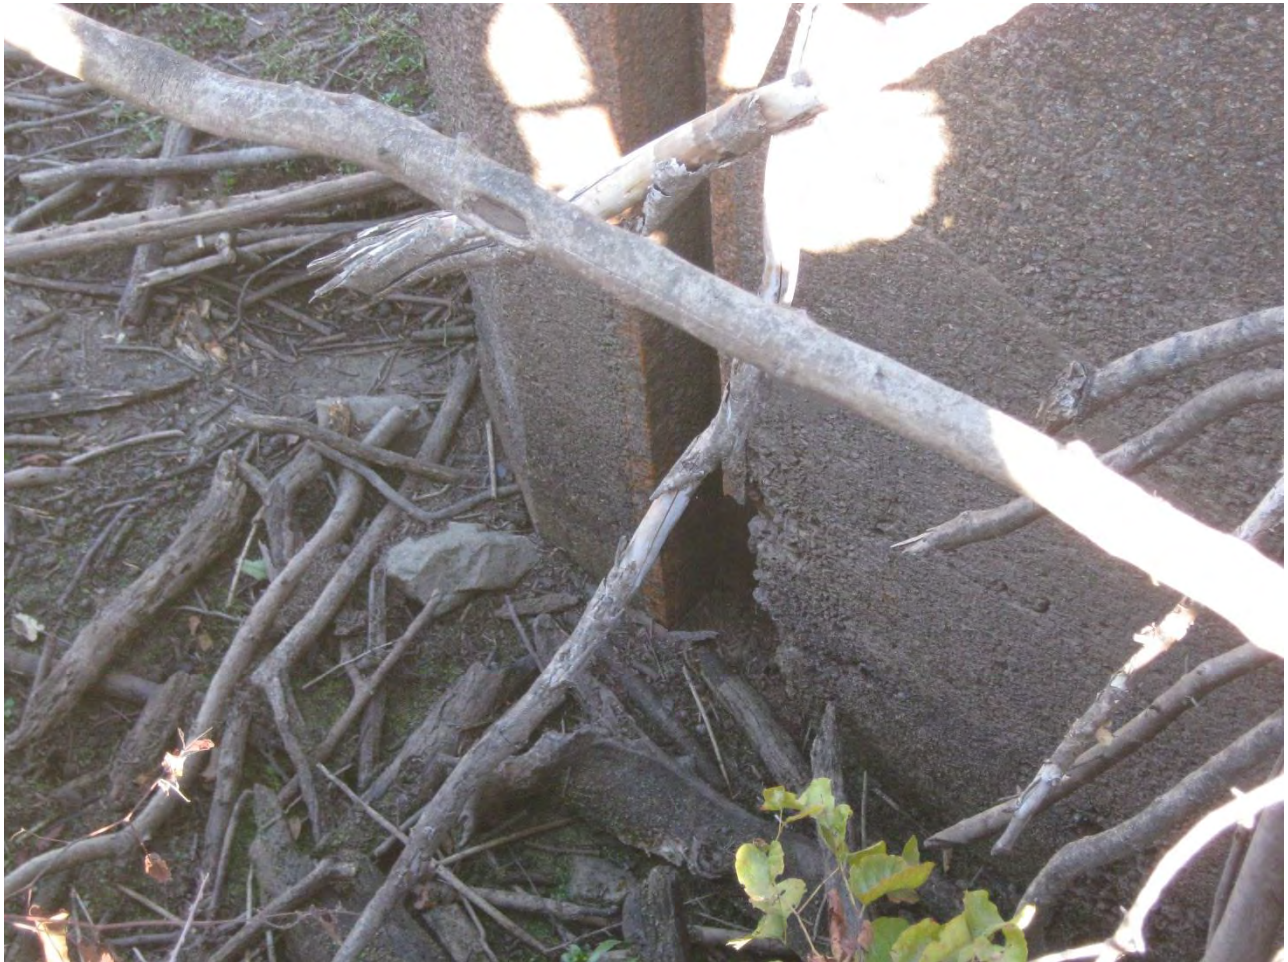
For the south slide gate, the concrete is pitted and at some locations adjacent to the stop log channels has broken away. In addition, the steel guide channels for the stop logs has

corroded and is partially missing. See Figure 5. Vegetative and earthen debris has partially blocked the use of the gates. See Figures 5 and 6.

Figure 5 - Area 1, Debris and missing guide frame and concrete spalling. North side of the southern 60" concrete pipes inlet.

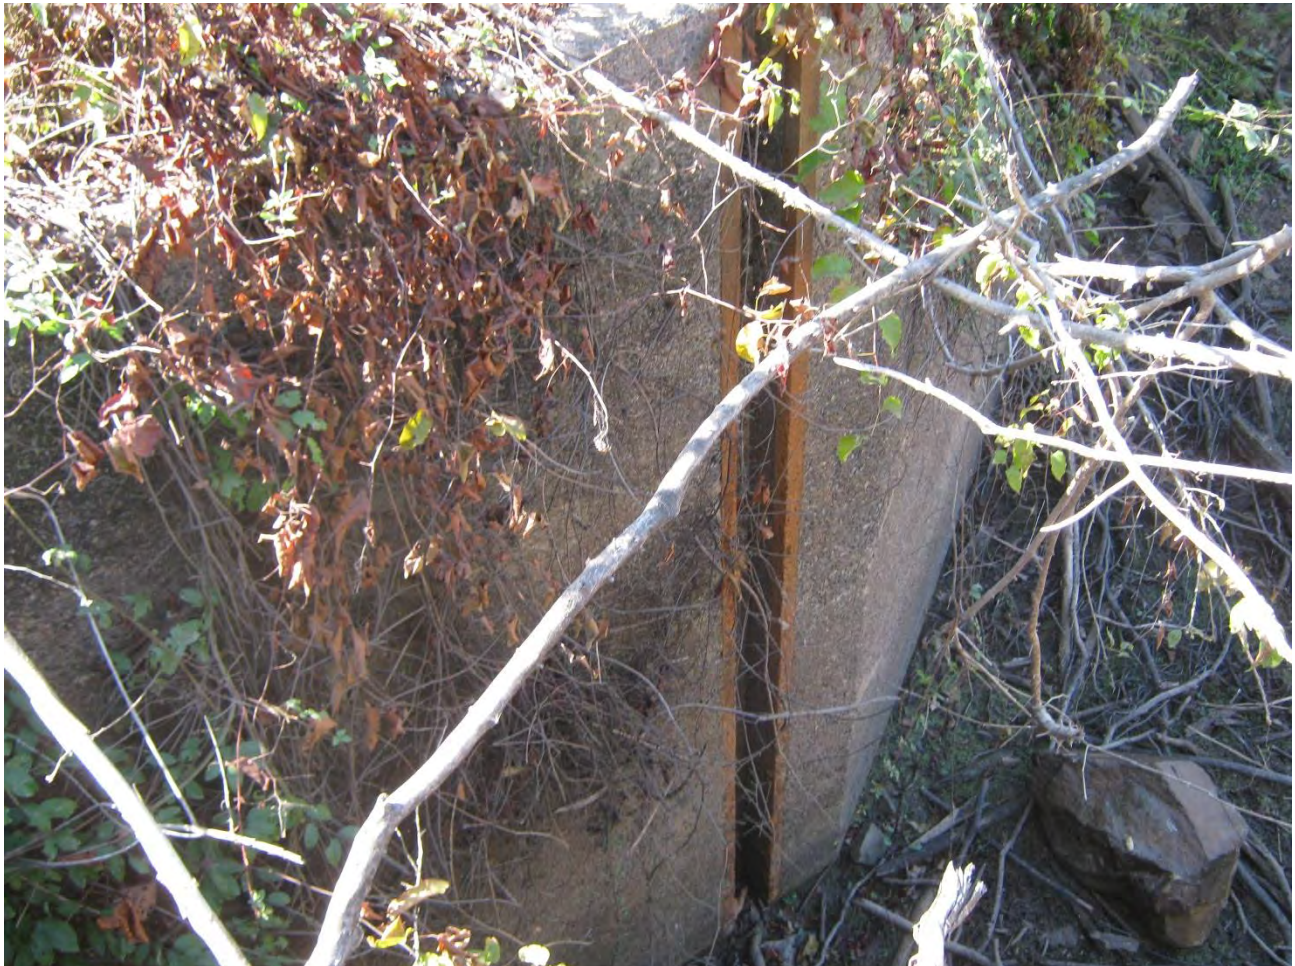
Figure 6 - Area 1, Debris and guide frame. South side of the southern 60" concrete pipes inlet.

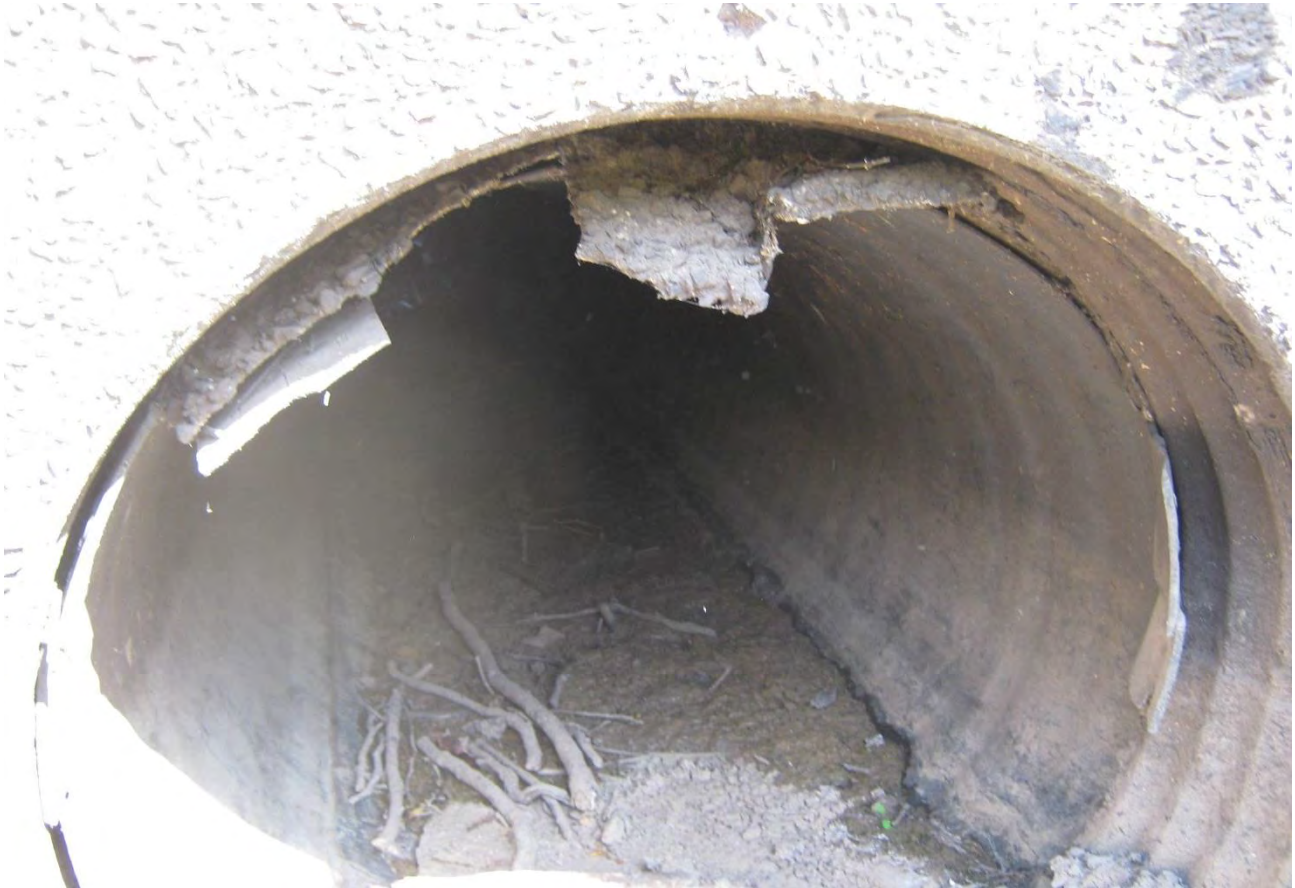
Figure 7 - Existing 36" CMP, 5440 feet east of Area 1. Typical liner installation. Note the poor liner adhesion at the pipes entrance.

Recommendation: With the exception of the end areas, the liner does seem to be functioning, however USACE's preferred method of repair would have been to use the SnapTite liner system and grout the annular space that remains to restore the pipes structural integrity and prevent soil intrusion. The USFWS should periodically inspect the liner to insure further failure has not occurred. Other than removal of the sediment deposit at the upstream end of the pipe, no further action is recommended.

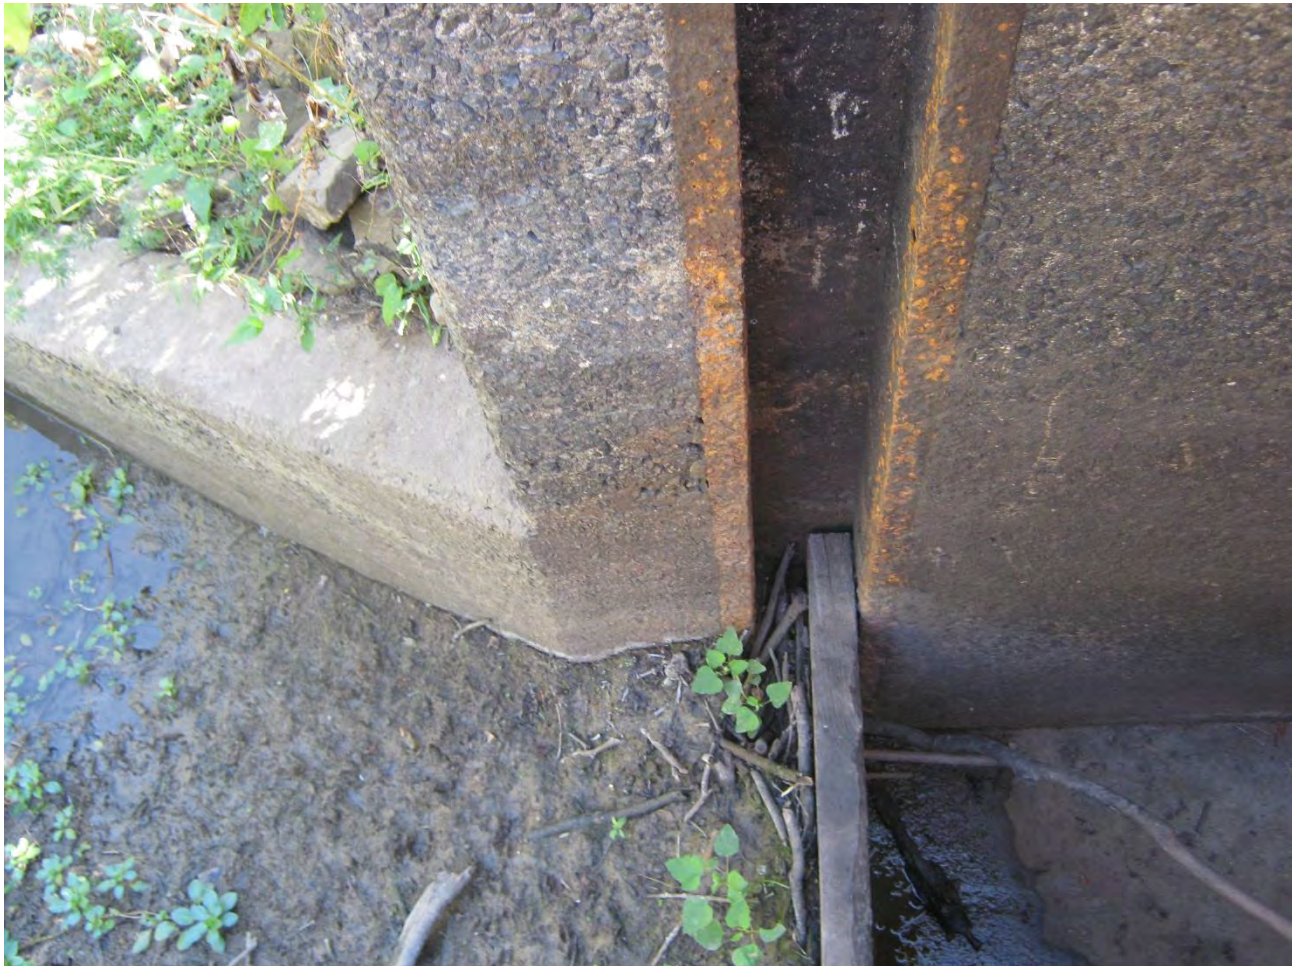
Figure 8 - Existing 36" CMP inlet 5440 feet east of Area 1. Typical guide installation. Note sediment on upstream side.

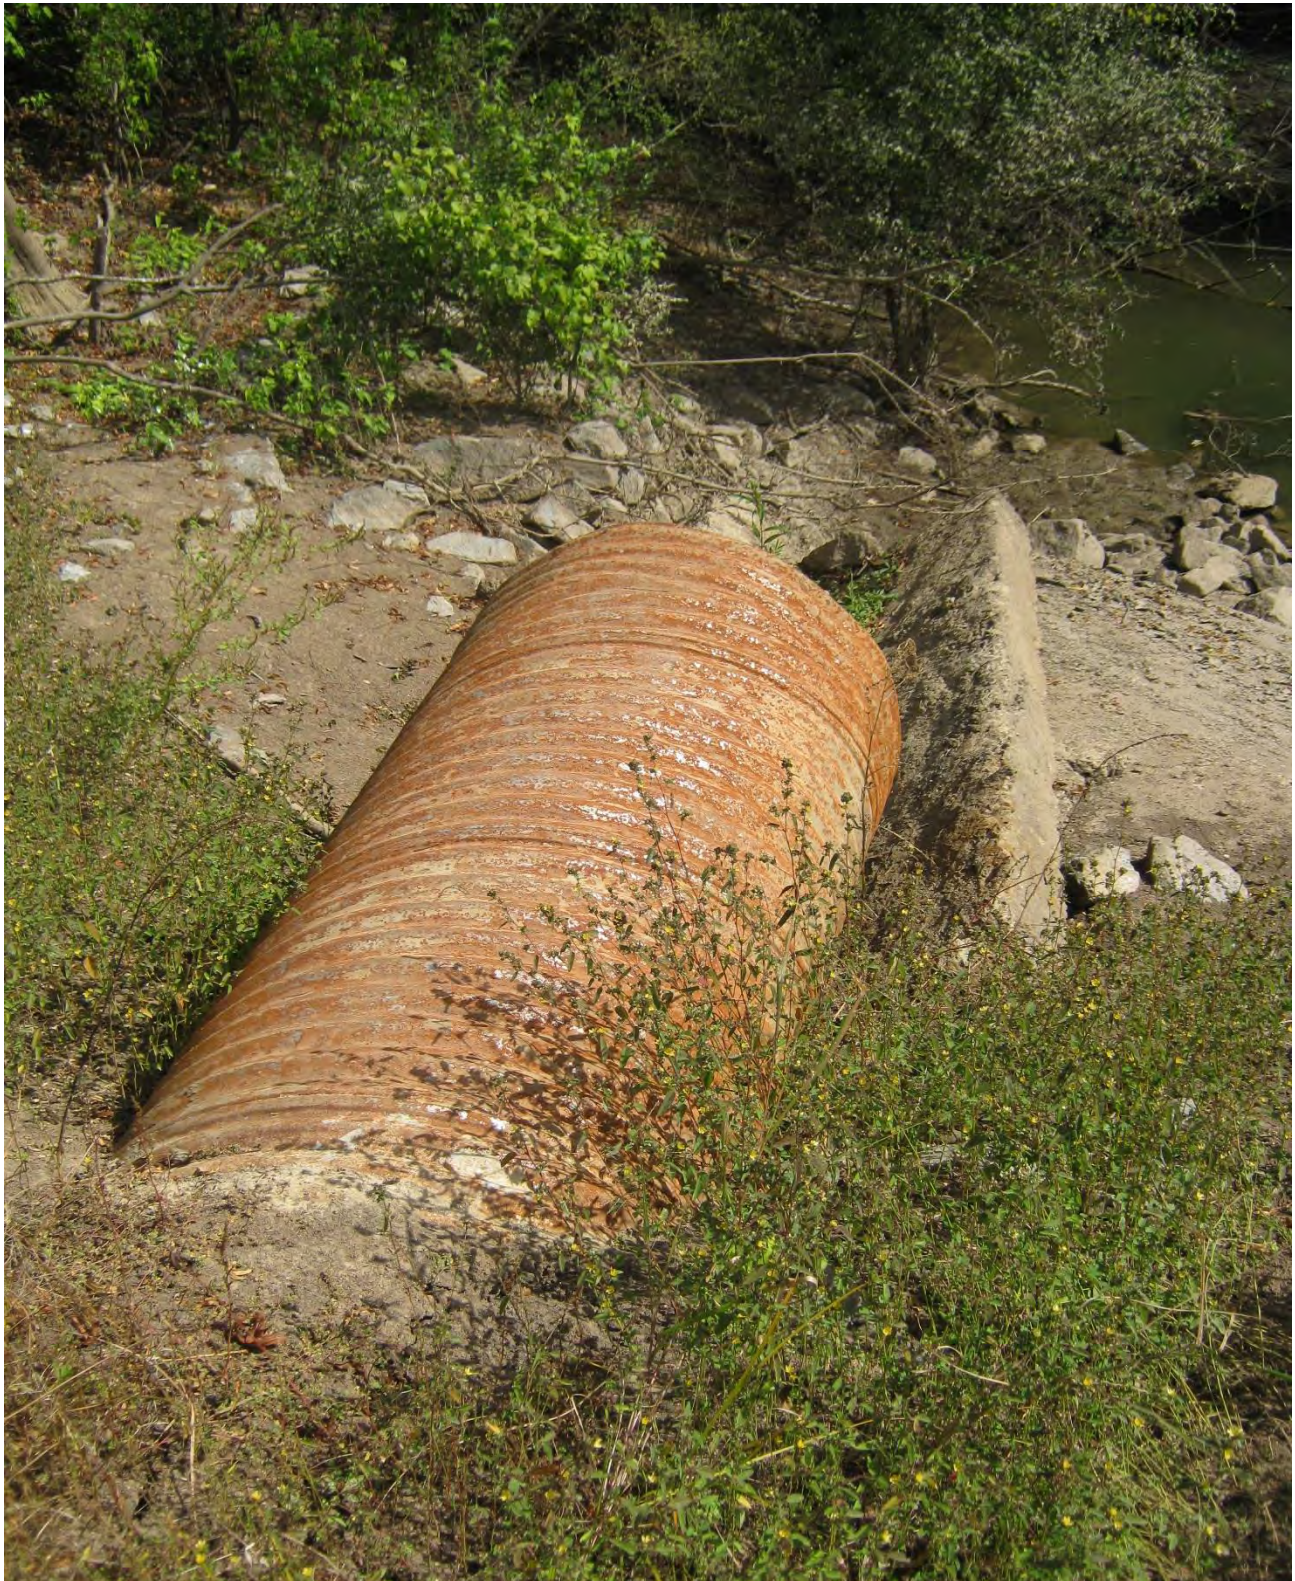
As mentioned in the Deficiencies Report the culvert has been replaced by the USFWS with a 36" CMP. The outlet looked like it had been armored with a combination of stone and concrete. See Figure 9. The existing levee looked in good shape and did not appear to require widening or additional stone protection. The drainage from the culvert does not go directly to the river but turns southerly and follows an old channel between the levee and the river. This channel has experienced some erosion in localized areas that are not very big. The USFWS has indicated that the sluice gate and culvert are not currently being used and that their preference would be to block them. These issues appear to fall within the Operation and Maintenance obligations of the USFWS.

Figure 9 - Area 4, Outlet end of 36" CMP replaced by the USFWS.

Recommendation: No further action is required.

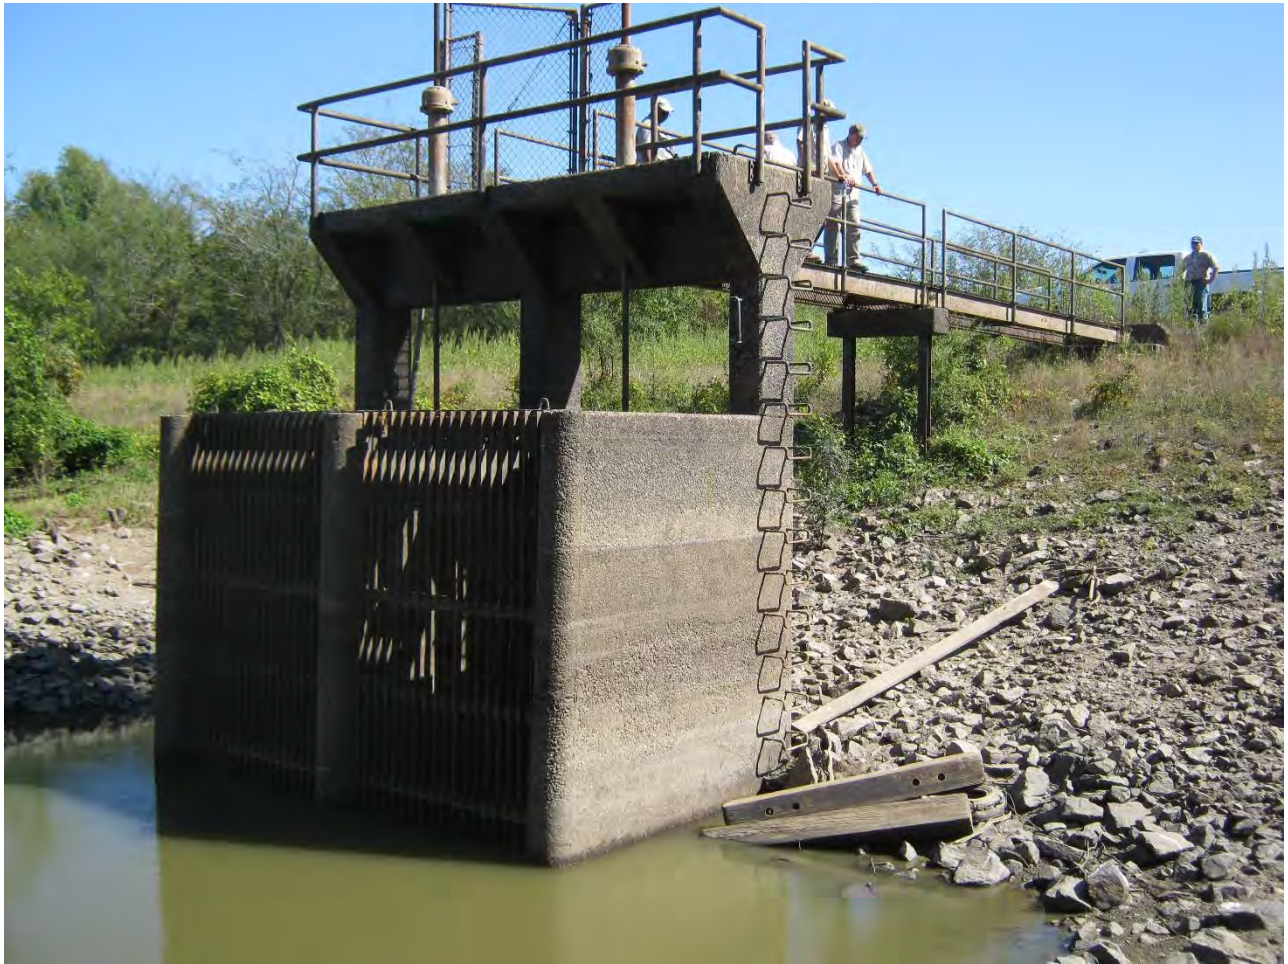
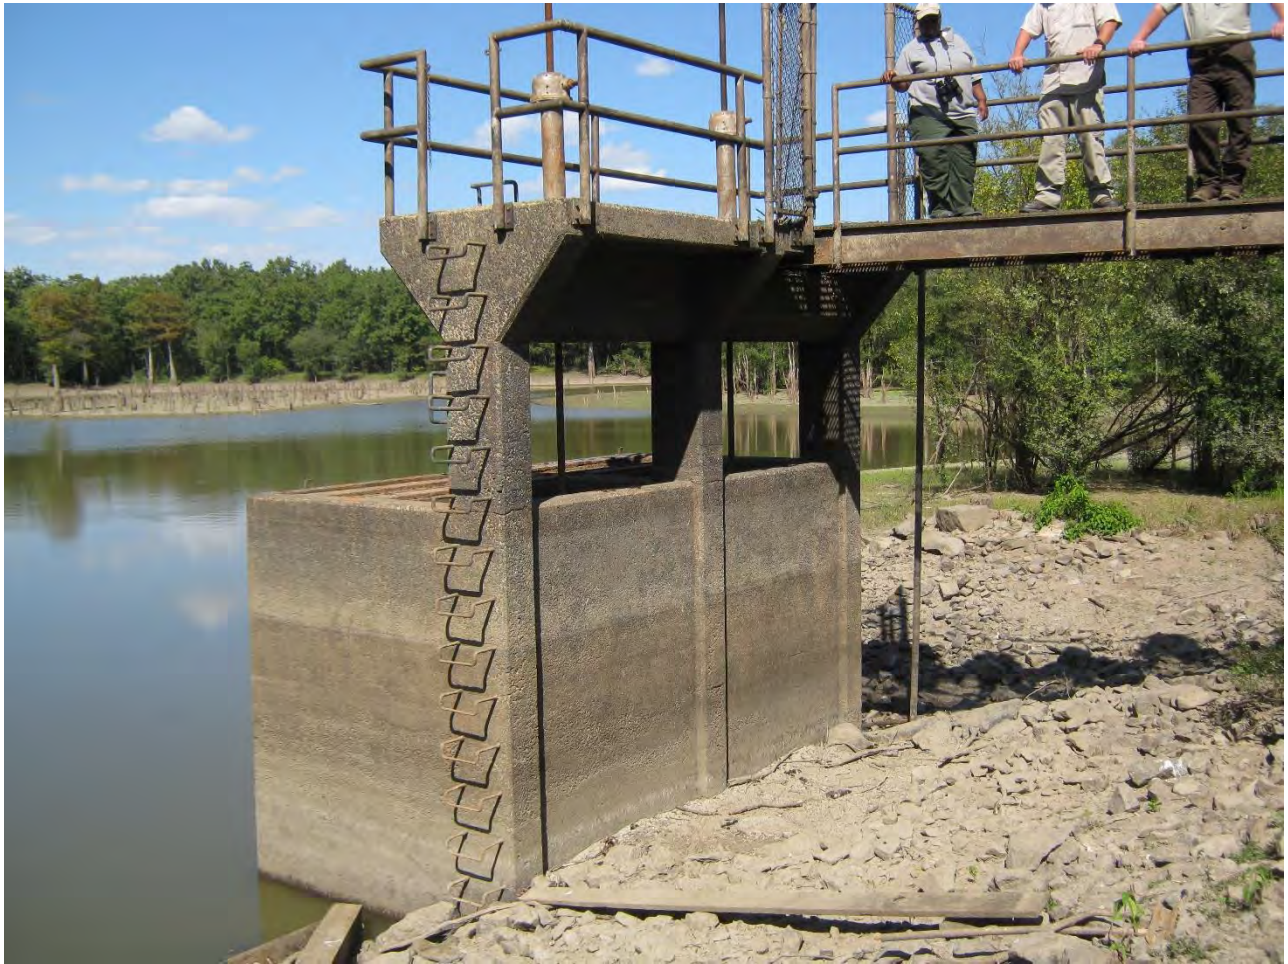
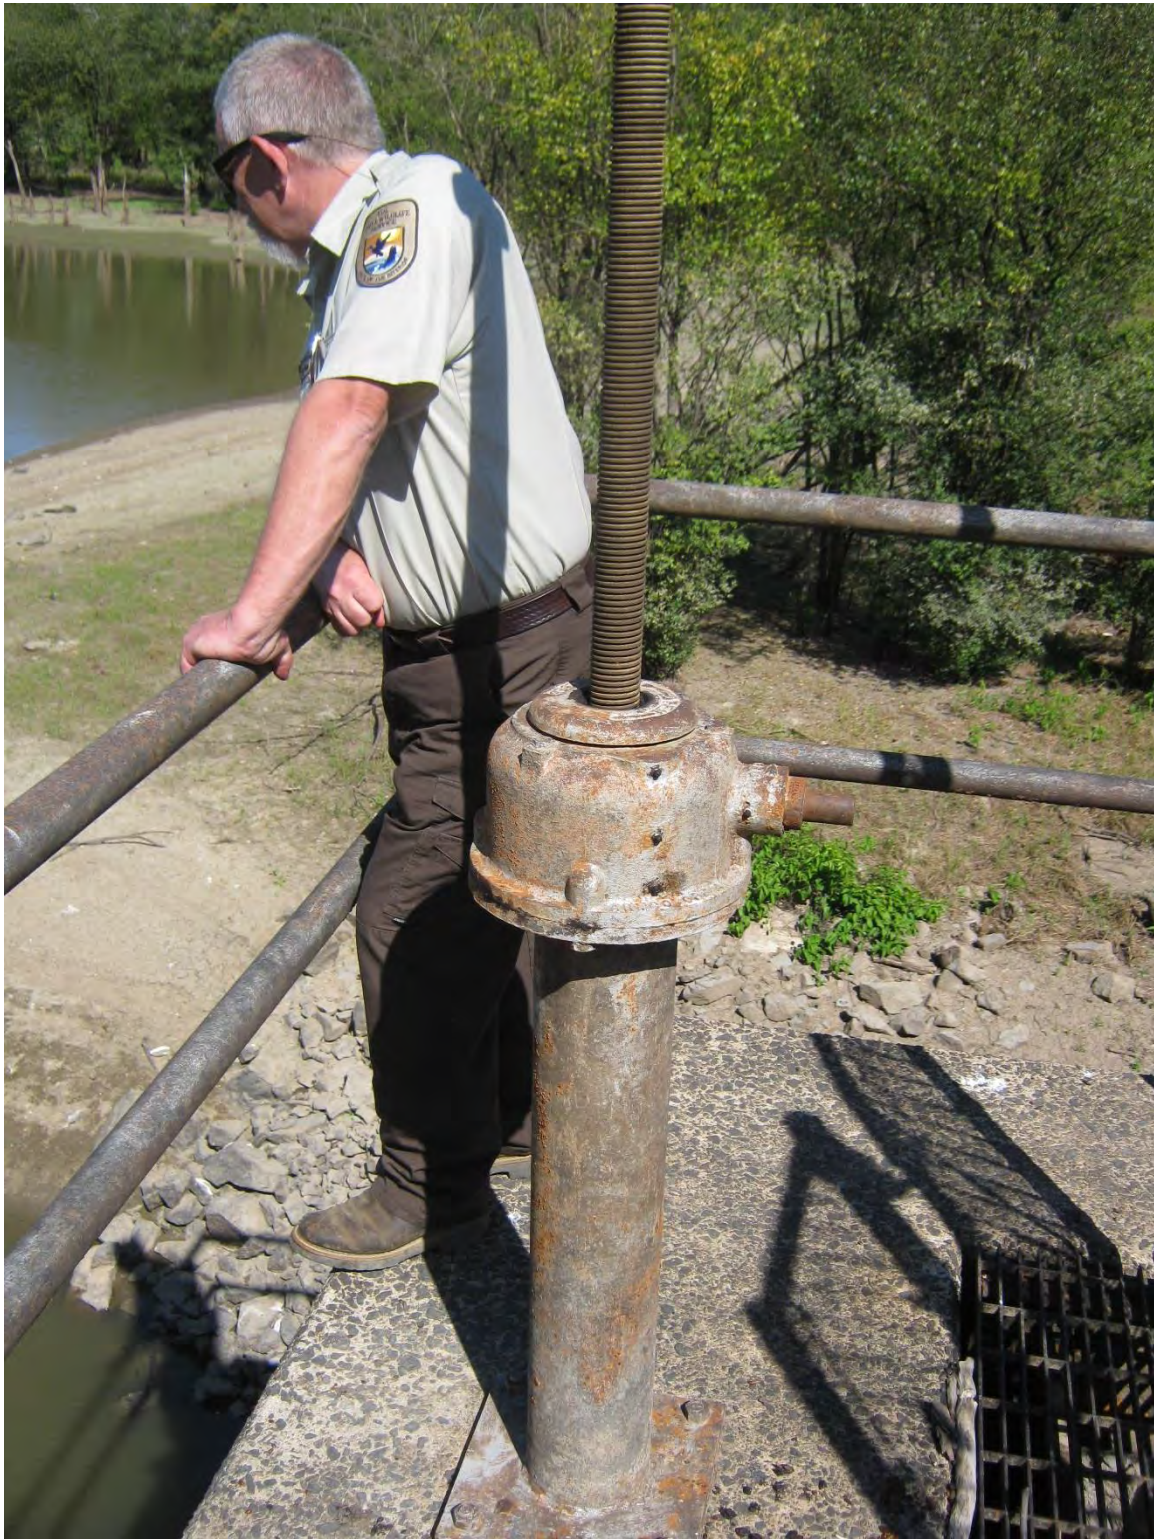
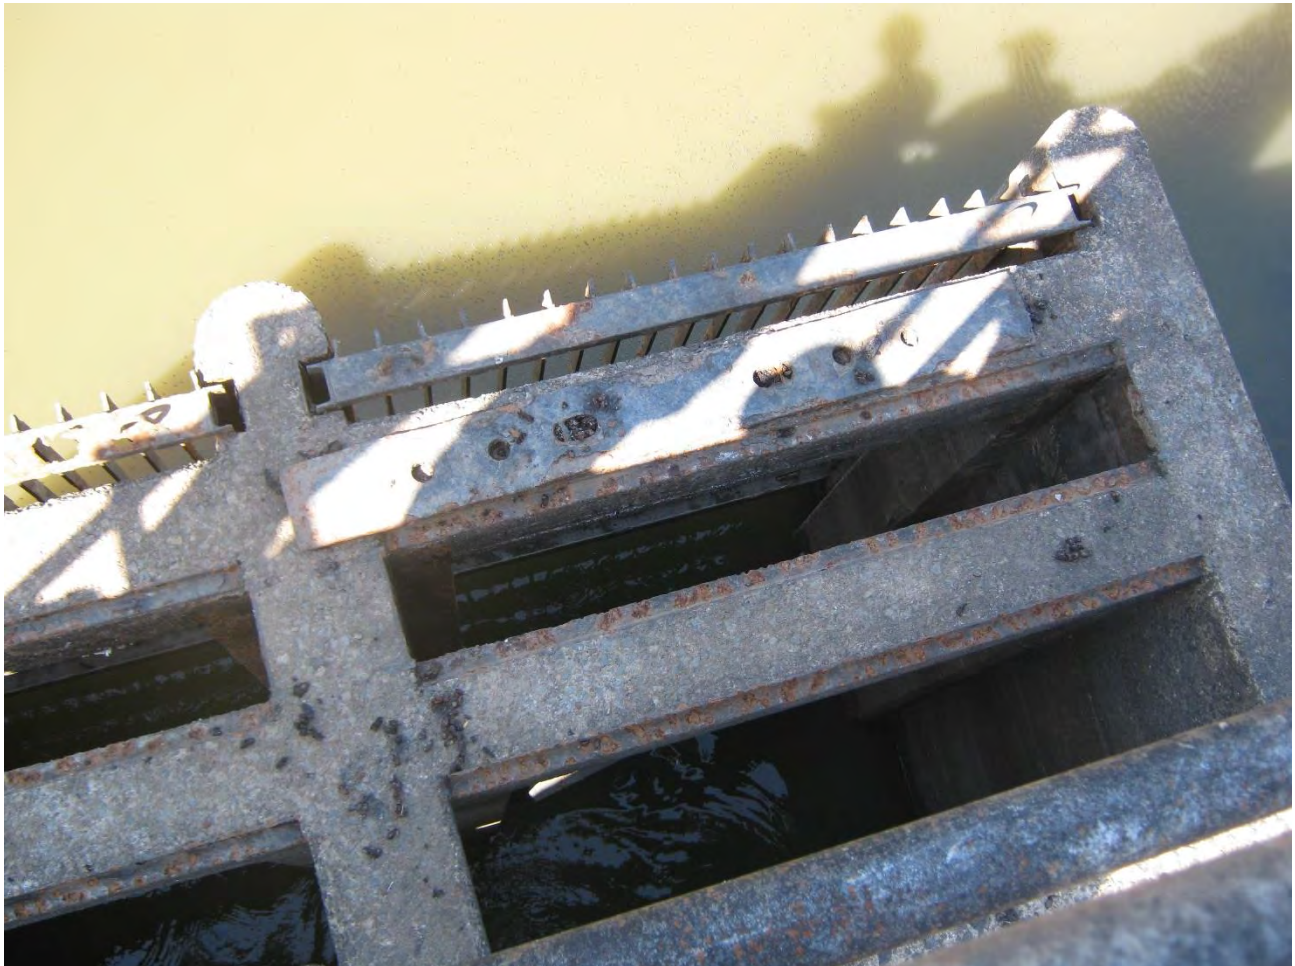
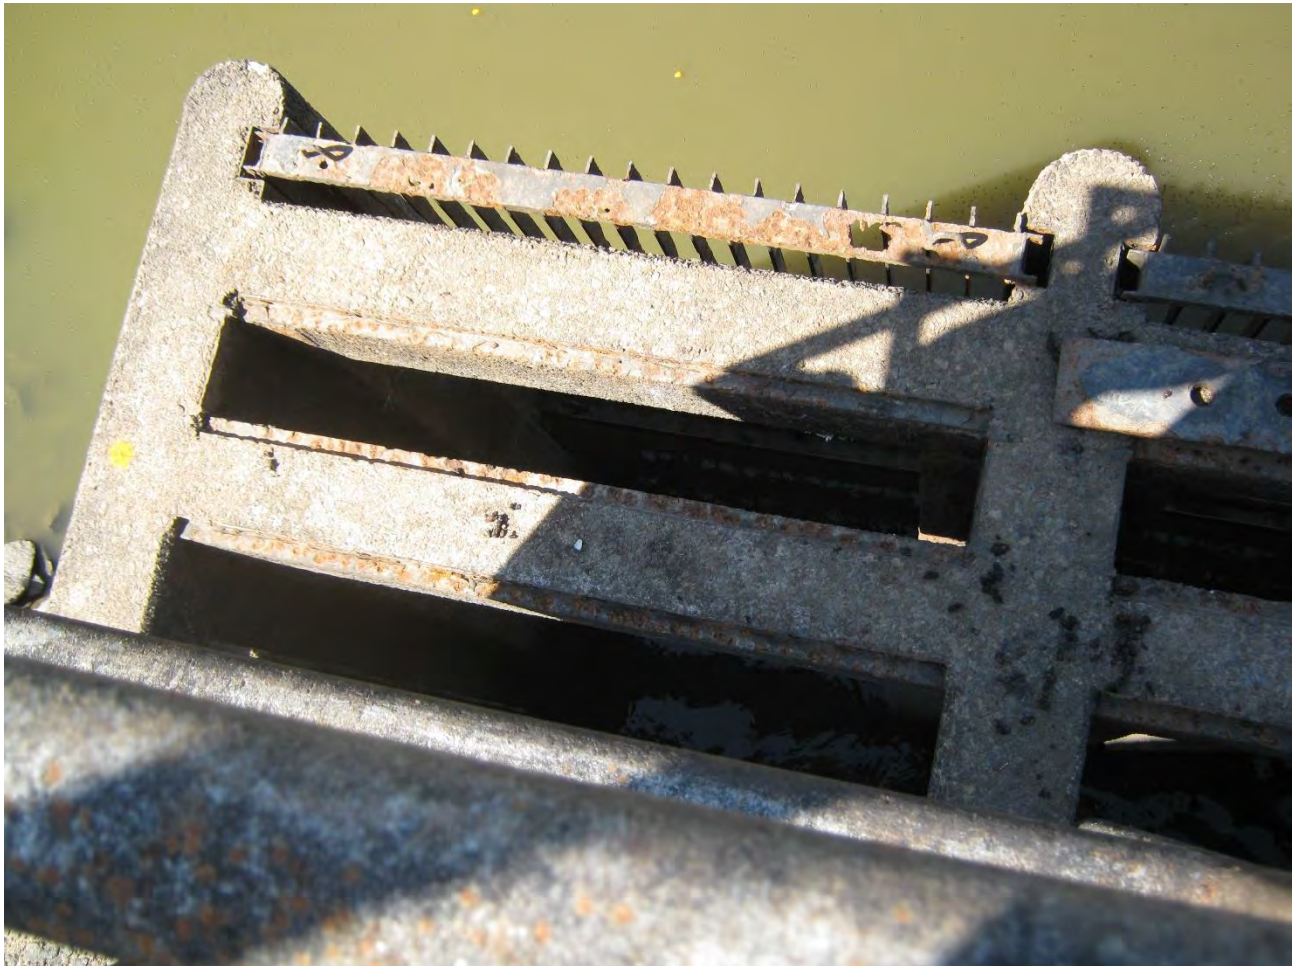
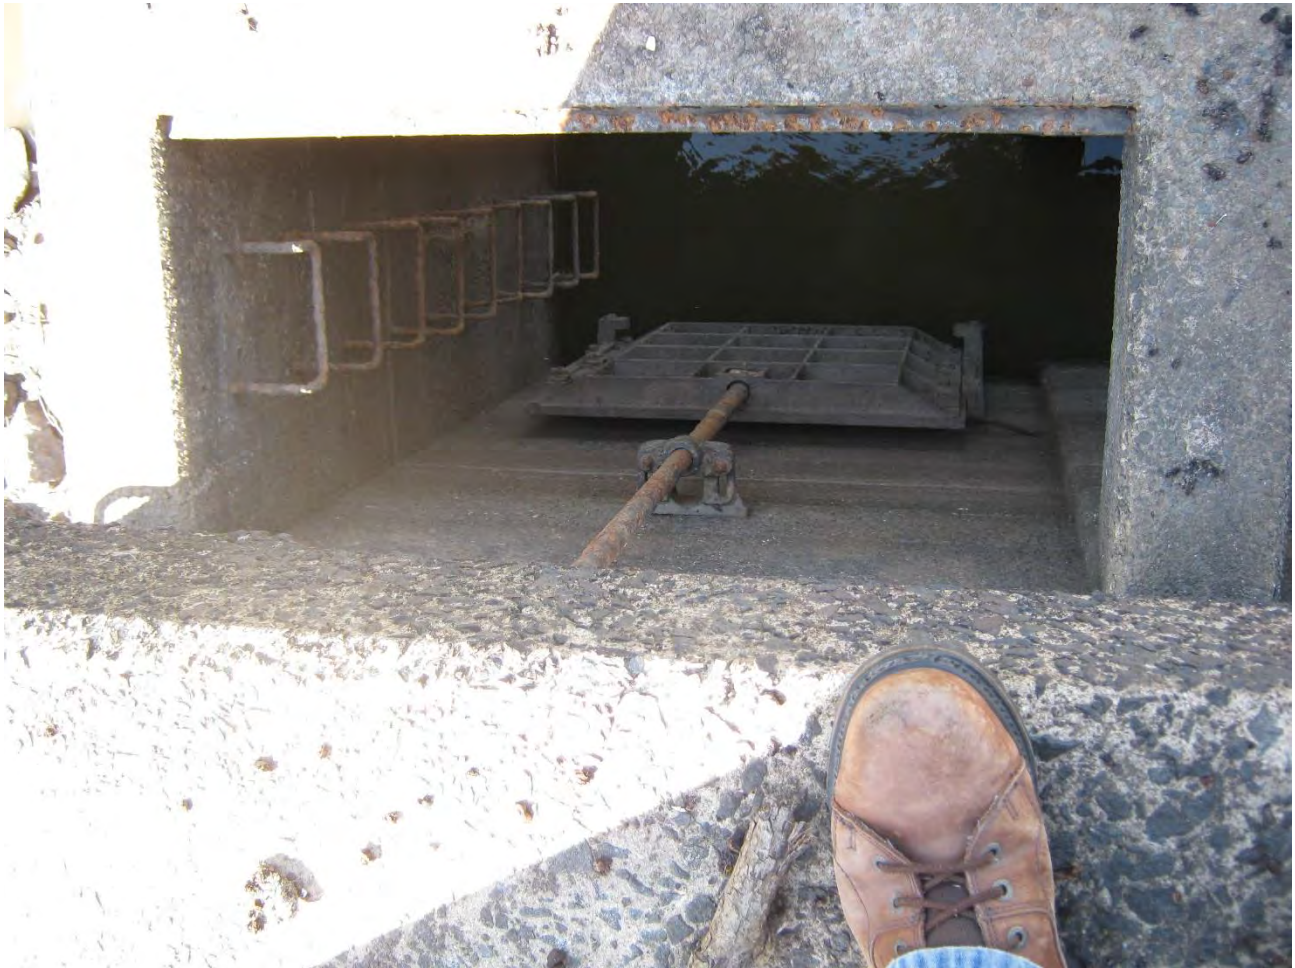
During the site visit the USFWS requested that the Dry Lake Gate Structure be looked at. Figures 10 – 16 provide representative views of the structure. A visual inspection indicated the structure was in good shape. Some minor repairs are required. They include rehabilitating and adding a protective coating to the trash racks to repair the holes which have appeared over time. The second would be to replace the missing covers over the grating. See Figure 14. The structure's outlet pipe is served by two CMP of unknown size. No physical damage was witnessed, but due to their age it is believed they are approaching their useful life and should be considered for lining sometime in the near future.
