Three Rivers Southeast Arkansas Study

Appendix C: Engineering

**Report on Design and Construction Deficiencies in the Dale Bumpers White River
National Wildlife Refuge, Arkansas**

SUBJECT: Site Visit to Inspect MKARNS Construction Deficiencies of Mitigation Structures
Dale Bumpers White River National Wildlife Refuge (WRNWR), Arkansas

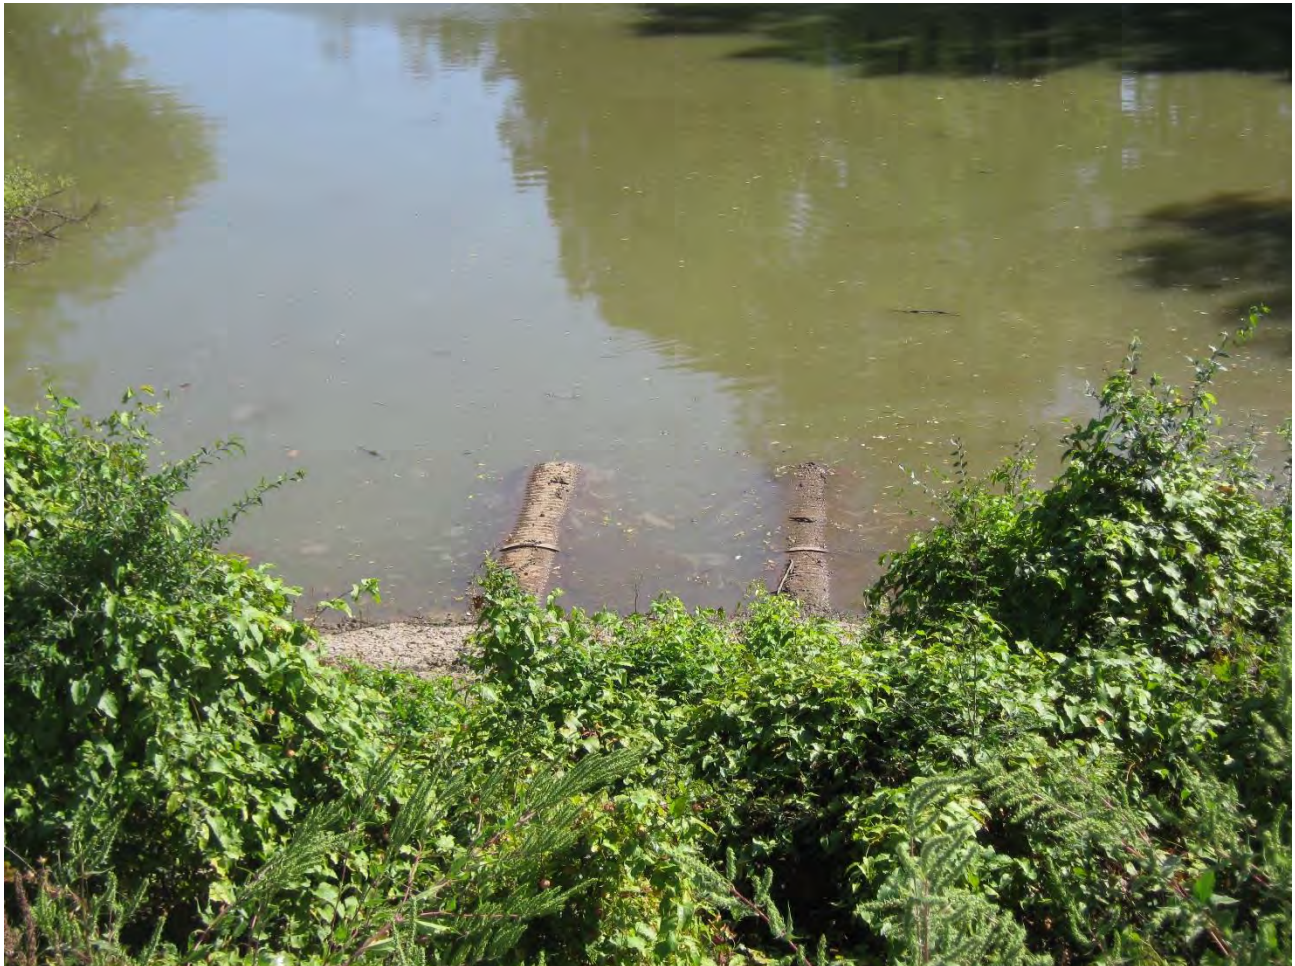
During the site visit the USFWS requested that the Dry Lake Gate Structure be looked at. Figures 10 – 16 provide representative views of the structure. A visual inspection indicated the structure was in good shape. Some minor repairs are required. They include rehabilitating and adding a protective coating to the trash racks to repair the holes which have appeared over time. The second would be to replace the missing covers over the grating. See Figure 14. The structure's outlet pipe is served by two CMP of unknown size. No physical damage was witnessed, but due to their age it is believed they are approaching their useful life and should be considered for lining sometime in the near future.

Figure 16 - Dry Lake Structure Outlet. (Not part of original mitigation deficiencies.)
