# Gum Log Creek Mitigation Bank Prospectus

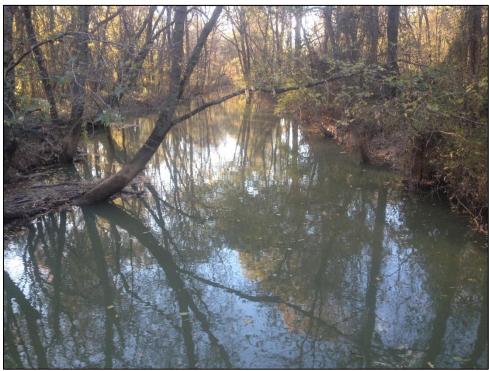
Gum Log Creek is a third order stream ~40ft wide flowing east to west across the northern portion of the property. Approximately 1,313LF of Gum Log Creek flows through the property. The ditched channel shows moderate to heavy evidence of lateral stress. Exposed streambanks will be stabilized using appropriate methods (Appendix B: Photos 1 & 2).

**Photo 1:** Photo Point 1 Gum Log Creek facing upstream showing straightened channel

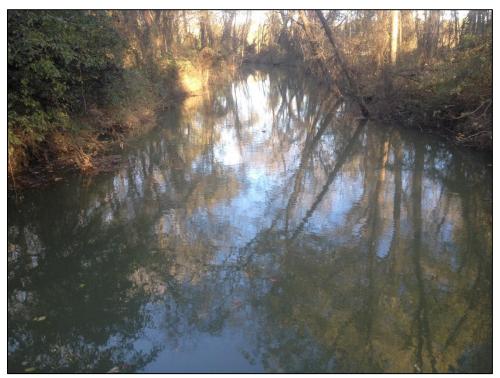
**Photo 2:** Photo Point 1 Gum Log Creek facing downstream showing straightened channel

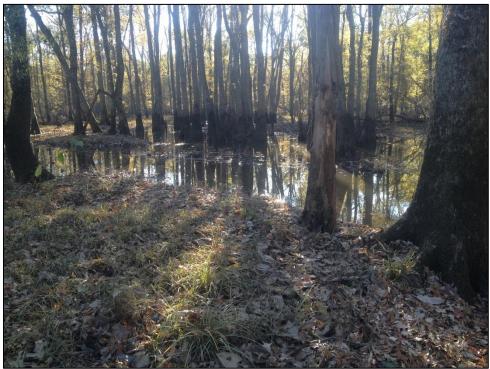
Reach B is a perennial channel that flows  $\sim$ 2,752LF from west to northeast through the center of the property. After the logging activities, tree tops and slash were left in the upper portion of the channel causing impacts to channel stability (Appendix B: Photos 3 & 4).

Photo 3: Photo Point 2 facing upstream on Reach B

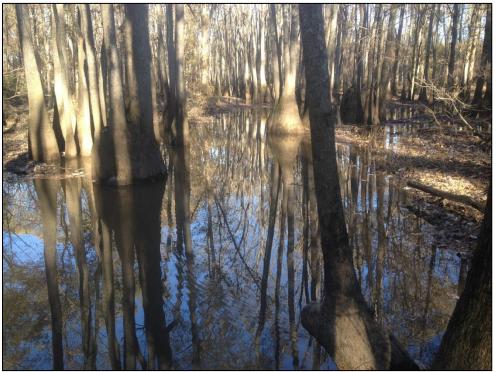
Photo 4: Photo Point 2 facing downstream on Reach B

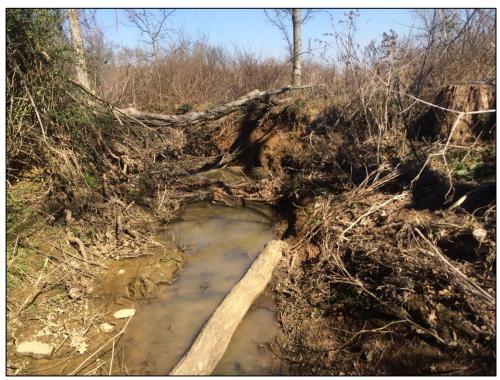
Reach C flows from the western boundary of the property to the northeast for ~764LF before flowing onto the adjacent property. This portion of Reach C lies within the clear-cut portion of the property (Appendix B: Photos 5 & 6). The channel is filled with slash piles, is moderately incised, and has been disturbed by logging equipment. Reach C re-enters the property and flows for ~1,103LF before it converges with Reach B. This portion of Reach C has no continuously defined channel. The brush piles and logging debris will be removed from the channel. Where the channel is undefined it will be reconstructed restoring it to appropriate dimension, pattern, and profile.

**Photo 5:** Photo Point 3 Reach C facing downstream showing incision and logging debris in channel

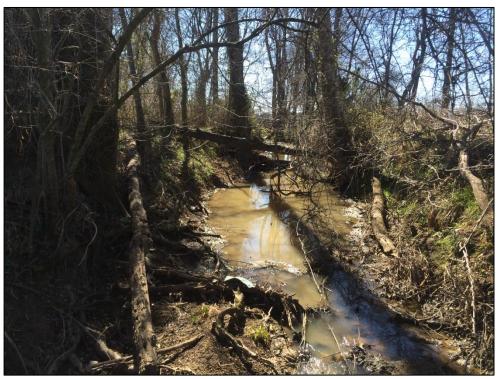
**Photo 6:** Photo Point 3 Reach C facing upstream showing incision and logging debris in channel

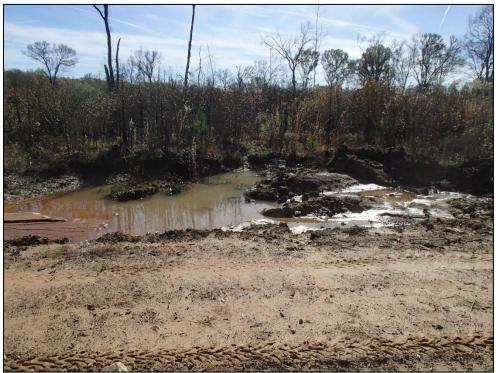
**Photo 7:** Photo Point 4 Reach D facing upstream showing sediment and logging damage

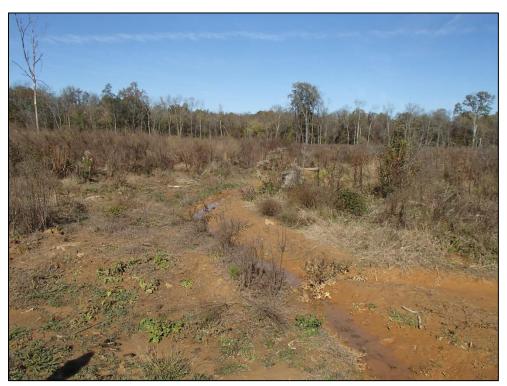
Photo 8: Photo Point 4 Reach D facing downstream showing sediment deposition

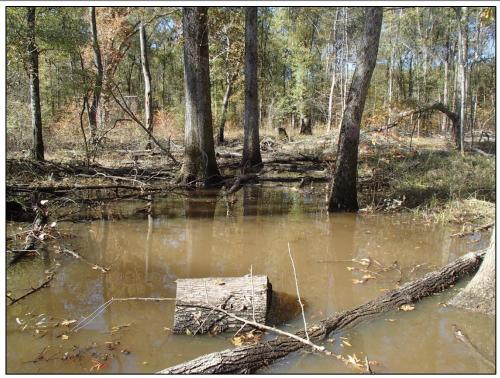
**Photo 9:** Photo Point 5 Reach G facing upstream showing logging debris within channel

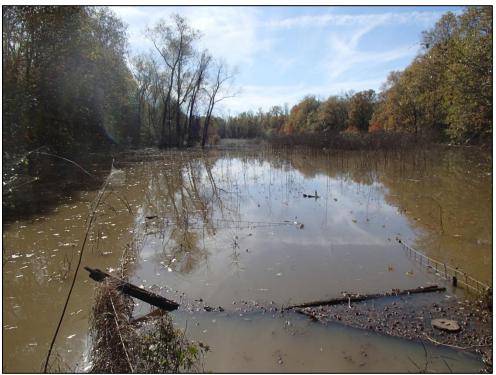
Reach F flows from west to east for  $\sim$ 465LF before it converges with Reach I. Reach F has been filled and has multiple head cuts migrating up stream (Appendix B: Photo 10). The channel will be reconstructed and the head cuts arrested.

Photo 10: Photo Point 6 facing upstream on reach F and the surrounding wetland area

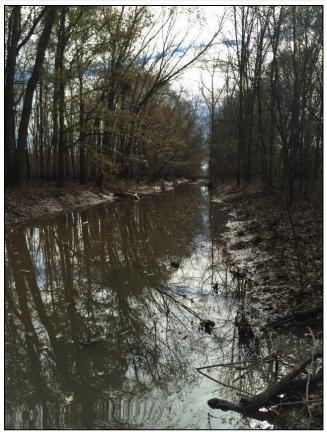
Preliminary site surveys found that White Oak Creek is a 20-30 ft. wide perennial channel that flows for  $\sim 1$  mile south to north along the eastern boarder of the site. White Oak Creek drains the City of Atkins and has been straight line ditched. The channel has multiple head cuts and is moderately incised. White Oak Creek will be reconstructed to be more closely aligned with historical conditions (Appendix B: Photos 11 & 12).

**Photo 11:** Photo Point 6 facing upstream on White Oak Creek showing straightened channel

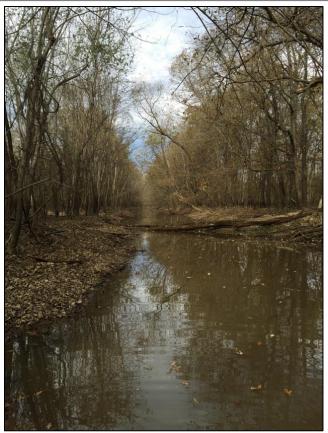
**Photo 12:** Photo point 6 of White Oak Creek facing downstream showing straightened channel

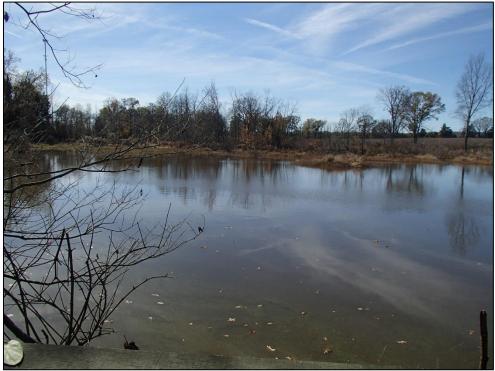
Reach G flows from west to east for  $\sim$ 3,513LF across the property. The upstream portion of Reach G flows through the southern portion of the clear-cut area before entering a pond (Appendix B: Photos 13 & 17). Within this section slash has been piled in the channel and multiple head cuts are migrating upstream. The section of Reach G downstream of the pond flows through the thinned timber and converges with Reach B (Appendix B: Photos 9, 14, 15 & 16). Within this section, slash has been left in the channel and the channel has been ditched. Debris piles will be removed from the upper portion of Reach G and the pond levee will be lowered to create deep water wetland habitat. In the lower section of Reach G, the slash will be removed and the channel returned to proper pattern, dimension, and profile.

Photo 13: Photo Point 7 showing a pond on Reach G

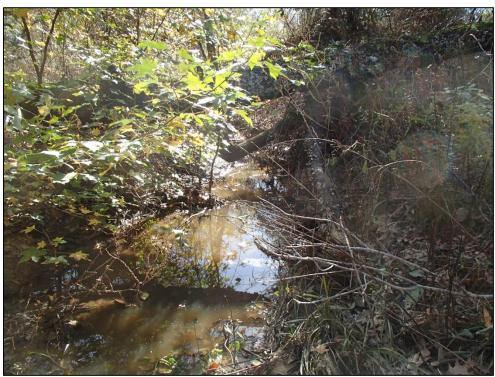
**Photo 14:** Photo Point 8 upstream on Reach G showing logging debris in the channel

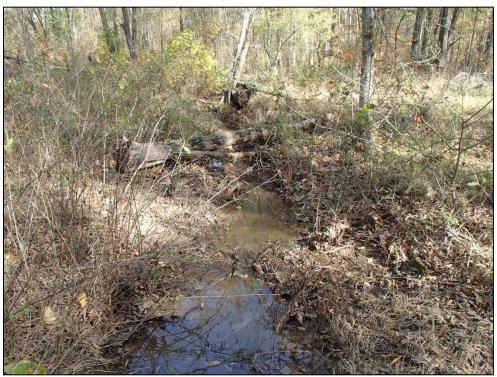
**Photo 15:** Photo Point 9 Reach G facing upstream showing logging debris in the channel

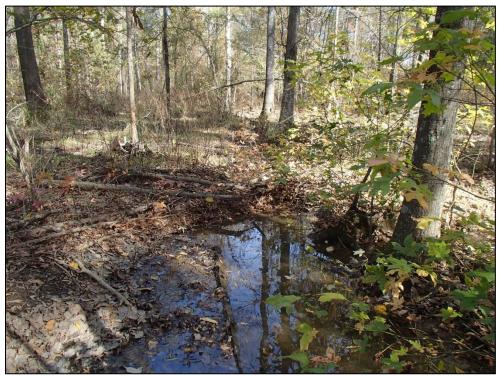
**Photo 16:** Photo Point 9 Reach G facing downstream showing logging debris in the channel

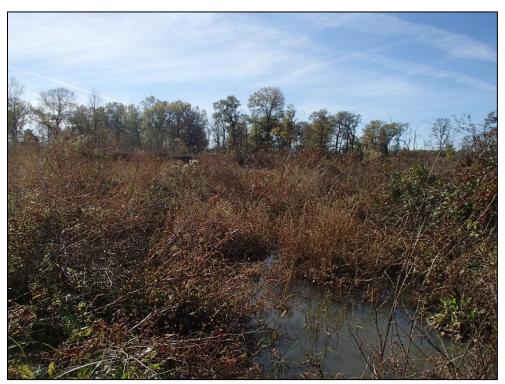
Photo 17: Photo Point 10 Reach G showing slash pile in channel

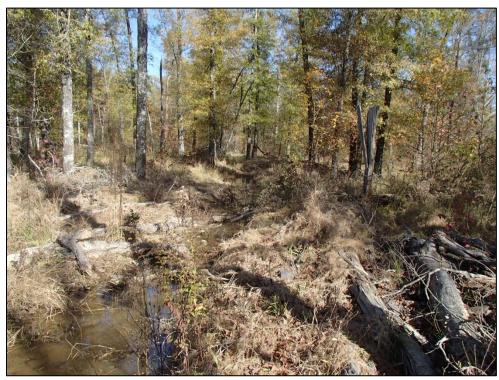
Photo 18: Photo Point 11 Reach I showing slash in channel facing downstream

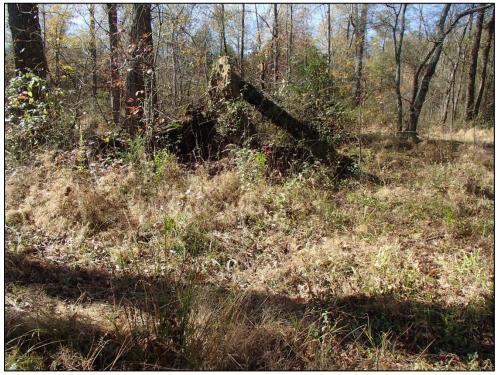
Photo 19: Photo Point 11 Reach I facing upstream showing no defined channel

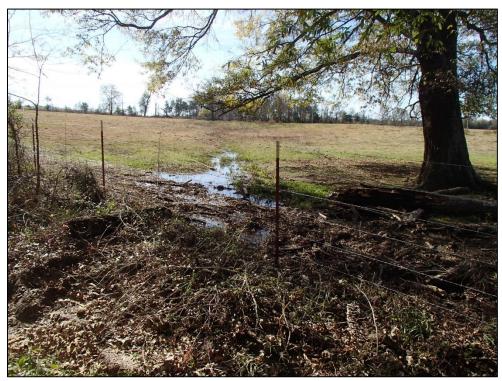
Reach I flows from the southwestern portion of the property ~5,932LF to the northeast. Reach I headwaters on the western neighboring property in a cattle pasture (Appendix B: Photos 20 & 21). Once the channel enters the proposed mitigation site it flows into a pond. From the pond the reach flows to the northeast and is filled with logging debris and there is no continuously defined channel (Appendix B: Photos 18 & 19). Within Reach I the pond levee will be lowered, creating deep water wetland habitat, and logging debris removed from the channel. New portions of the channel will be constructed to reconnect the remnant portions that remain.

Photo 20: Photo Point 12 Reach I facing upstream onto neighboring property

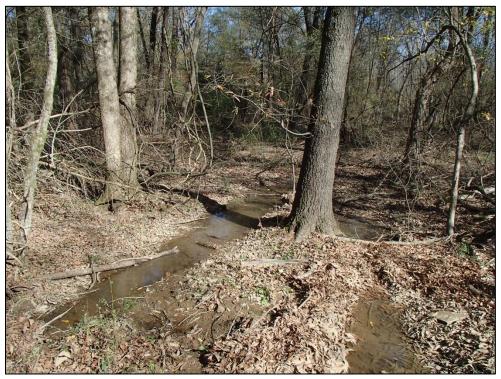
Photo 21: Photo Point 12 Reach I showing no defined channel

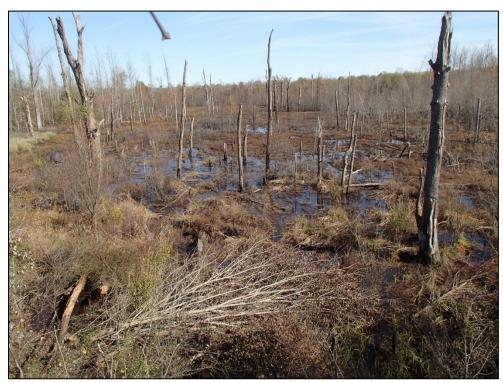
Reach K flows from the southern border of the property to the northeast for  $\sim$ 1,721LF before converging with Reach J. This channel has debris from a tornado in 2008 and there is no continuously defined channel (Appendix B: Photo 22). The debris will be removed and the channel will be redefined by connecting the remnant portions of the channels.

**Photo 22:** Photo Point 13: Reach K and the surrounding wetland area showing tornado damage
