#### THREE RIVERS SOUTHEAST ARKANSAS

The Three Rivers Southeast Arkansas Feasibility Study (Three Rivers Study) is being conducted by the U. S. Army Corps of Engineers (USACE) to recommend modifications to the McClellan-Kerr Arkansas River Navigation System (MKARNS) that would provide long-term sustainable navigation and promote the continued safe and reliable economic use of the MKARNS.

1.	GENERAL	3
2.	HYDROLOGY AND HYDRAULICS (H&H)	5
3.	SURVEYING, MAPPING AND OTHER GEOSPATIAL DATA REQUIREMENTS	5
4.	GEOTECHNICAL	6
5.	ENVIRONMENTAL ENGINEERING	7

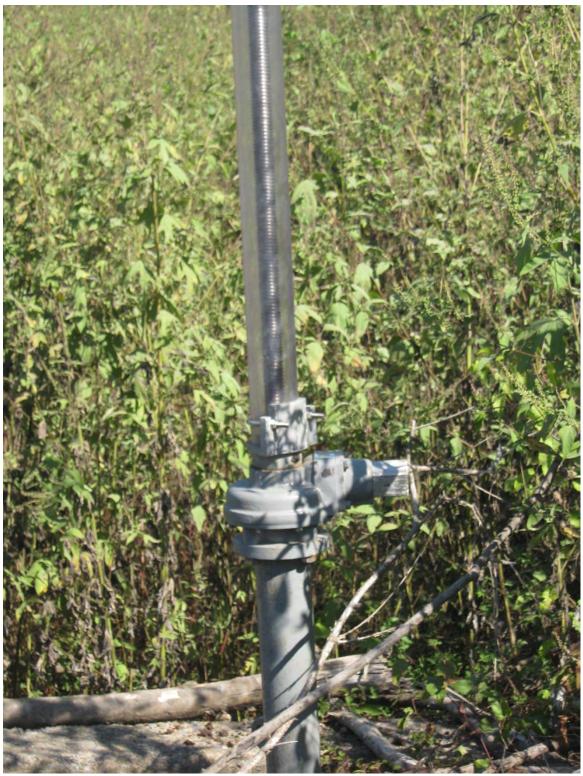
Figure 1 - Area 1, New Gate Mechanism installed by USFWS in 2003.

The north slide gate has been replaced by Ducks Unlimited under contract with the USFWS. A "Hydrogate", Model IB5, with a 4:1 lift ratio was used to replace the original sluice gate. See Figure 1.

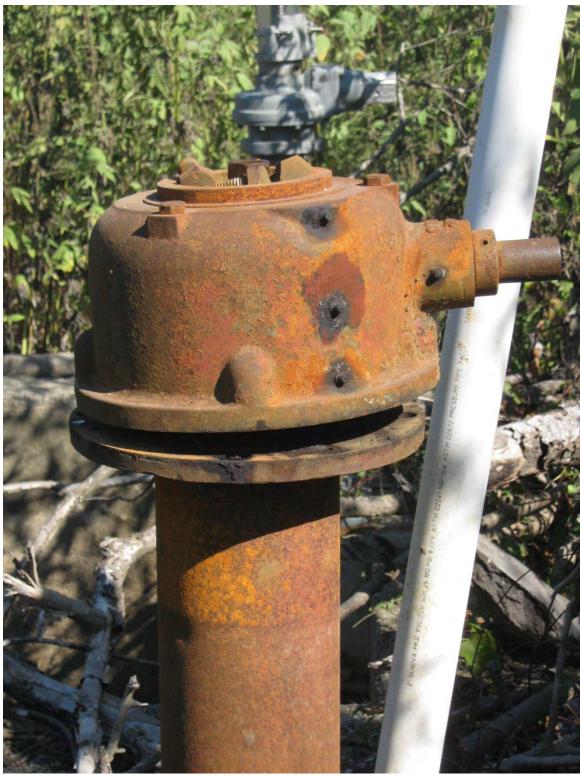
Figure 2 - Area 1, Existing Gate Mechanism (Note that it has been disassembled.)

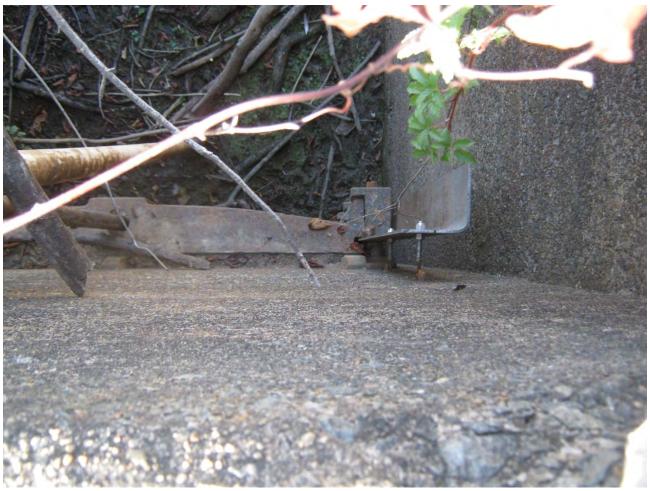
Figure 4 - Area 1 - Existing southern slide gate. Note that the anchor bolts are not connected.

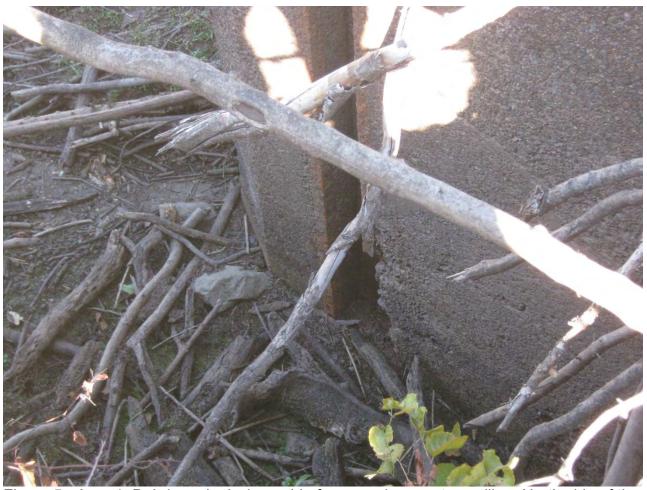
Figure 5 - Area 1, Debris and missing guide frame and concrete spalling. North side of the southern 60" concrete pipes inlet.

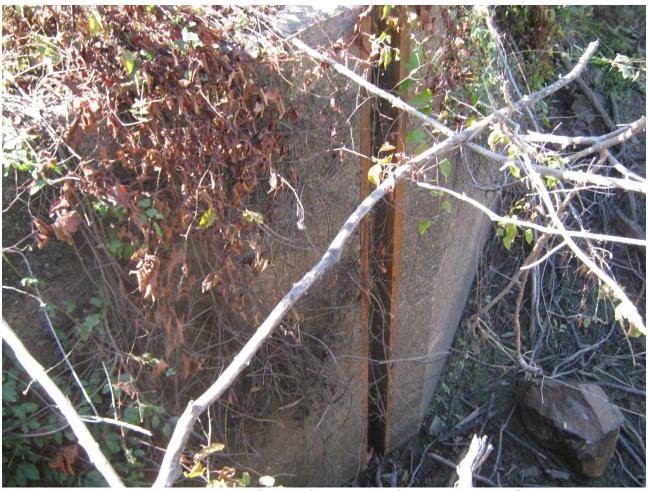
Figure 6 - Area 1, Debris and guide frame. South side of the southern 60" concrete pipes inlet.

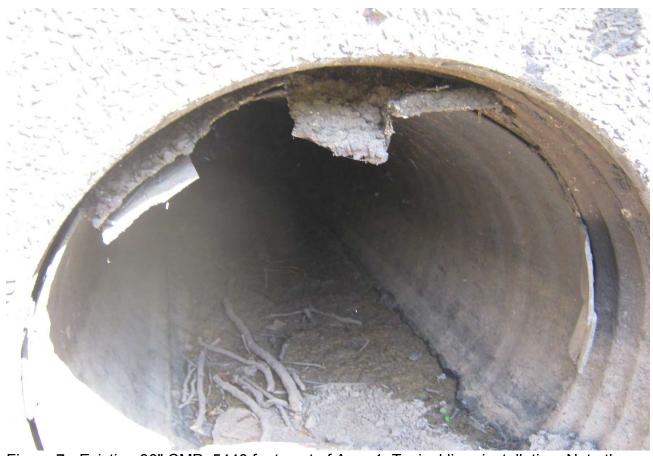
Figure 7 - Existing 36" CMP, 5440 feet east of Area 1. Typical liner installation. Note the poor liner adhesion at the pipes entrance.

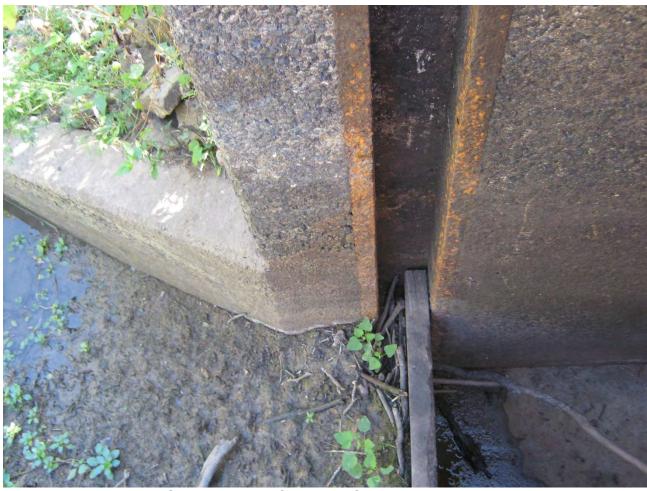
Figure 8 - Existing 36" CMP inlet 5440 feet east of Area 1. Typical guide installation. Note sediment on upstream side.

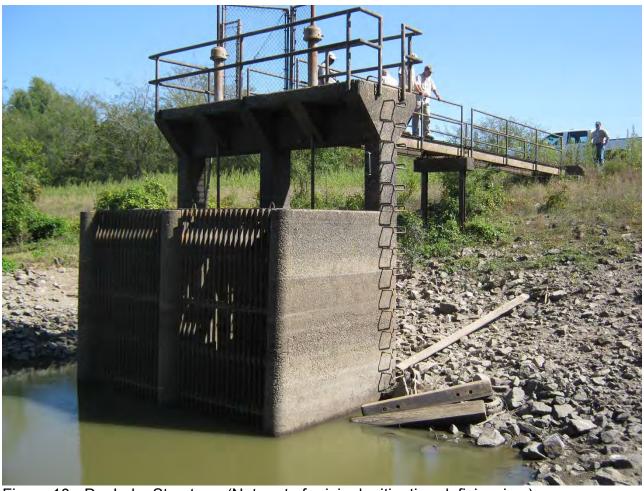
Figure 10 - Dry Lake Structure. (Not part of original mitigation deficiencies.)

During the site visit the USFWS requested that the Dry Lake Gate Structure be looked at. Figures 10 – 16 provide representative views of the structure. A visual inspection indicated the structure was in good shape. Some minor repairs are required. They include rehabilitating and adding a protective coating to the trash racks to repair the holes which have appeared over time. The second would be to replace the missing covers over the grating. See Figure 14. The structures outlet pipe is served by two CMP of unknown size. No physical damage was witnessed, but due to their age it is believed they are approaching their useful life and should be considered for lining sometime in the near future.

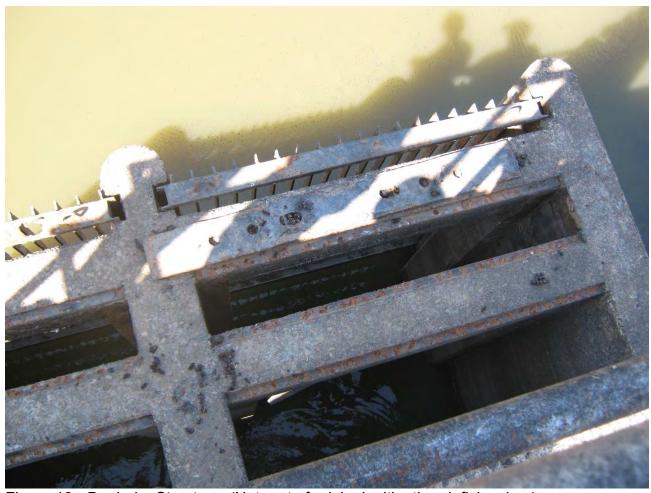
Figure 13 - Dry Lake Structure. (Not part of original mitigation deficiencies.)

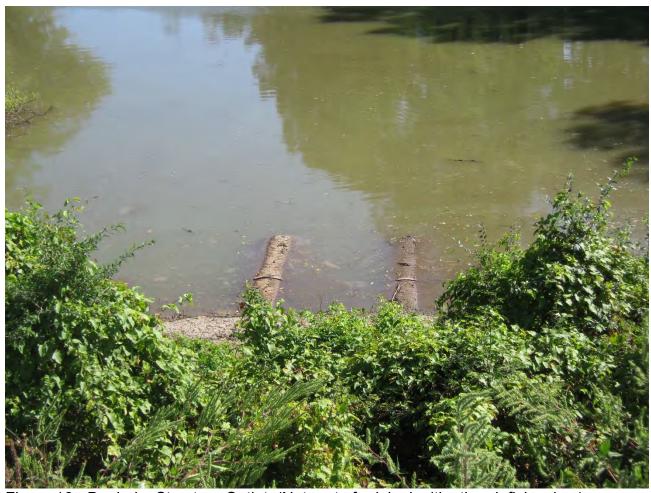
Figure 16 - Dry Lake Structure Outlet. (Not part of original mitigation deficiencies.)
