**Prospectus for the
Bayou Meto Drainage Basin Mitigation Bank
Pulaski County, Arkansas**

Arkansas State Highway and Transportation Department

June 2012

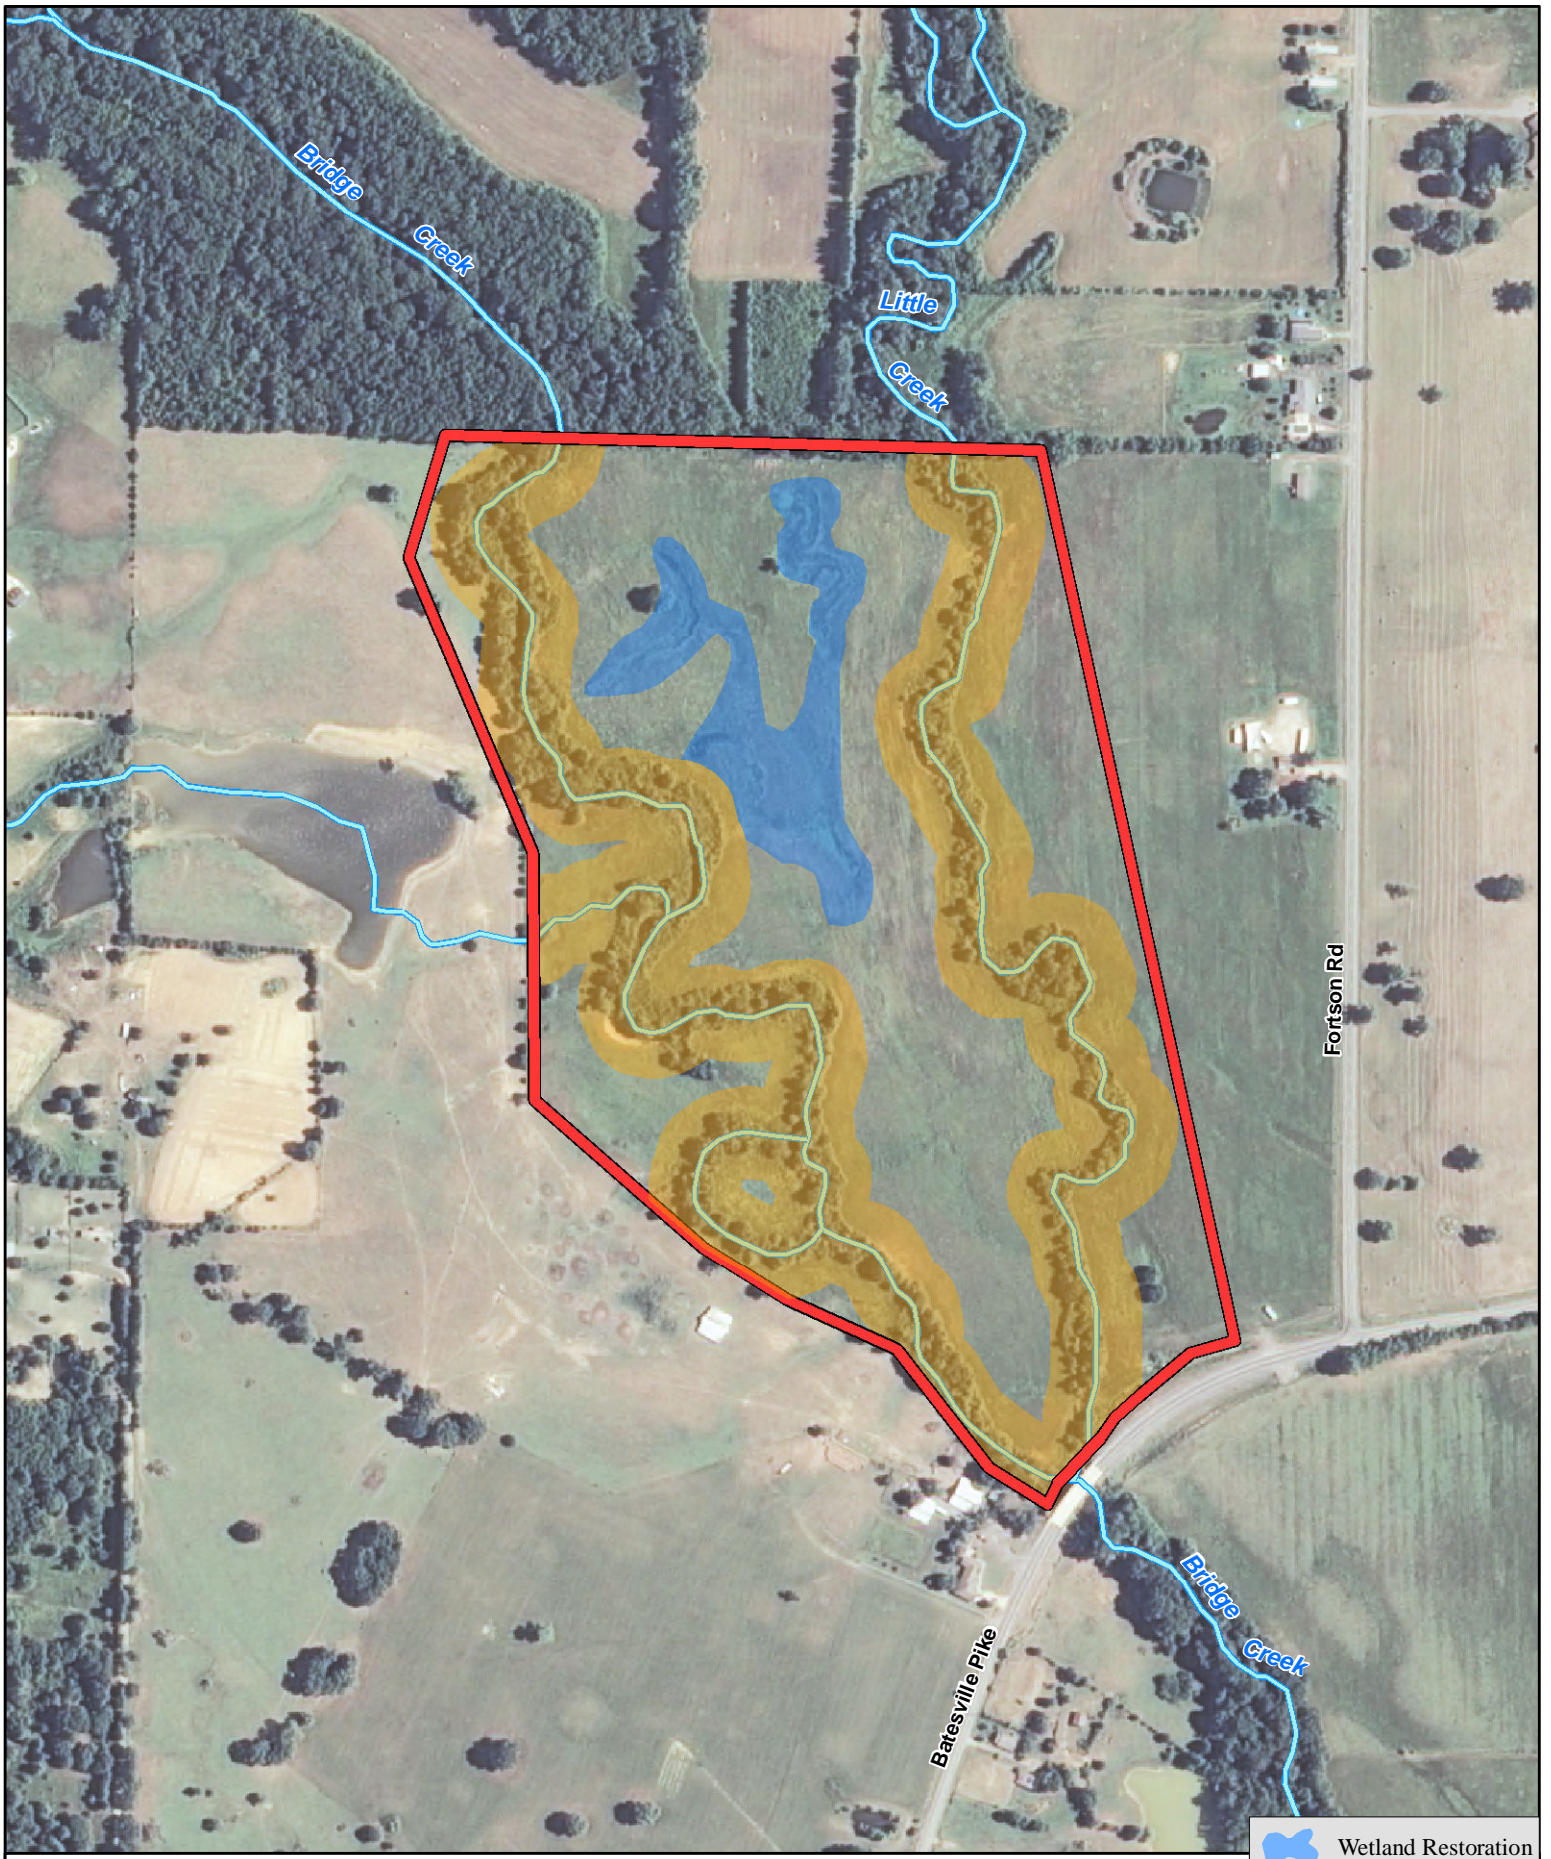
Figure 3
Restoration Plan

-   Wetland Restoration
-

Riparian Buffer
-   Streams
-   Mitigation Area

A. Management Goal and Objectives: The management goal for the mitigation bank is the restoration, enhancement, and protection of streams, wetlands and associated uplands. Objectives include the restoration of riparian buffers, preservation of stream channels, and the reforestation of uplands and wetlands. Approximately 6,765 linear feet of stream will be preserved and enhanced by the removal of an at-grade crossing for agricultural equipment as well as the removal of cattle, horses and the associated agricultural practices from the property. The 30.6 acres of riparian buffer restoration and 5.0 acres of wetland restoration will be reforested with bottomland hardwood trees (Figure 3). Nonnative vegetation will be removed in the stream restoration areas to promote the growth of bottomland hardwood trees.

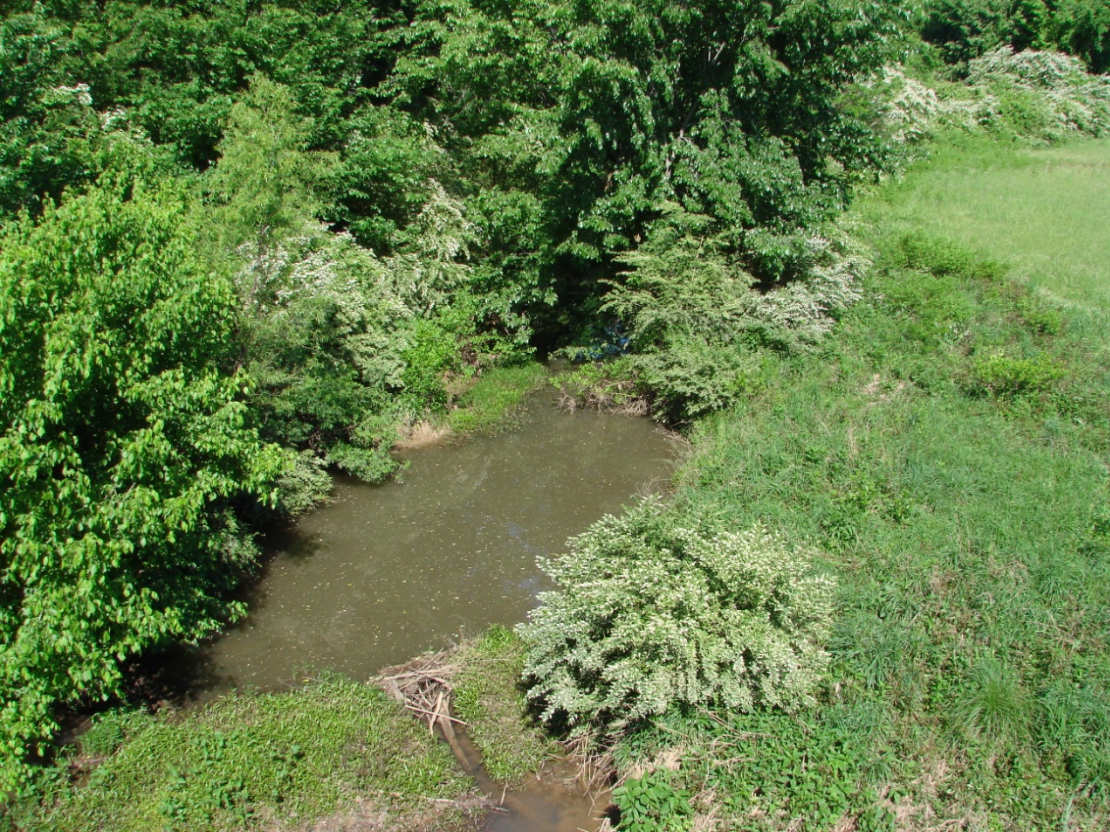
Figure 6. Typical view of Little Creek (April 2012).

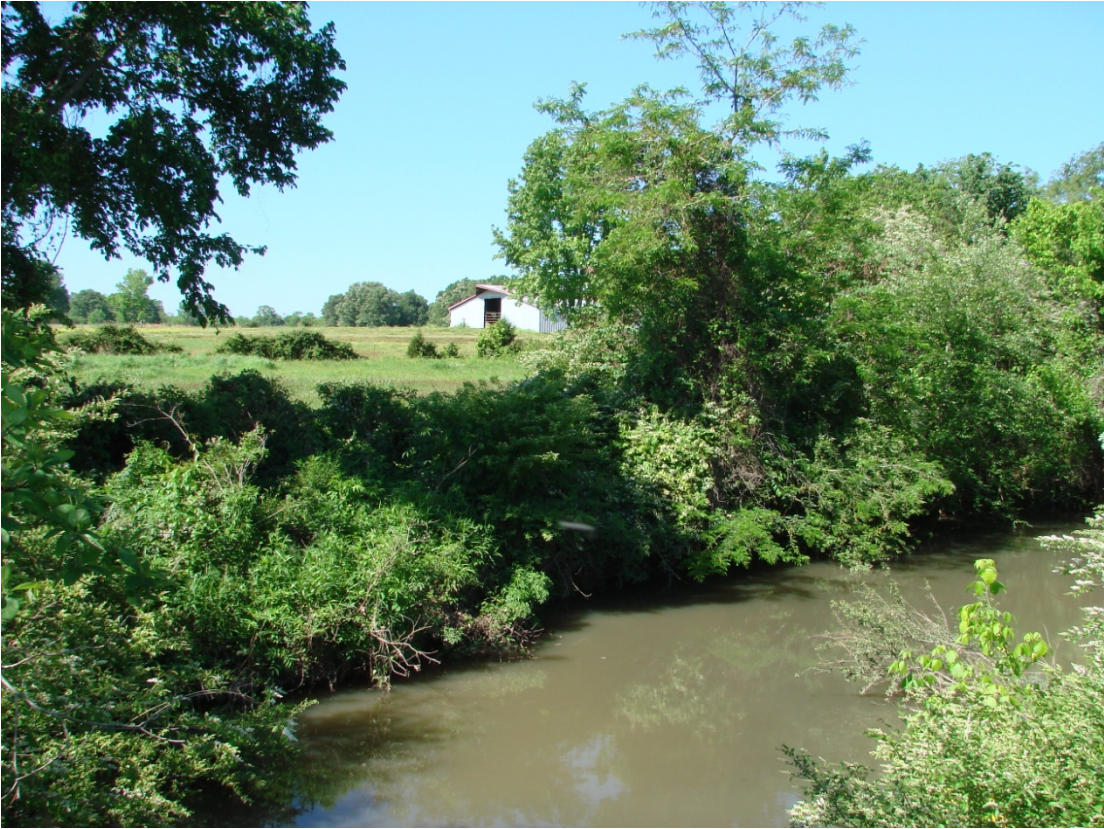
Figure 7. Typical view of Bridge Creek (April 2012).

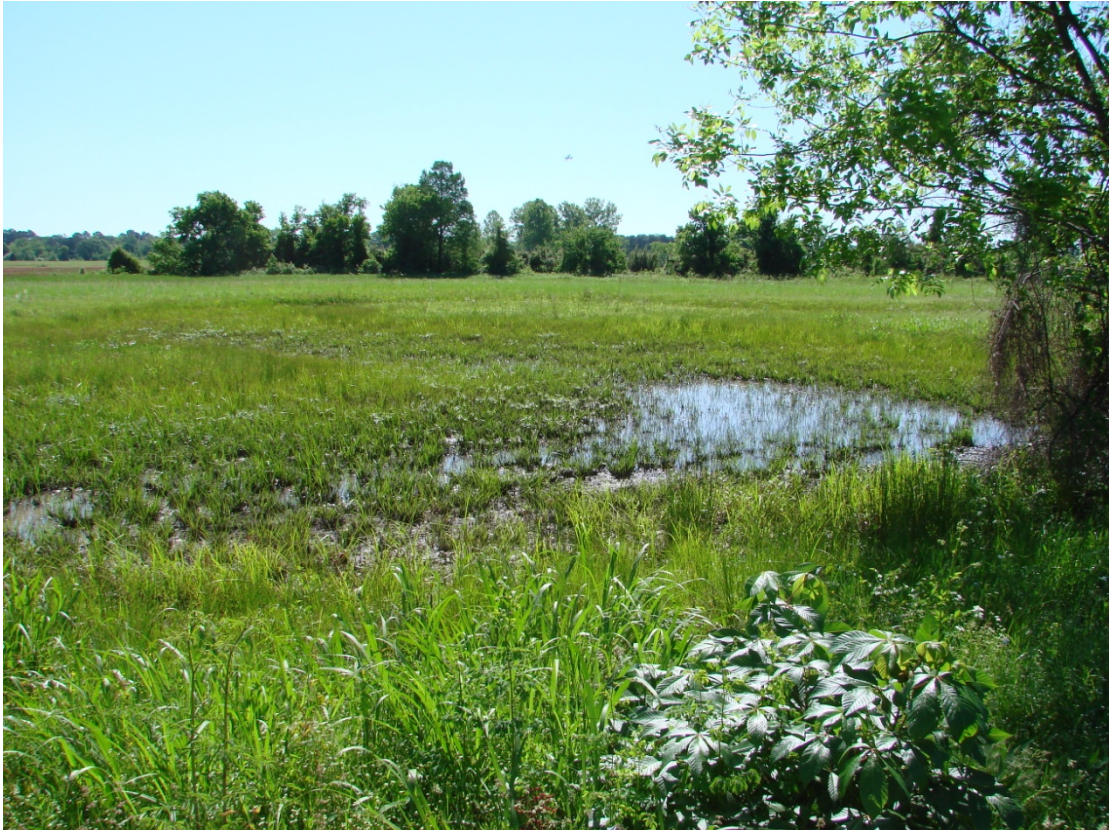
Figure 8. View of wetland to be reforested (April 2012).

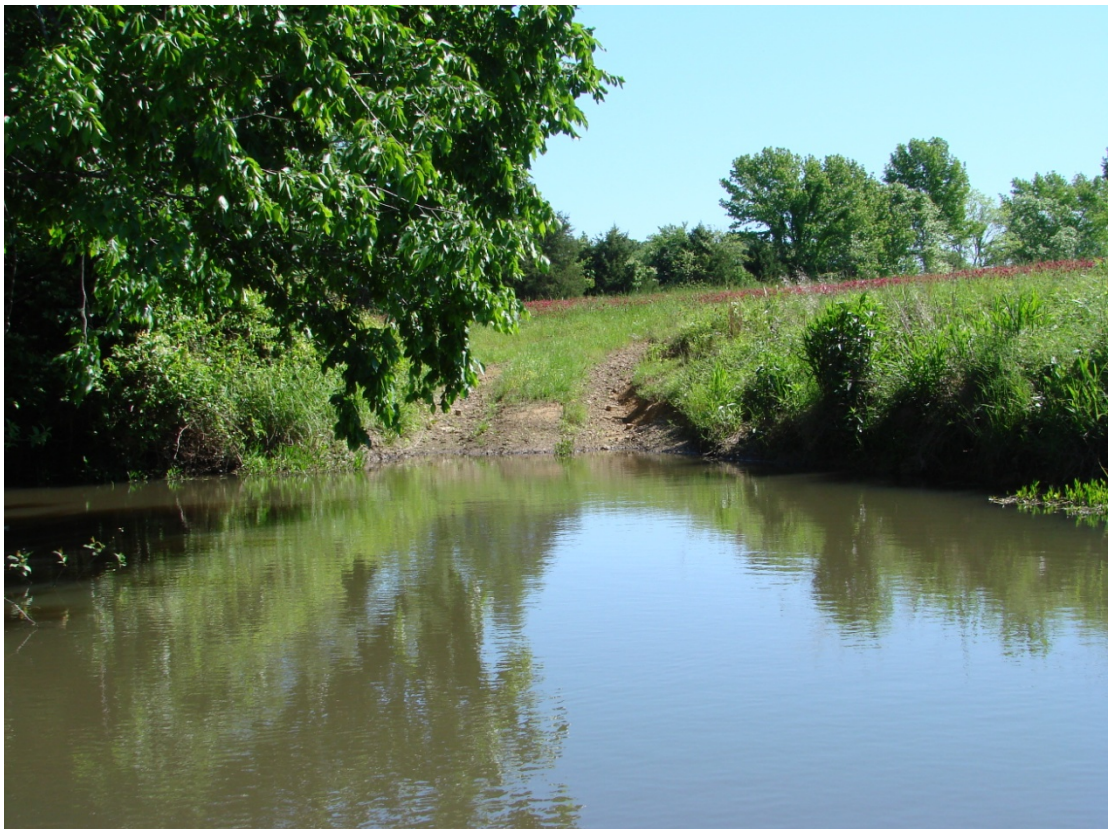
Figure 9. View of at grade stream crossing (April 2012).

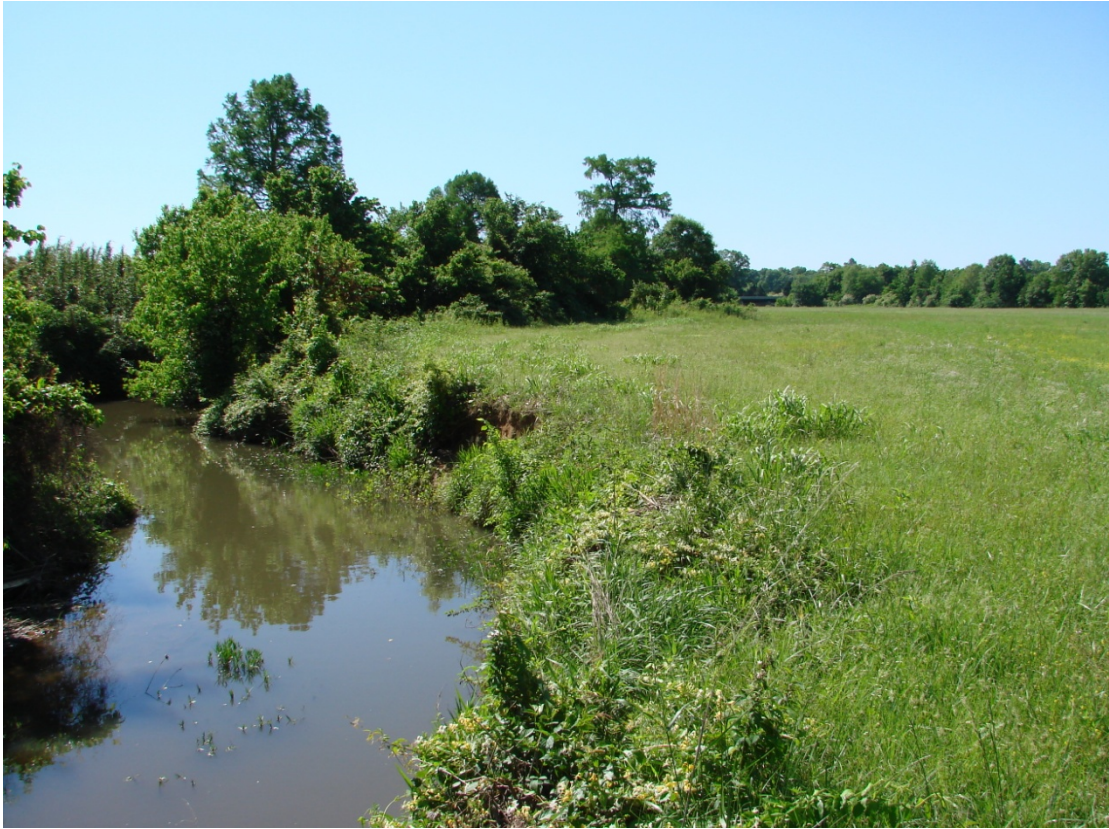
Figure 10. View of eroding stream bank on Little Creek (April 2012).
