GROTTO SPRINGS RANCH, LLC.
101 NEWNATA CUTOFF
MOUNTAIN VIEW, ARKANSAS 72560

**RATTLESNAKE CREEK
STREAM MITIGATION BANK
DRAFT PROSPECTUS**

DECEMBER 2011

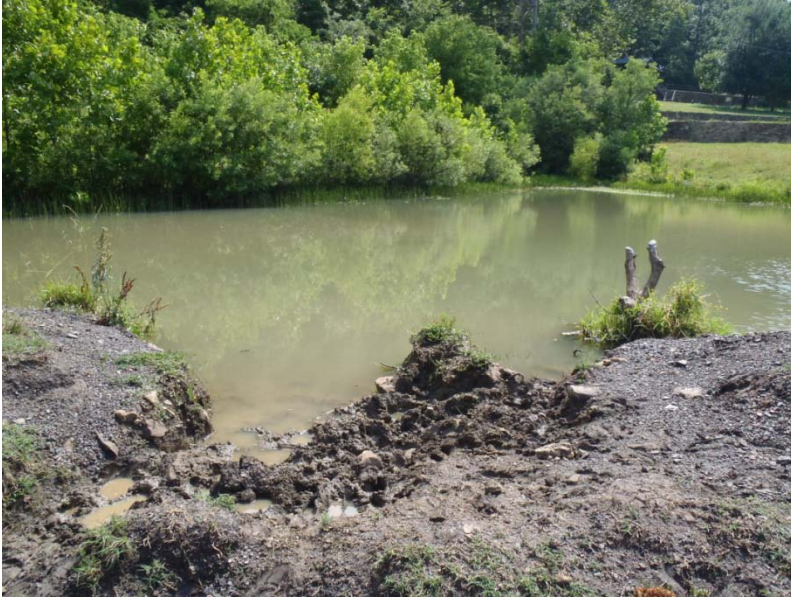
Appendix 2: Site Photos
Proposed Rattlesnake Creek Mitigation Bank, Stone County, Arkansas

Top left: spring pond with cattle access fed by cave spring
Top right: cattle in outflow of spring pond
Middle left: eroding gravel road leading to stream crossing
Middle right: cattle in main tributary
Bottom left: spring box to 1.5 mile long cave

have been impounded and livestock granted full access to ponds, streams and riparian areas. Riparian areas are inadequate or extremely limited (< 10 feet) along many of the stream reaches. Low water fords and culverts along the road servicing the property also contribute to erosion and present aquatic organism movement barriers. Clearing of pasture land resulted in rock levees along portions of the streams that impede floodplain function and cause erosion and instability in the stream channel. Site photographs are included in Appendix 2. Additional conditions include:
