Prospectus

Wiseman
Mitigation
Bank

Izard County
Arkansas

December
2016

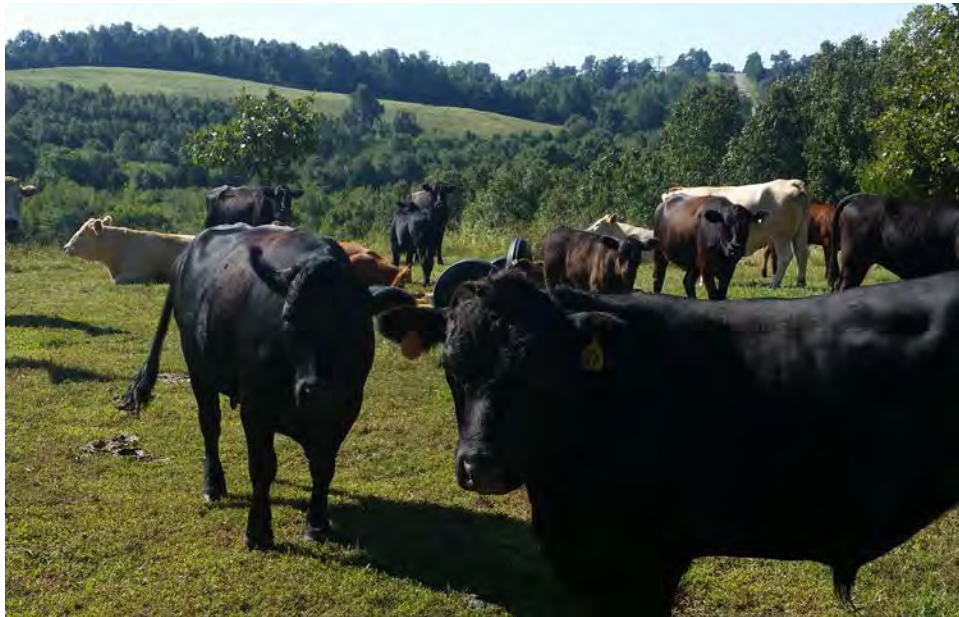
Figure 8 Active cattle grazing on property (September 2015)

The main goal of this proposed mitigation bank is to provide compensation for unavoidable impacts to Waters of the United States associated with highway projects permitted under section 404 of Clean Water Act. This will be accomplished through the objectives of restoration, enhancement, and preservation of streams, wetlands, glades, and associated uplands. Cattle and the related agricultural practices were ceased upon purchase of the property by AHTD in late 2015 (Figure 8).

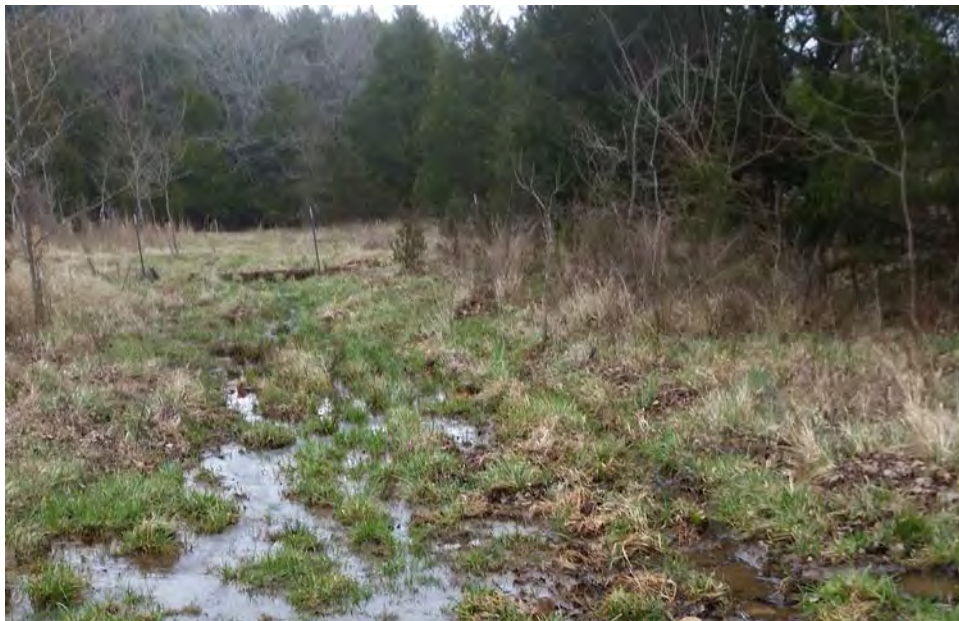
Figure 9 Seepage wetland (March 2016)

Numerous springs and seepages are located throughout the property creating a mosaic of small pocketed wetlands (Figure 9). Historic anthropogenic activities degraded the landscape including ponding, installation of spring boxes, and pasture (Figure 13). Appropriate measures will be taken to restore these unique features and maximize functionality. Mitigation will include the removal of impoundments to improve hydrology and exotic species will be controlled to promote native vegetation growth.

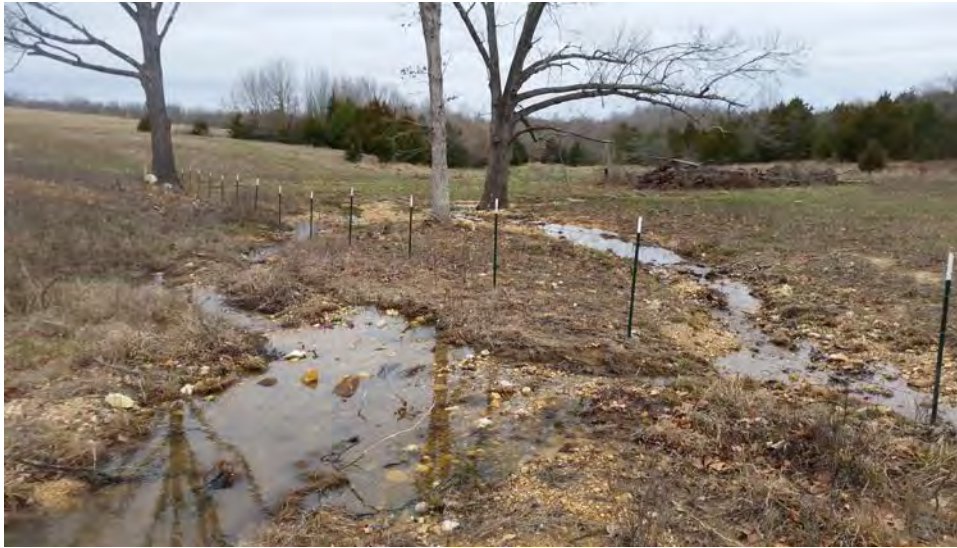
Figure 10 Degraded intermittent streams lacking riparian vegetation (March 2016)

ephemeral streams. Preliminary surveys identified 4,592 linear feet of intermittent streams with substantial degradation in need of restoration. The remaining 5,358 ft. of stream are in good to excellent condition suitable for preservation. Methods for stream restoration will be dependent on further morphological surveys. Potential methods will include but are not limited to: levee removal for floodplain connection, channel creation to restore hydrology, habitat enhancement using rock and log in stream features, and natural channel designs with sinuosity and grade control. Representative photographs of streams can be found in figures 10-15.

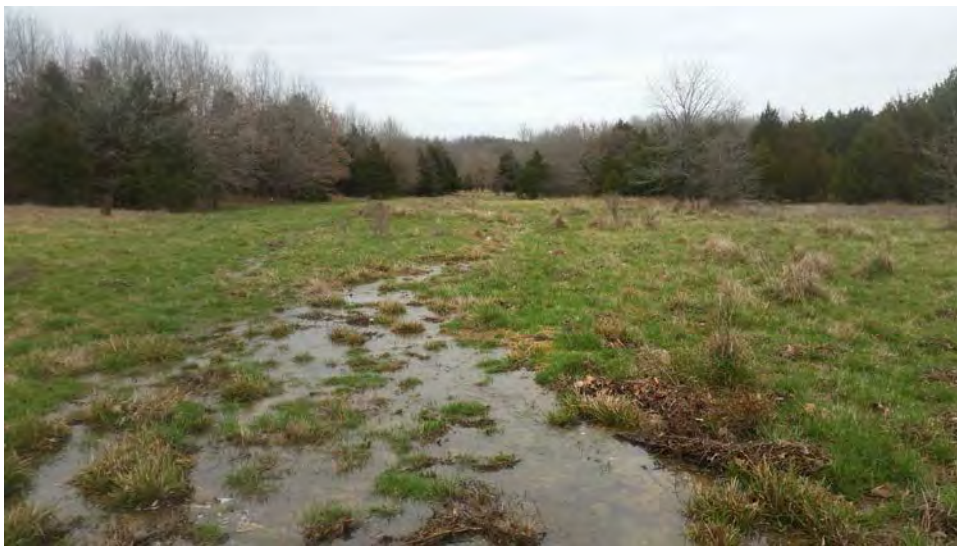
Figure 11 Aggraded intermittent stream flowing through a pasture (March 2016)

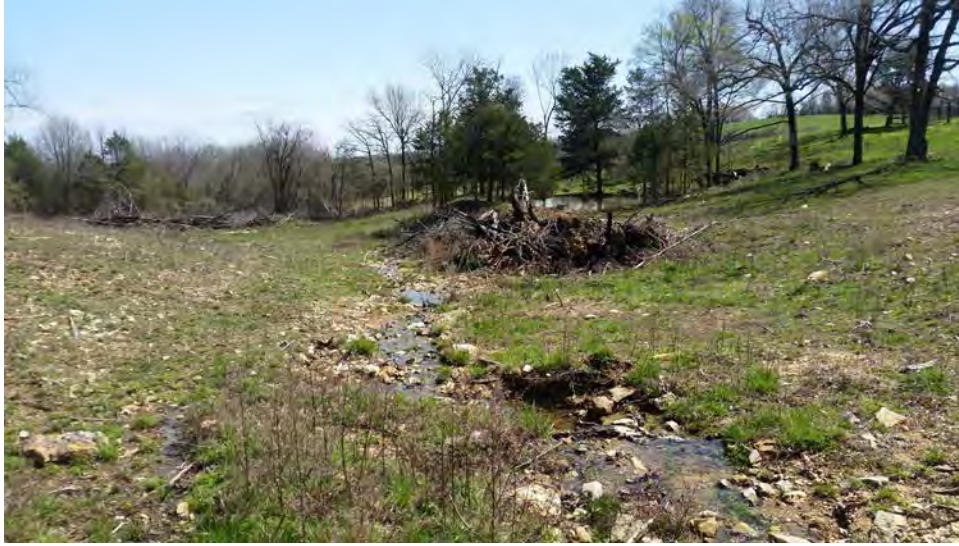
Figure 12 Recently cleared riparian with debris piles in channel (March 2016)

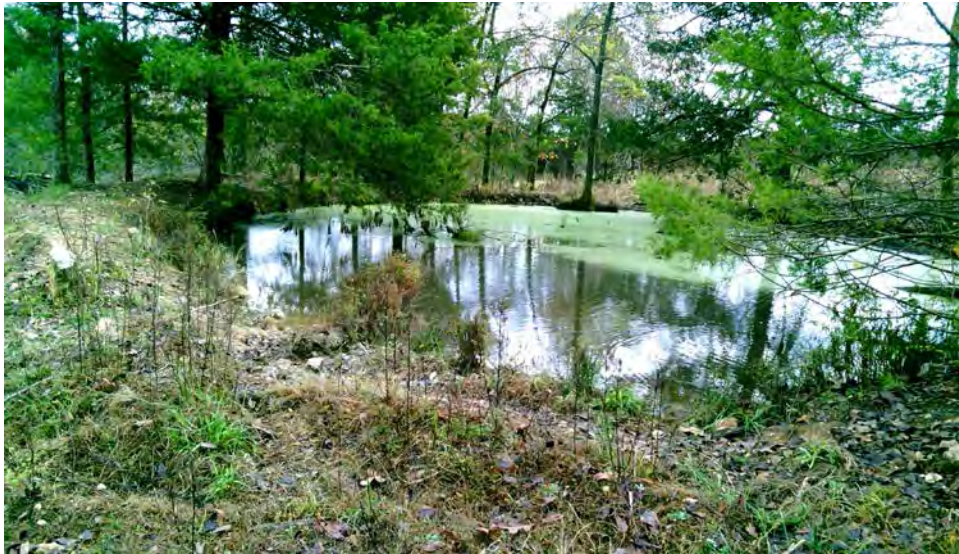
Figure 13 Impoundment of seepage or spring (October 2015)

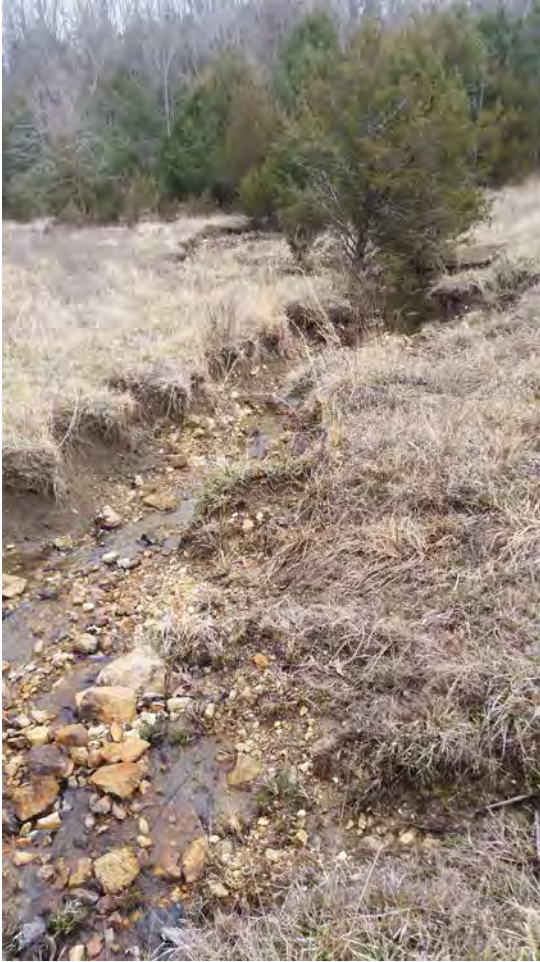
Figure 14 Incised stream with no riparian vegetation (March 2016)

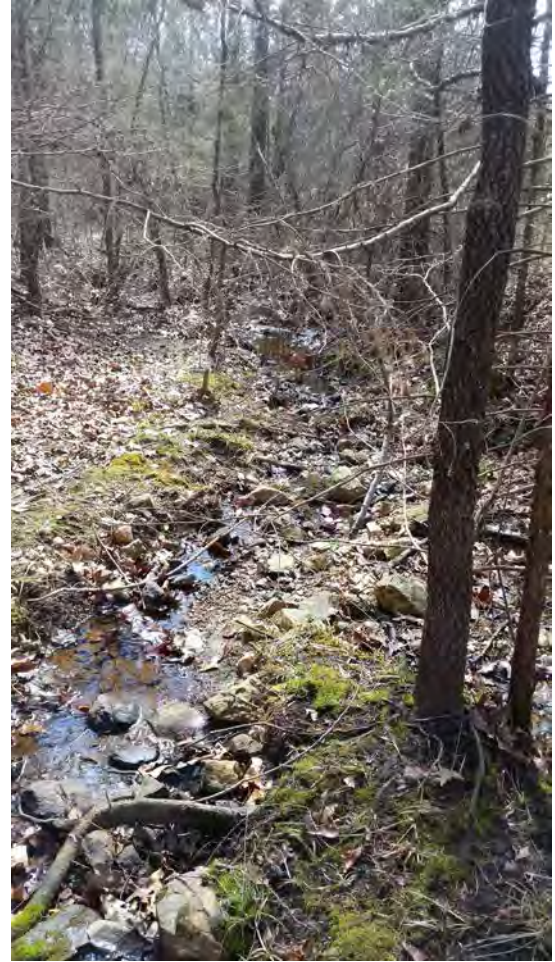
Figure 15 Typical ephemeral preservation stream (March 2016)

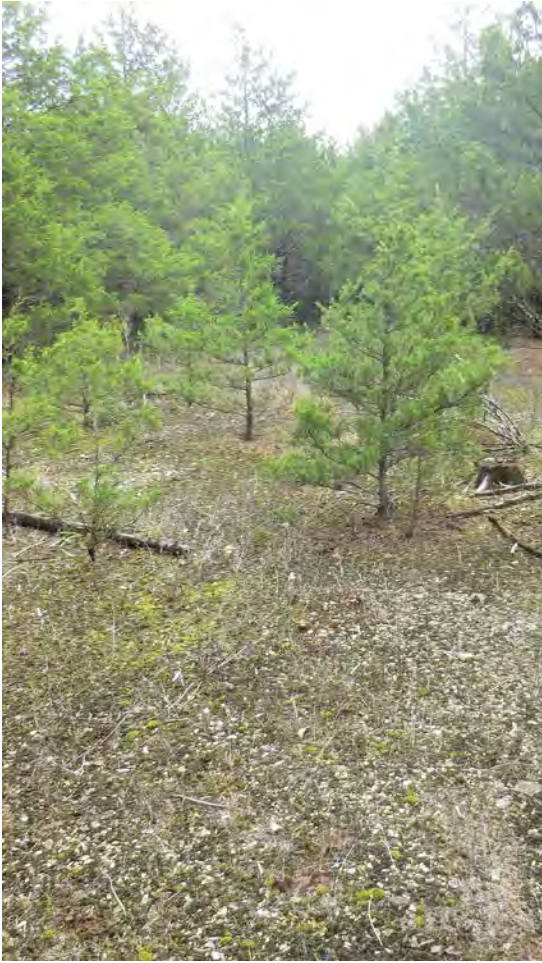
Figure 16 Cedar encroached glades
(March 2016)
