Hydraulic Analysis of Puppy Creek, Lowell, AR

near AR-264

Hydraulics and Technical Services Branch

Date: April 24, 2018

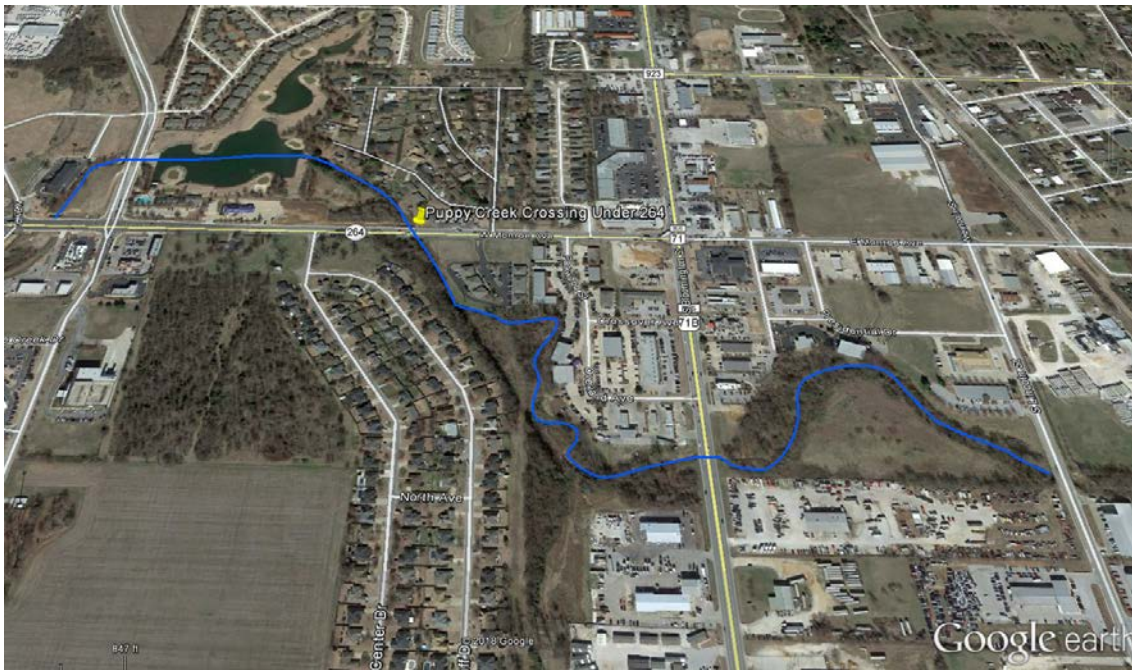
Figure 1. Google Earth view of study area with Puppy Creek outlined in blue, point of interest shown as yellow tack.

The city of Lowell, AR requested a hydraulic analysis of water surface elevation at and near where Puppy Creek crosses under Arkansas Highway 264 between Franklin Ave, and Center Drive (Figure 1). The purpose of the investigation is to determine ways to reduce the water surface elevation upstream of the culvert crossing Highway 264. A hydraulic model was created using the Hydrologic Engineering Center River Analysis System (HEC-RAS). The model extends from downstream of Puppy Creek's crossing with Lincoln St, and downstream of Puppy Creek crossing with Dixieland Road (Figure 1, Figure 2).

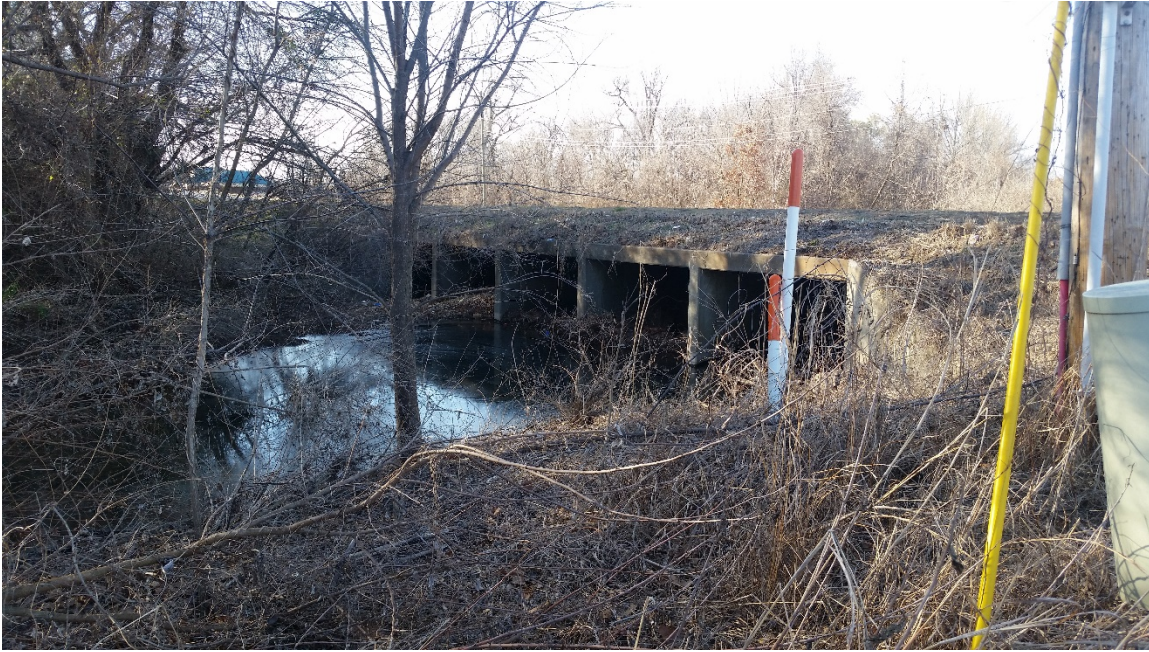
Figure 3. Upstream of culvert looking downstream towards Highway 264 on right bank.

The six different scenarios were modeled to investigate the effects cleaning out the culvert and the upstream or downstream channel will have on the water surface elevation upstream of the culvert. The channel upstream of the culvert is partially blocked on the left side. Sediment has started to build up in the left two most culvert boxes to several feet in depth (Figure 4 - Figure 5). At a field visit the depth was estimated at 3 to 4 feet. The cleaning out of the channel upstream of the culvert consisted on removing deposited sediment that is blocking the culvert. The goal was to clean out the channel so sediment is not blocking the approach to the culvert and then to smoothly transition from the culvert opening back to the normal channel width. The channel was cleaned out and slowly tapered back to normal channel width over approximately 200 ft.

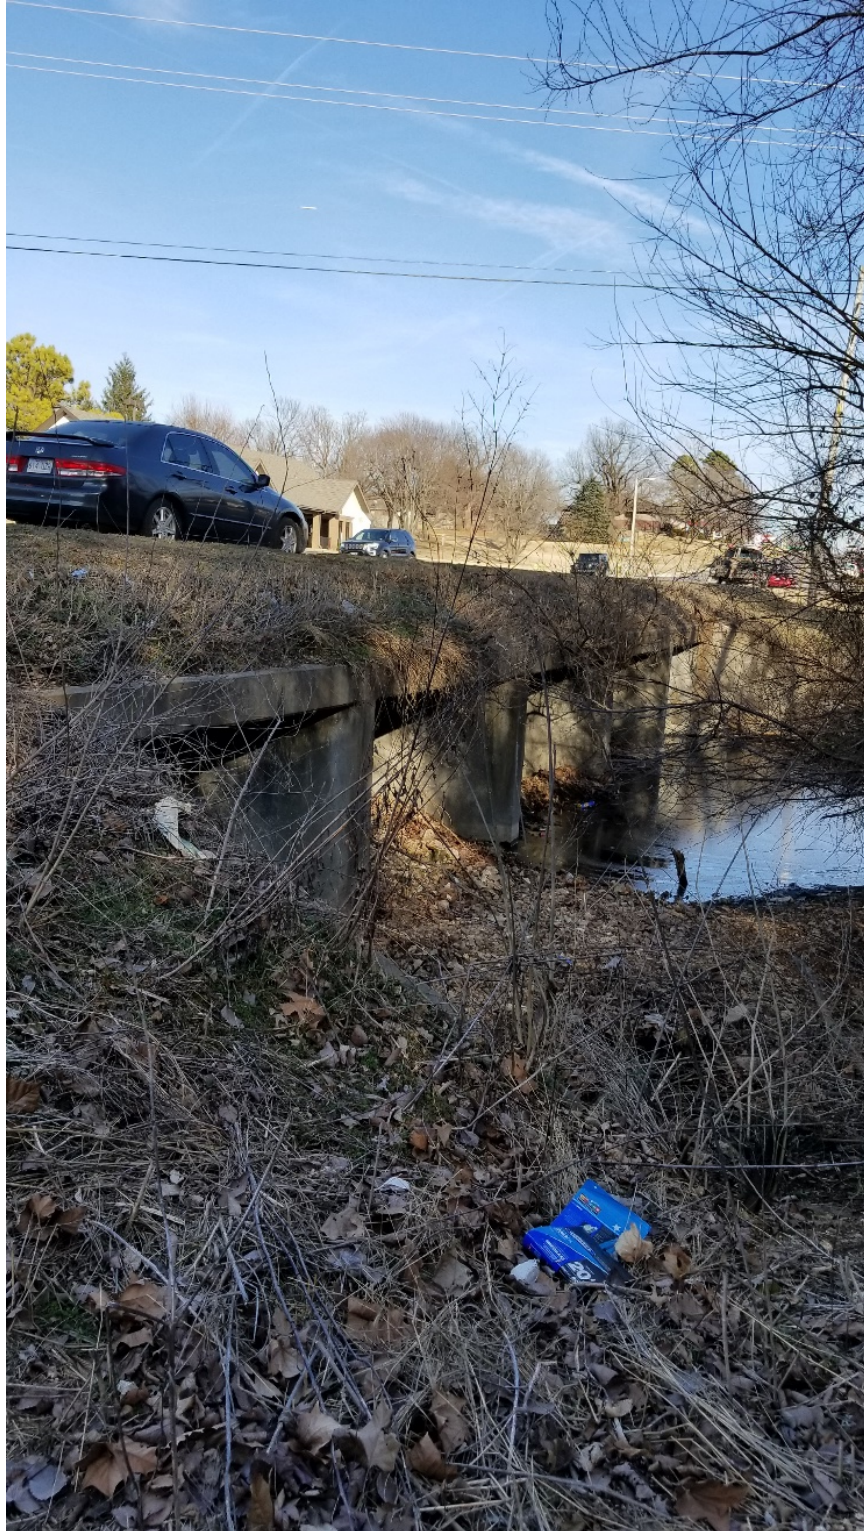
Figure 4. Upstream of culvert looking downstream towards Highway 264 on left bank.

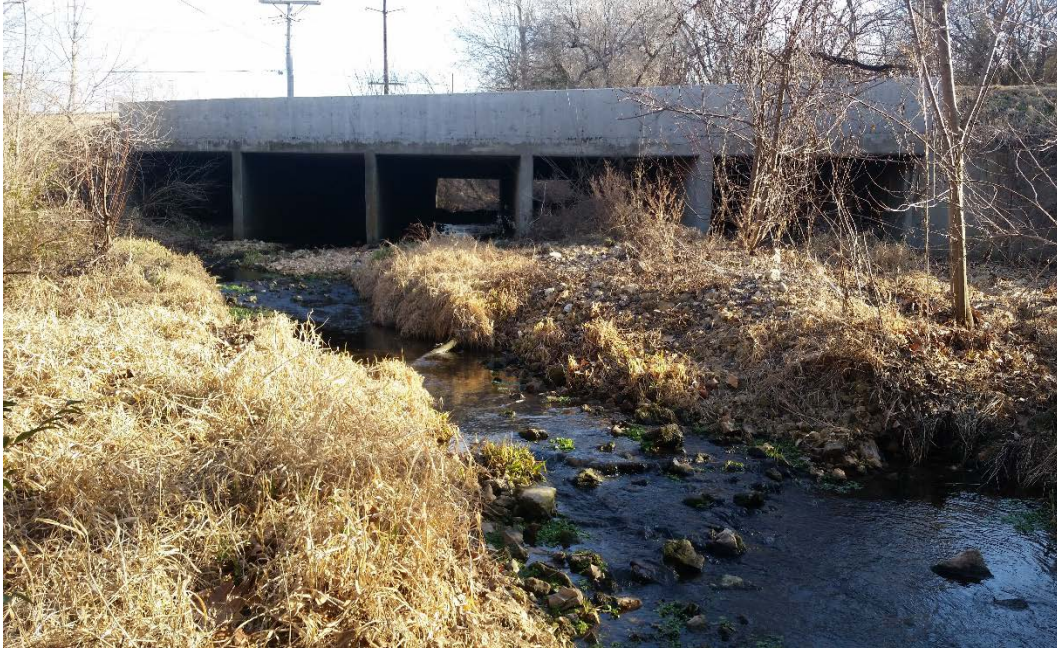
Figure 5. Downstream view looking upstream at Highway 264 culvert

The channel downstream of the culvert partially blocks flow out of the culvert. The left bank has debris and sediment built up in front of it. There are shrubs and trees

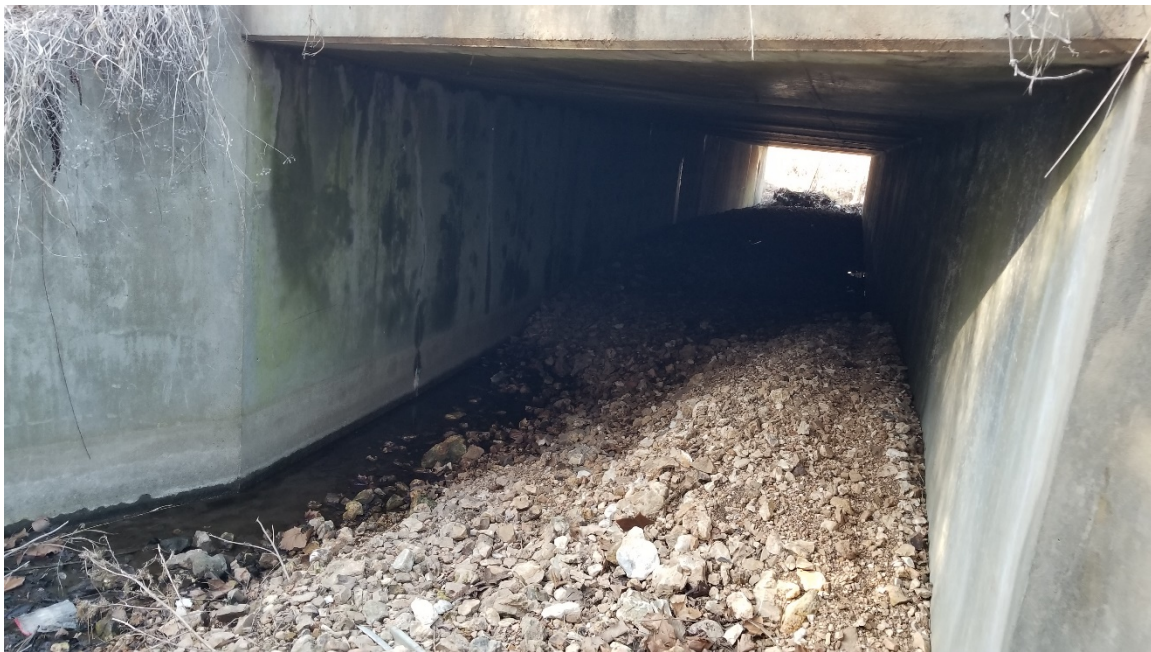
Figure 6. Downstream view looking upstream into Highway 264 culvert: Culvert adjacent to right bank.

starting to grow in this channel, which can also impede flow (Figure 6-Figure 7). The channel was cleaned out similar to the upstream channel with sediment cleaned out to not block the culverts and then to taper back to normal channel.

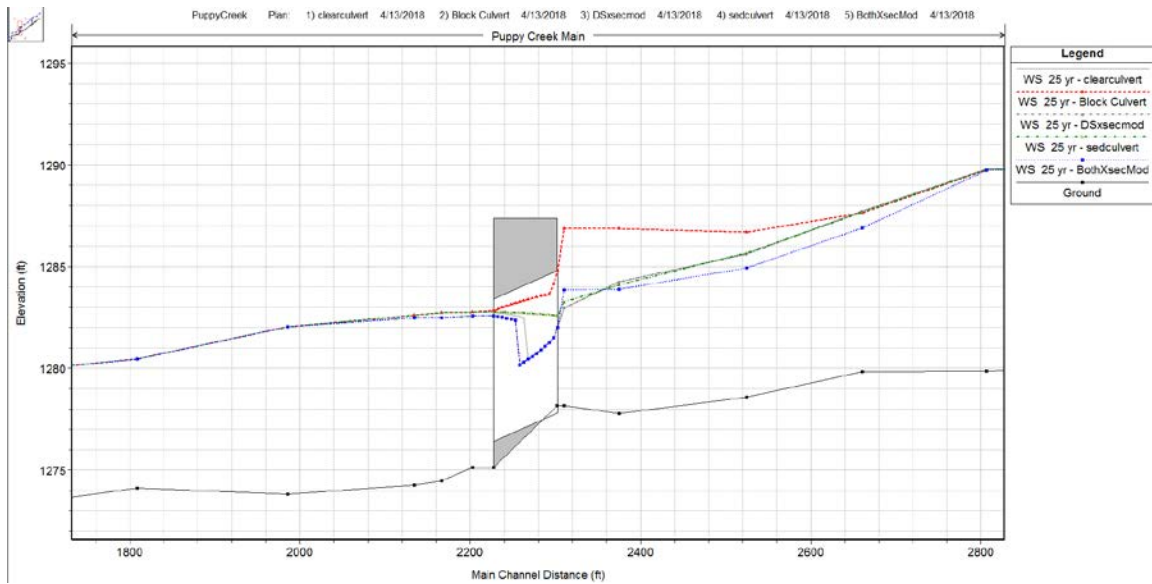
Figure 9. 25 year storm for red (original- blocked), green (sediment in culvert), light gray (clean culvert), dark grey (clean culvert and channel DS), blue (clean both upstream and downstream channel).

Figure 9 - Figure 12 show a profile plots for the 25 year to 500 year storms. The drop in water surface elevation ranges from 0.5 ft to 3 feet depending on the location and the scenario, whether cleaning out just the culvert or the channel and the culvert.
