Caney Creek Mitigation Bank Prospectus

A single-client bank for Southwestern Energy Company

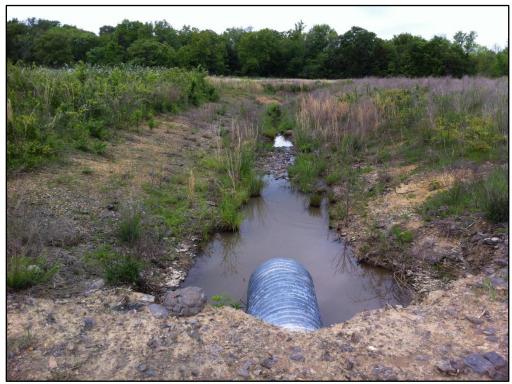
Photo 1: Reach C downstream of shale pit and crossing

Reach A is a first order stream which enters Caney Creek at station 1+168. Similar to Caney Creek, the channel is incised with eroding banks located throughout. Enhancement activities will include bank stabilization and grade control where necessary. Reach B is located along the western edge of the mitigation area and enters Caney Creek downstream of the mitigation site. This reach will be preserved and the left descending bank will be re-vegetated to ensure a minimum 100ft buffer. The majority of restoration activities will take place along Reach C. Reach C drains approximately 0.25 mi² and is approximately 3,600 LF. The upper portion of the reach was filled years ago in order to increase hay production and cattle grazing. The lower portion was altered by extensive surface soil removal and ditching. Activities will include

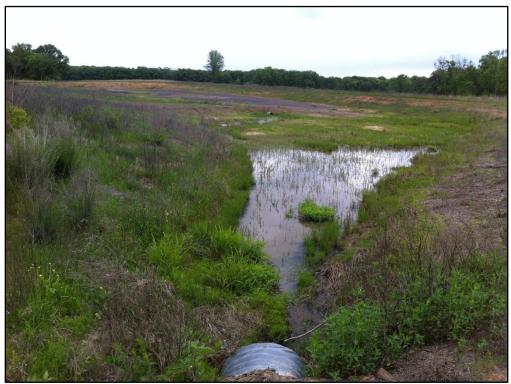
Photo 2: Reach C upstream facing shale pit

The wetland activities will be a combination of restoration, buffer enhancement, and creation on 28-acres of the site (Figure 4). There are two separate wetland restoration areas totaling approximately 9.09 acres. The three-acre shale pit will be converted into a shallow wetland in conjunction with the restoration of Reach C. Soils will be replaced and planted with appropriate vegetation grown within the Streamworks Mitigation Services, LLC greenhouse operation. The 1.37-acre Pin oak (*Quercus palustris*) flat located along the western boundary is only slightly impaired and will be used for preservation.

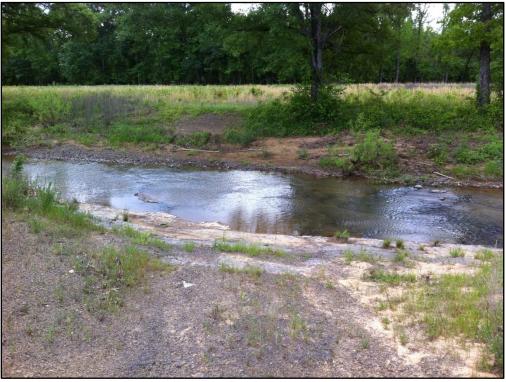
Photo 3: Caney Creek former road crossing

Caney Creek is a third order stream running east to west along the southern boundary of the property. The channel is incised to bedrock and overwidened with areas of severe to moderate bank erosion. Bank stabilizations efforts will be implemented where needed and feasible.

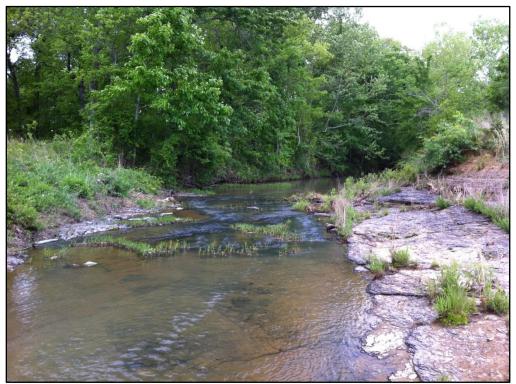
Photo 4: Caney Creek facing downstream from crossing

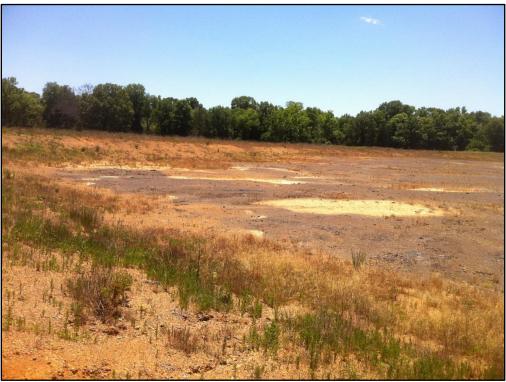
Photo 5: Shale pit adjacent to Reach C

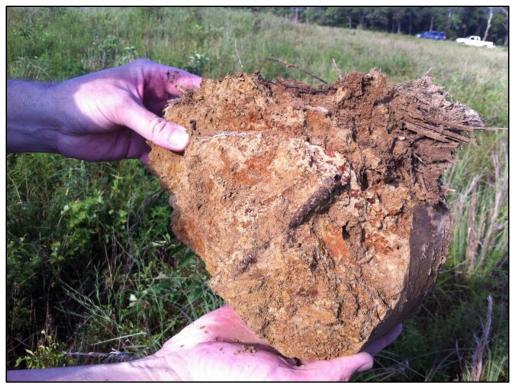
Photo 6: Wetland soil sampling showing iron oxidation lenses

Wetland delineation sampling was conducted in June 2012. Soil sampling revealed the presence of wetland indicators including, but not limited to, oxidized rhizospheres, reduced iron lenses, and saturation visible on aerial photos (Figure A-5). Soils are mapped into three primary units, all are considered partially hydric. The majority of the site, 70-acres, is Leadville silt loam, one to three percent slopes. These are moderately well-drained soils with a parent material of loamy colluvium derived from shale and siltstone. The secondary soils, 25-acres, are Ouachita silt loam, occasionally flooded. These soils are a loamy alluvium located in the floodplain of Caney Creek and Reach C. The third unit is Taft silt loam, zero to two percent slopes located along four acres of the left descending bank of Caney Creek (Figures A-6 & A-7).
