# Upper Black River Wetland Mitigation Site Butler County, MO

## **Butler County Wetland Mitigation Site Baseline Conditions Report**

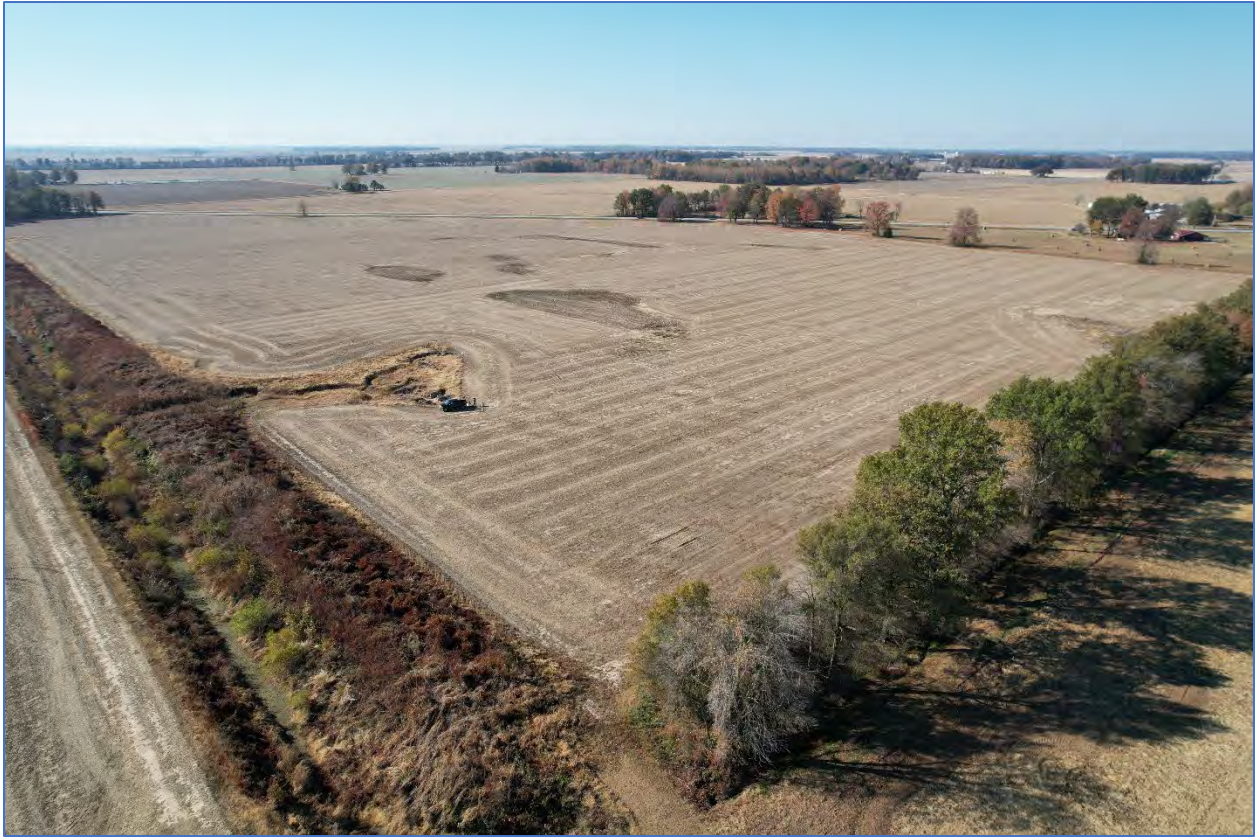
1 – Aerial overview of proposed project area facing southwest.

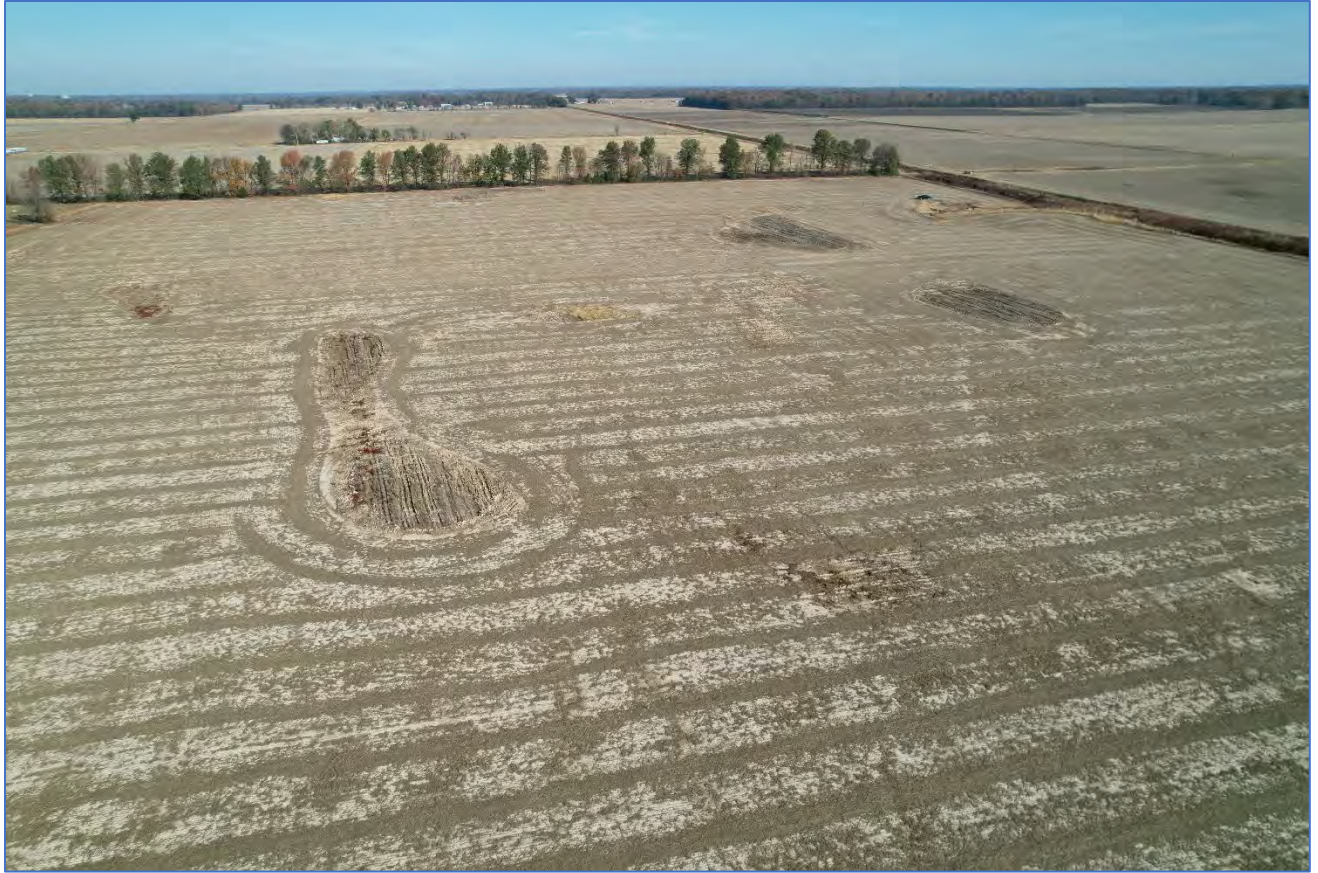
2 – Aerial overview of the proposed project area facing north.

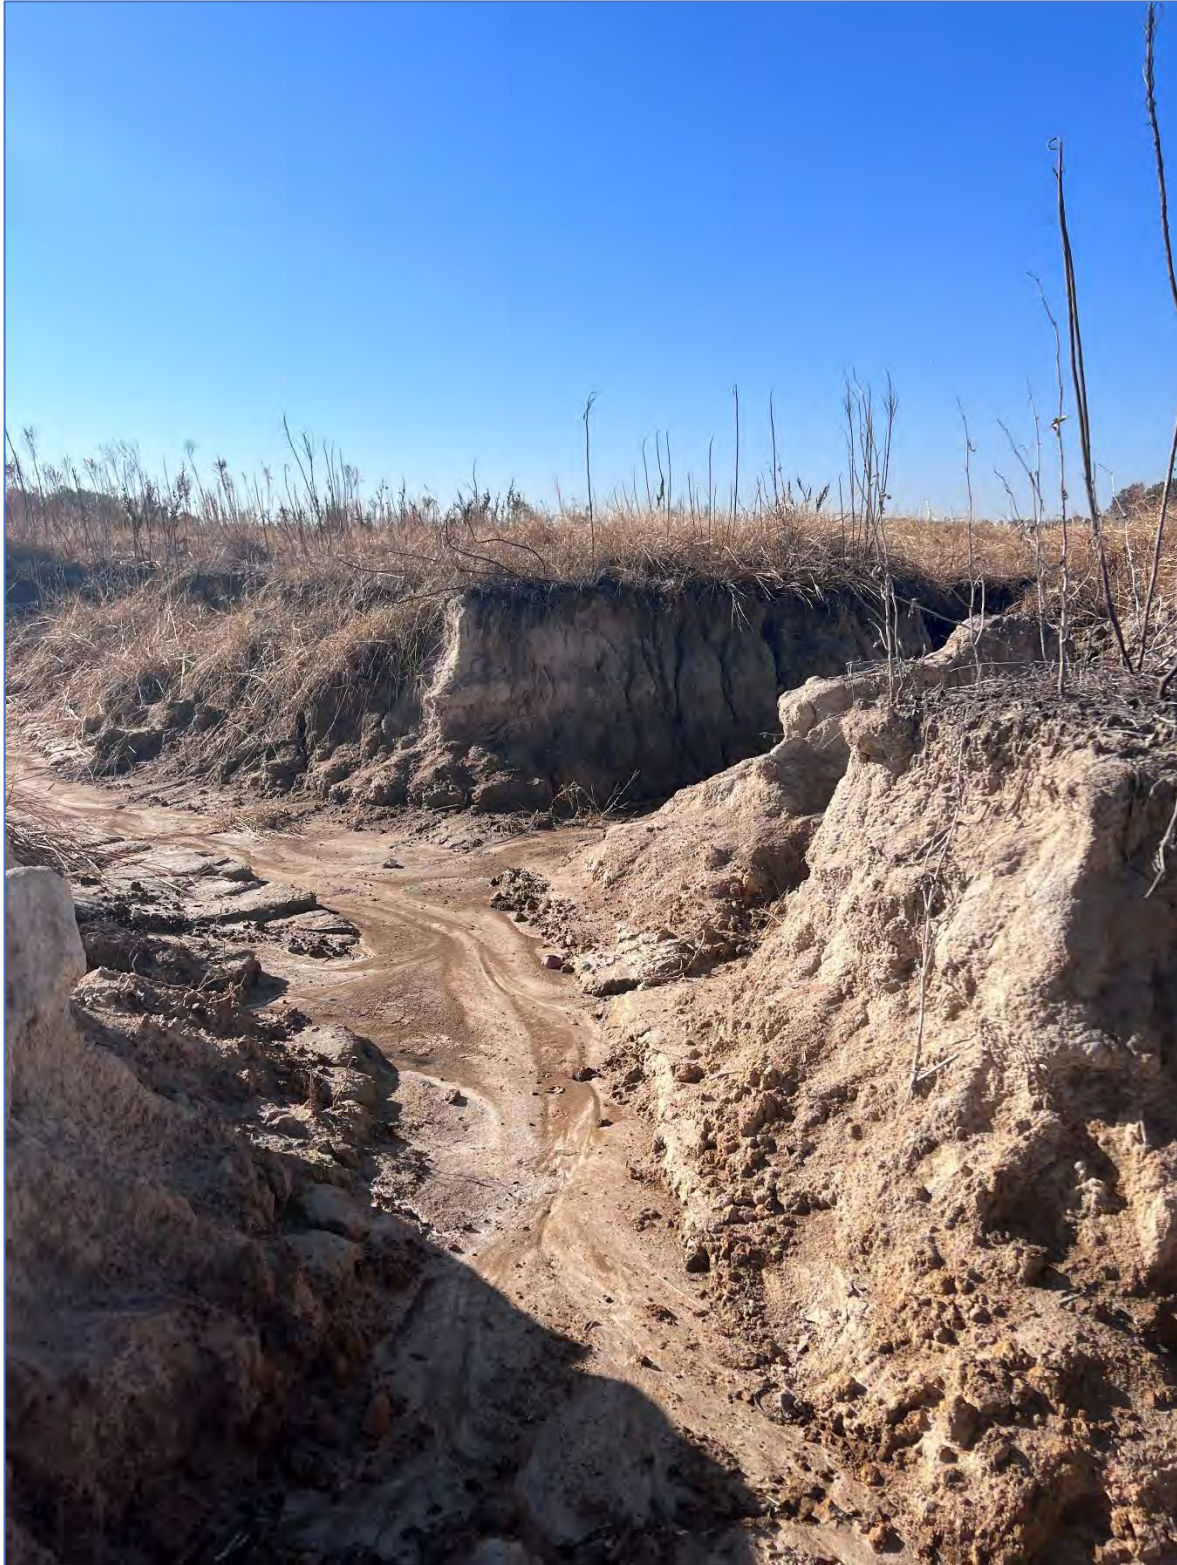
3 – Detail view of eroding drainage feature connecting the agricultural field to the unnamed perennial tributary. This feature will be blocked to create the proposed wetland.

The proposed wetland areas are highly suitable for wetland restoration with hydric soils and evidence of wetland vegetation. However, the site is currently drained and is not functioning as a wetland. The site is graded to drain eastward to the unnamed perennial tributary, which forms the eastern border of the site. There is a drainage feature exhibiting some erosion where runoff from the field enters the tributary. A water control berm will be placed across this drainage feature to prevent water from draining to the unnamed perennial tributary and across the southern boundary of the proposed mitigation area to prevent water from draining southward.

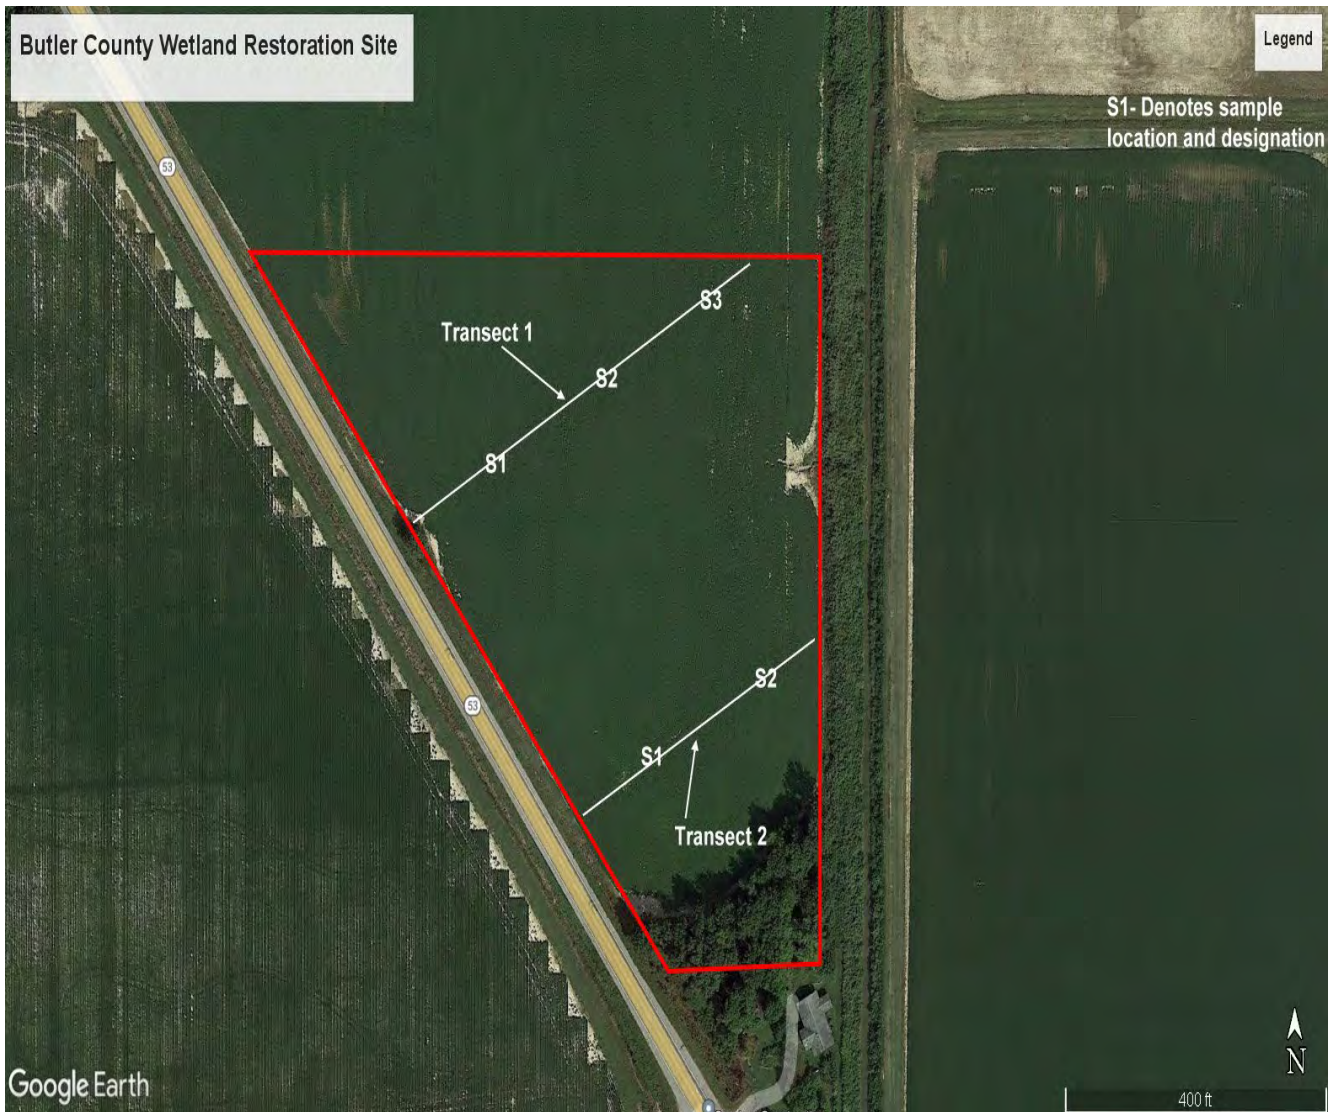
Since the site has been row cropped for many decades, the traditional wetland characteristics have been masked or altered. Due to row cropping, the vegetation has been altered from its natural state therefore our focus was on hydrology and soils. The site is adjacent to an existing drainage ditch that has been present since the early 1900's. A historic slide review was conducted to determine the frequency of saturation or inundation. Historic aerial photos were reviewed that covered years 1985 through 2020. During those years, there were areas that showed inundation during the growing season. Below is an aerial photo showing the location of the sample sites.
