**Application Number: SWL-2024-00202**

## GLEASON PROPERTY MITIGATION BANK PROSPECTUS

## FAULKNER COUNTY, ARKANSAS

Attachment A
Section 404 Delineation: Gleason Property: Faulkner County, AR
Section 404 Delineation: Gleason Property: Faulkner County, AR
Section 404 Delineation: Gleason Property: Faulkner County, AR
Section 404 Delineation: Gleason Property: Faulkner County, AR
Section 404 Delineation: Gleason Property: Faulkner County, AR
Section 404 Delineation: Gleason Property: Faulkner County, AR

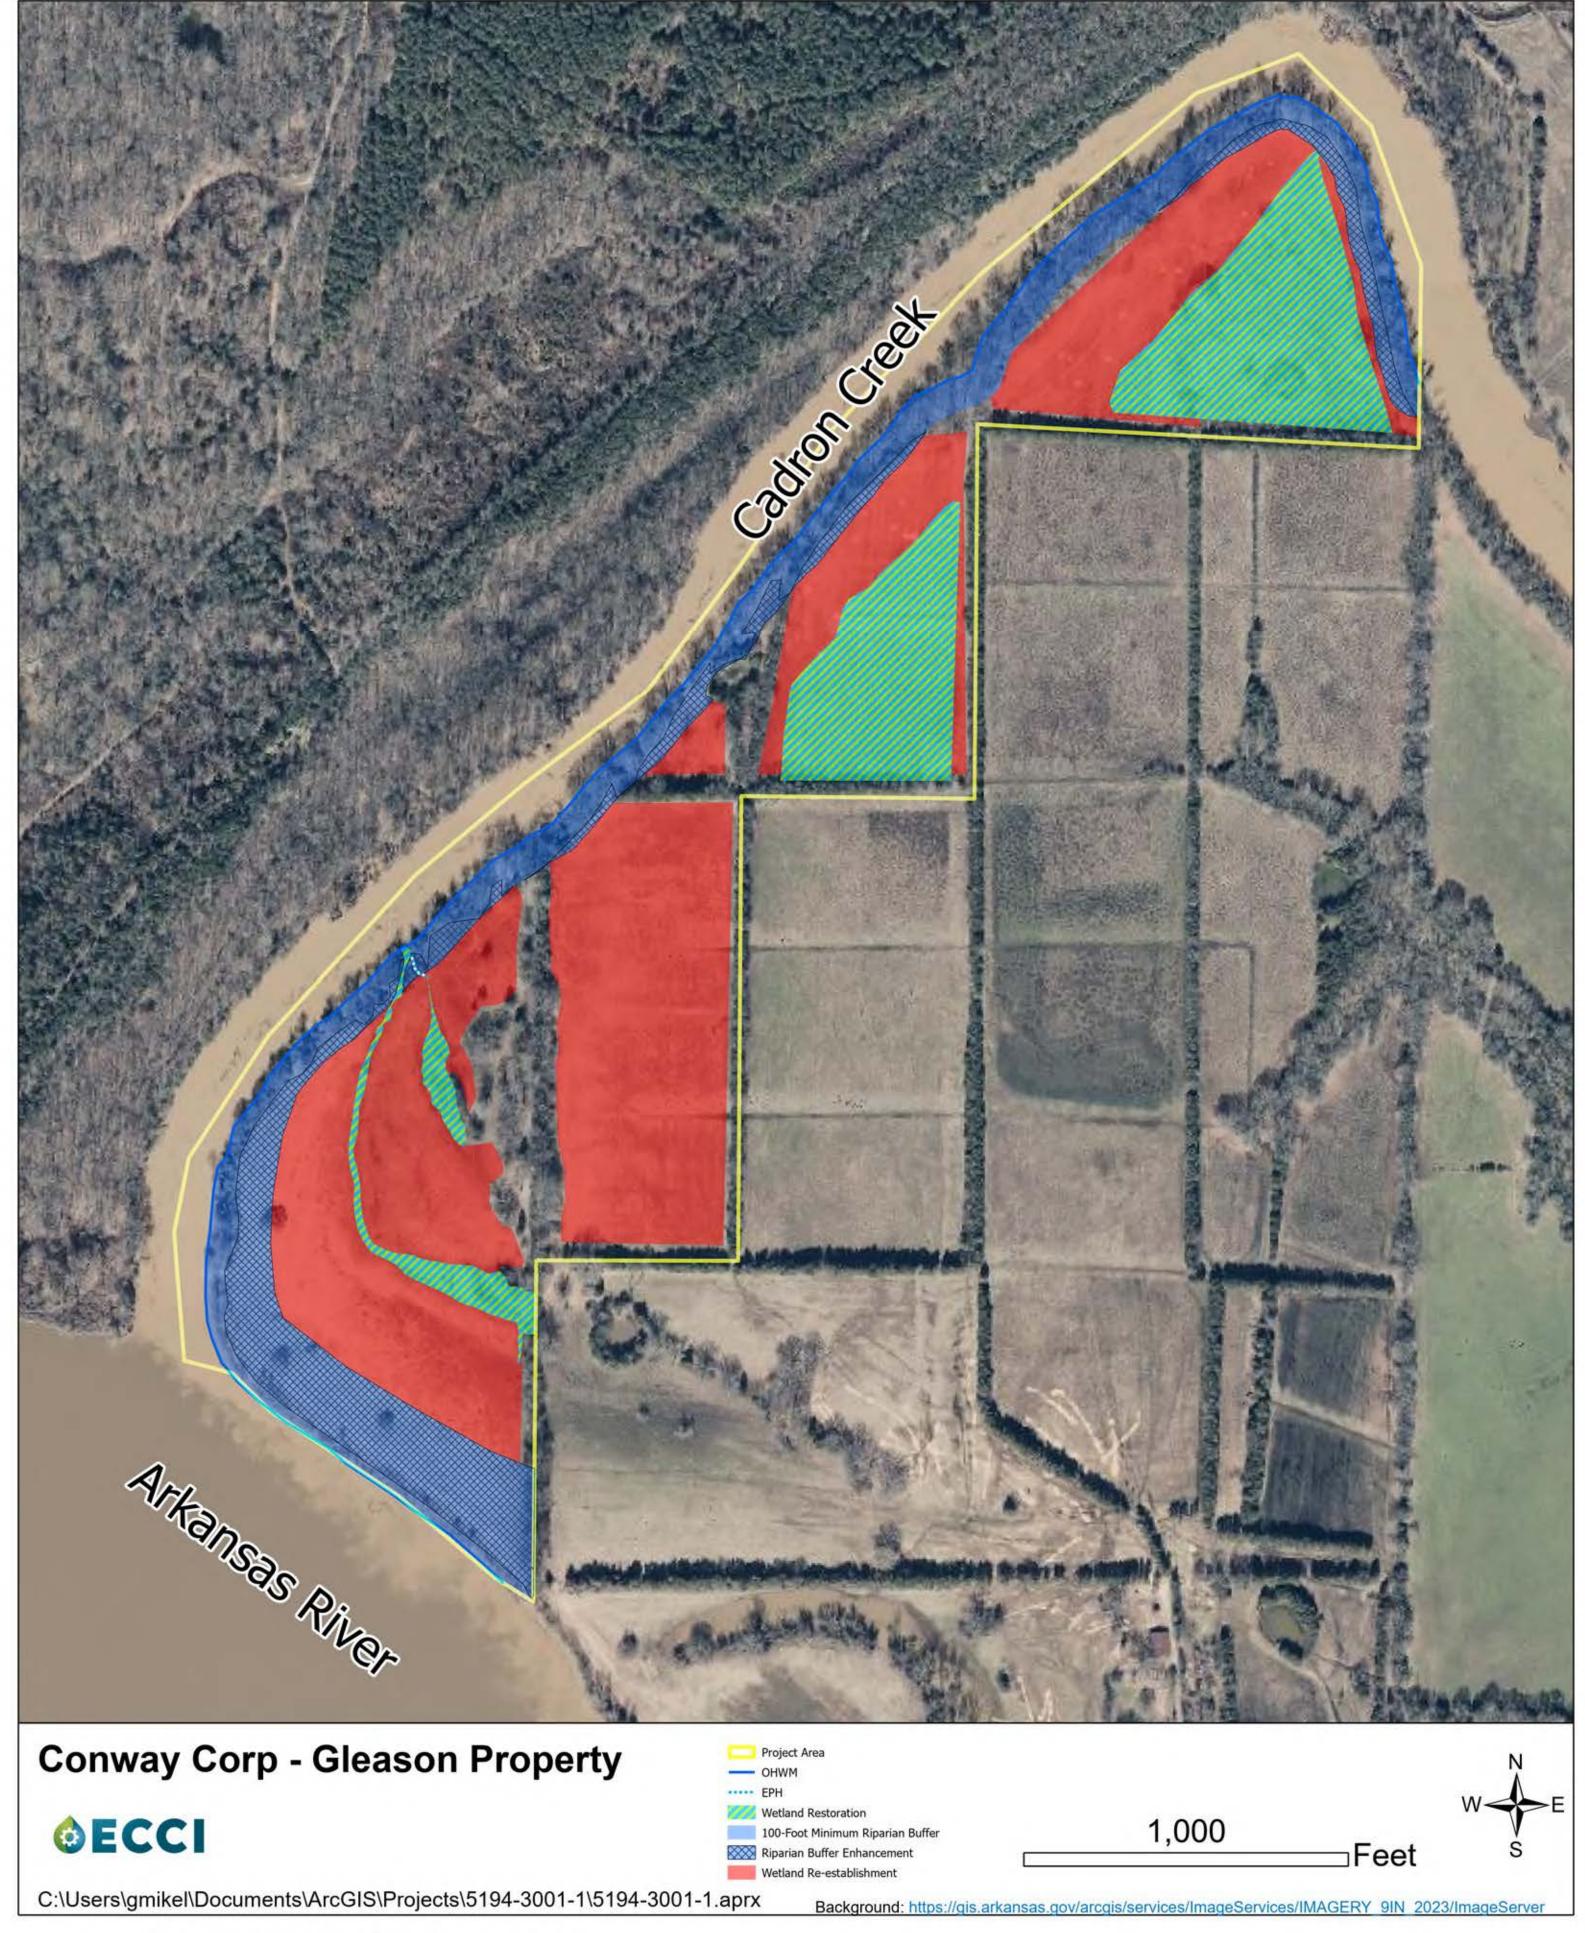
Figure 7. Mitigation Plan Concept Map

The project is located within a 115-acre area and would re-establish approximately 45 acres of wetlands, restore approximately 11.5 acres of wetlands, preserve approximately 11.5 acres of riparian buffer, and enhance approximately 11 acres of riparian buffer along Cadron Creek, increasing the functions and values within the mitigation bank area. The mitigation bank would

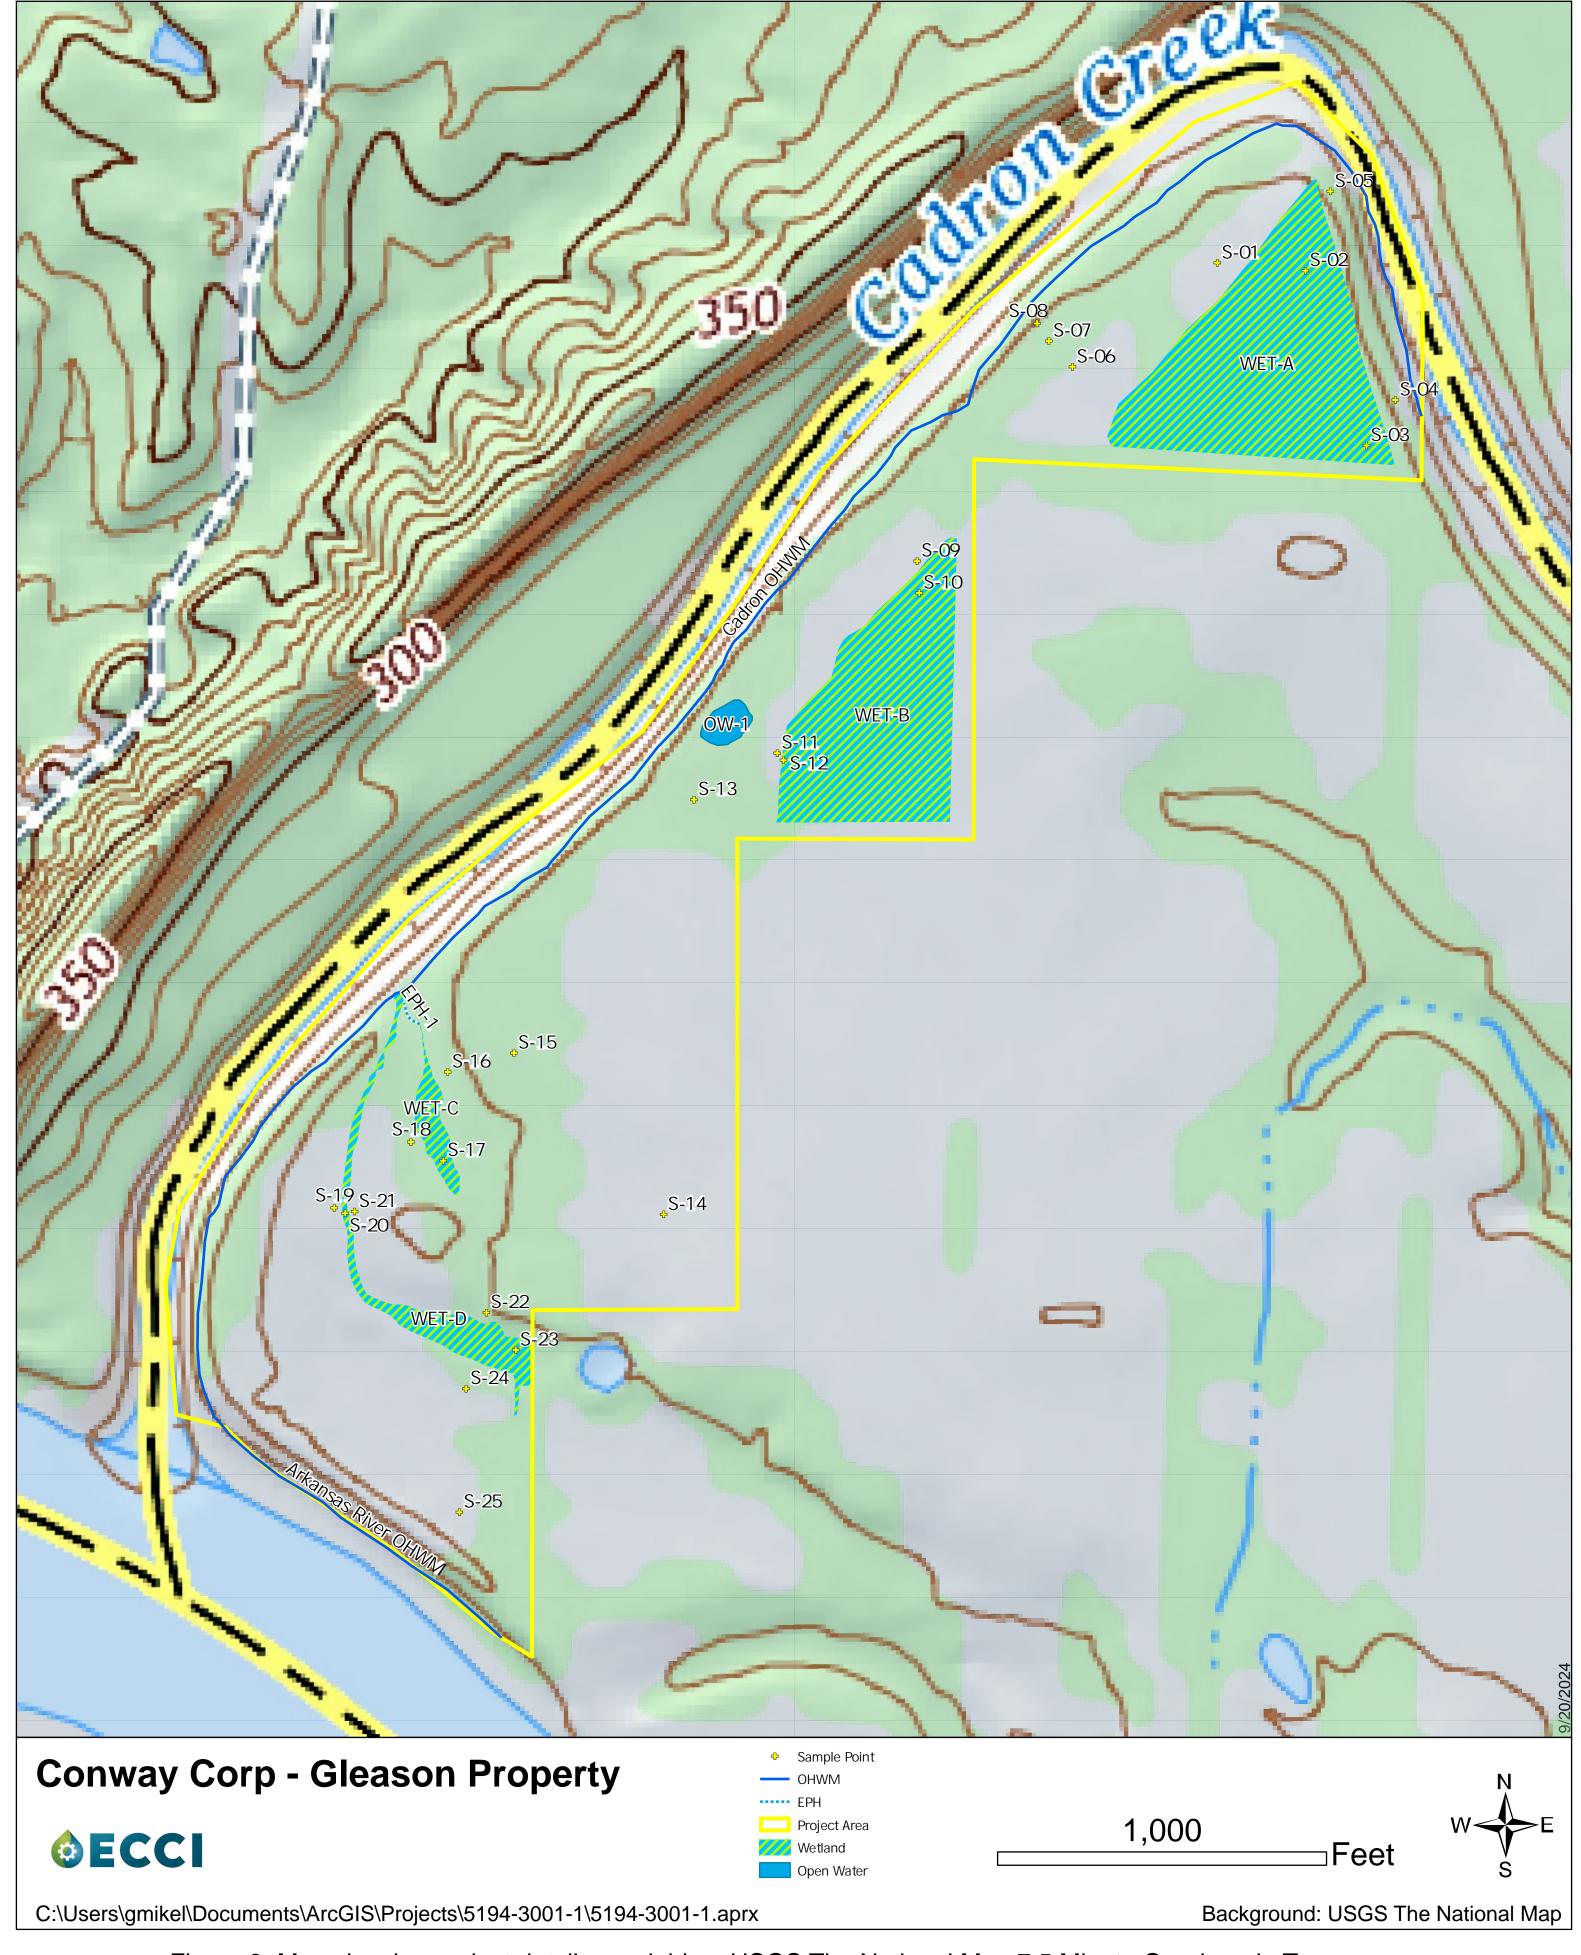
Figure 3. Map showing project details overlaid on USGS The National Map 7.5 Minute Quadrangle Topo .

ECCI observed four wetland features (WET-A, WET-B, WET-C, and WET-D) totaling approximately 18.21 acres that meet the technical criteria for classification as wetland (Figures 3 and 4). Table 2 provides a summary of each wetland feature.

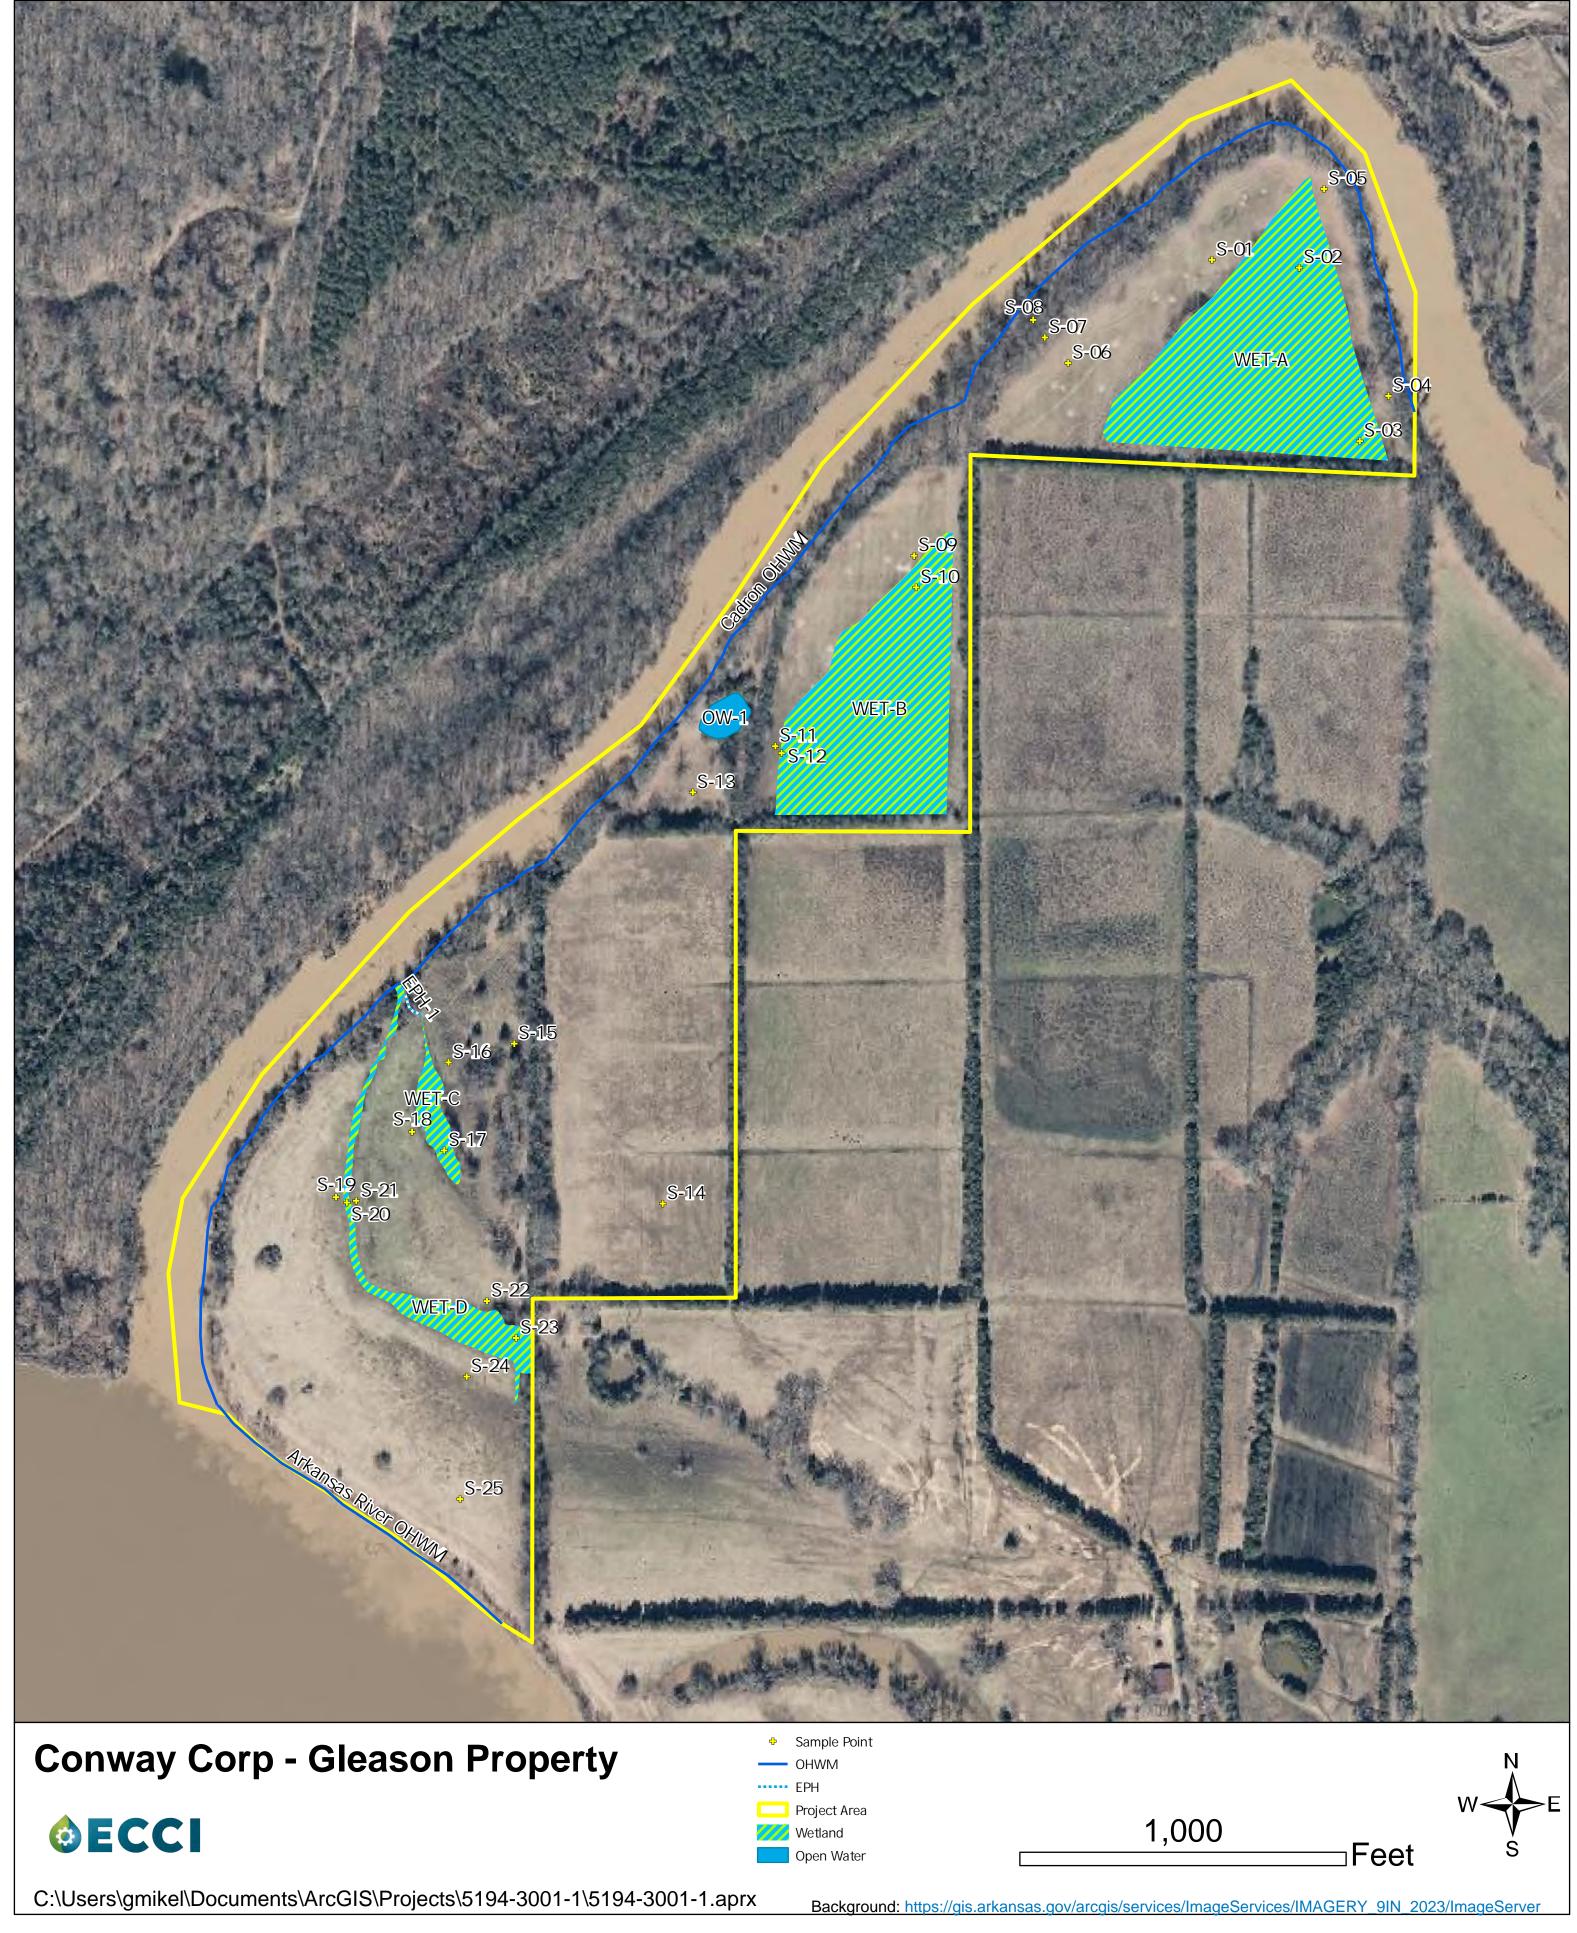
Figure 4. Map showing project details overlaid on 2023 9-inch aerial imagery.

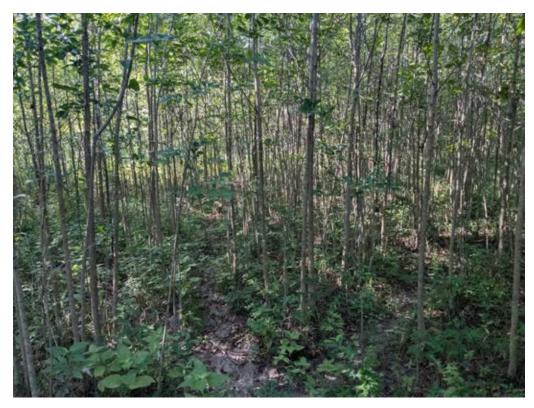
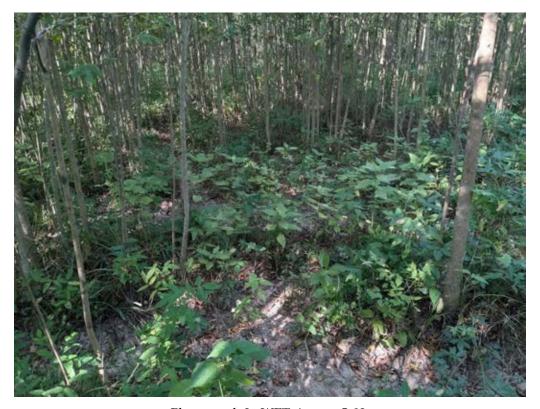
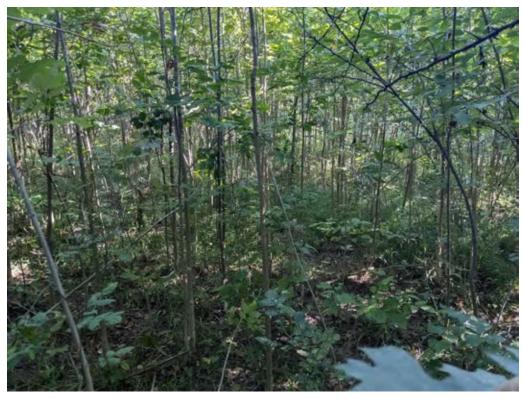
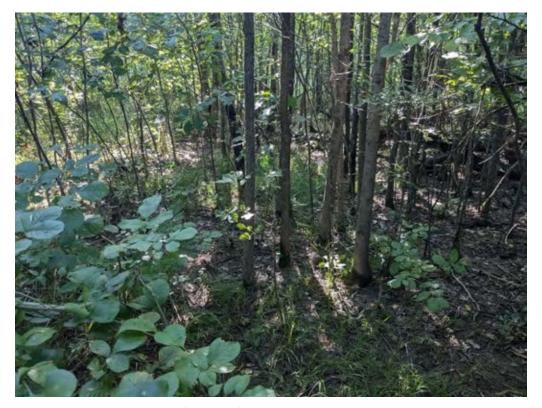
Photograph 1: WET-A, near S-02.

Photograph 2: WET-A, near S-02.

Photograph 3: WET-A, near S-03.

Photograph 4: WET-A, near S-03

The successional sapling wetland community, observed within WET-A and WET-B, is primarily dominated by green ash, honey locust (*Gleditsia triacanthos*), panicledleaf ticktrefoil

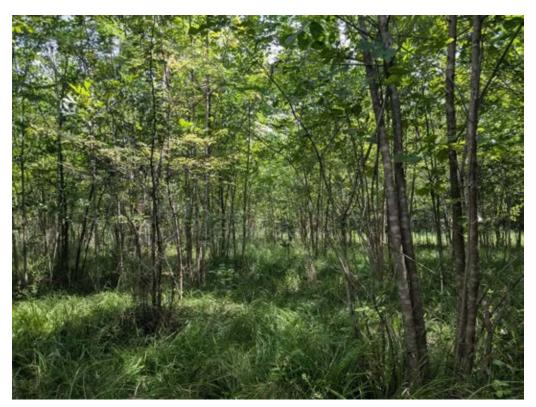
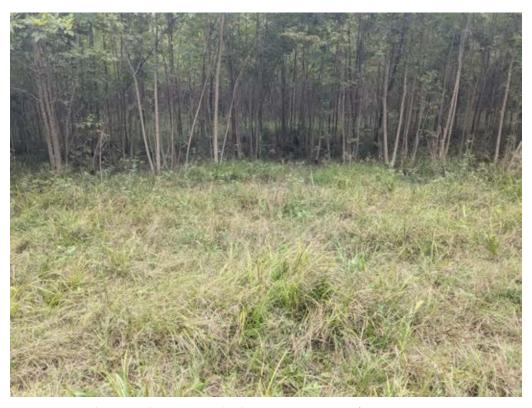
Photograph 5: WET-B, near S-10.

Photograph 6: WET-B, looking east at WET-B from near S-11.

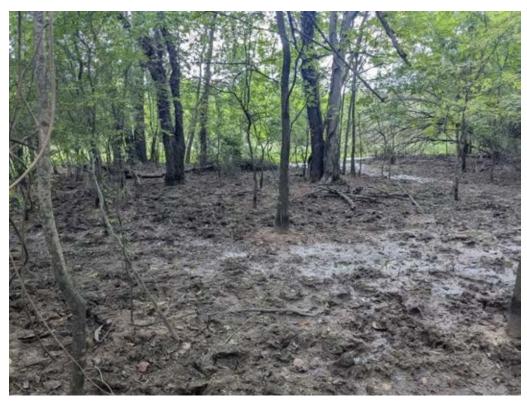
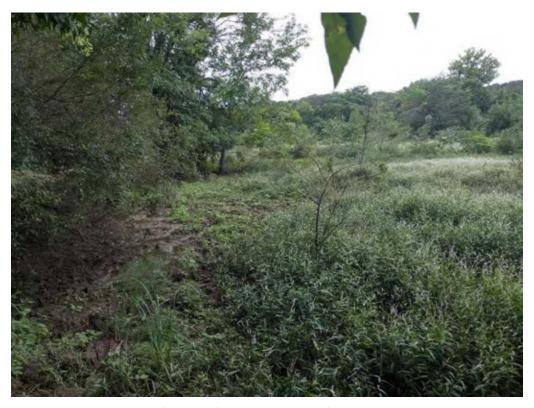
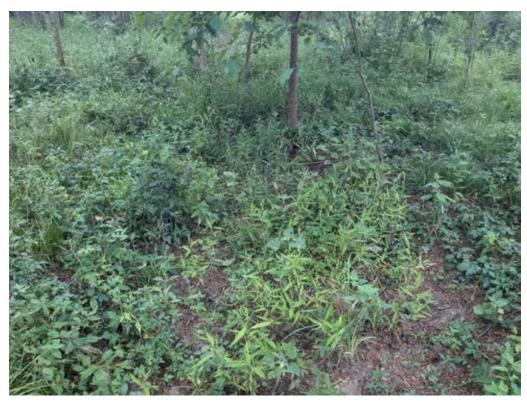
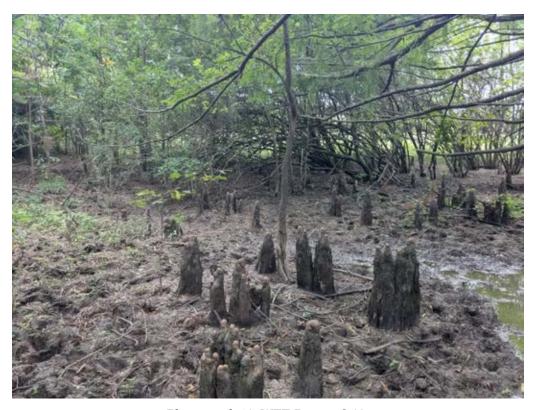
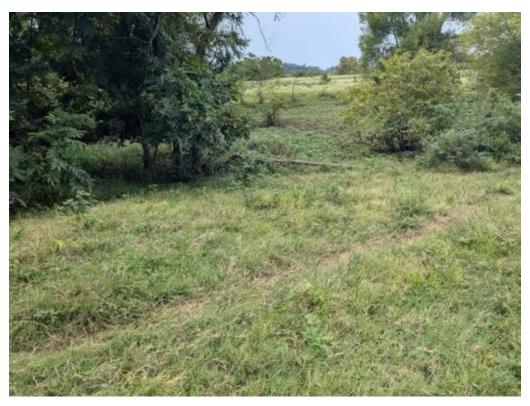
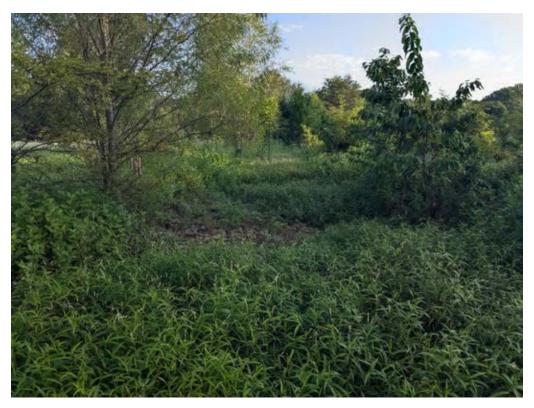
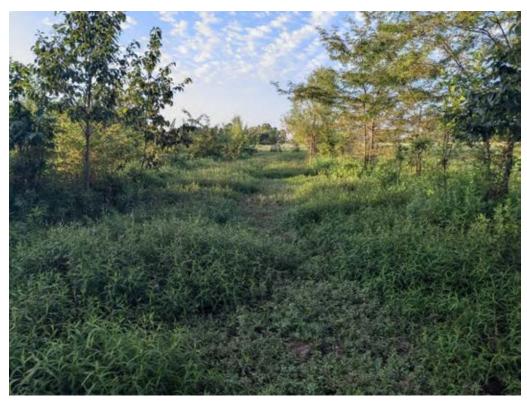
Photograph 7: WET-C, near S-17.

Photograph 8: WET-C, central portion.

Photograph 9: WET-C, linear portion at northern end.

Photograph 10: WET-D, near S-23.

Photograph 11: Overlooking WET-D from near S-22 (upland area in foreground).

Photograph 12: WET-D, near S-20, looking north.

Photograph 13: WET-D, near S-20, looking south.

The mixed-strata wetland community, observed within WET-C and WET-D, is primarily dominated by green ash, honey locust, sugarberry (*Celtis laevigata*), American elm (*Ulmus americana*), eastern bald cypress (*Taxodium distichum*), common button-bush (*Cephalanthus occidentalis*), black willow (*Salix nigra*), swamp smartweed (*Persicaria hydropiperoides*), and floating primrose-willow (*Ludwigia peploides*) (Attachment B, Photos 7-13).

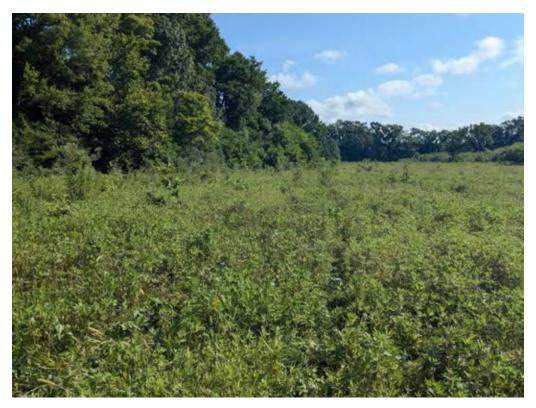
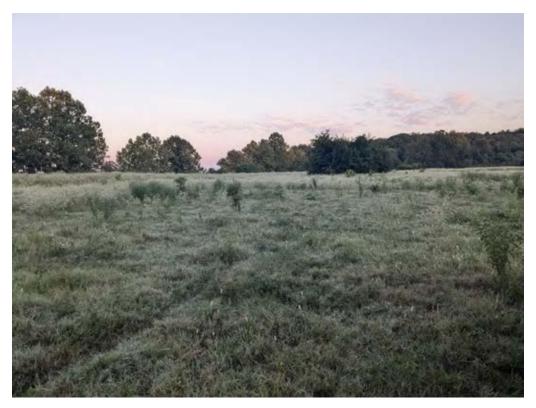
Photograph 14: Upland field, near S-06.

Photograph 15: Upland field, near S-25.

An upland field community, observed within the majority of the project area, is dominated by annual marsh elder, honey locust, Japanese clover (*Kummerowia striata*), beaked panicgrass (*Coleataenia anceps*), Bermuda grass (*Cynodon dactylon*), straw-colored flat sedge (*Cyperus strigosus*), annual bluegrass (*Poa annua*), Dallis grass (*Paspalum dilatatum*), bahiagrass (*Paspalum notatum*), wooly croton (*Croton capitatus*), and white clover (*Trifolium repens*) (Attachment B, Photos 14-15).

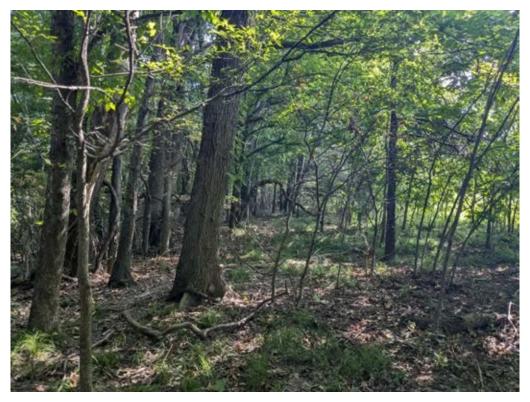
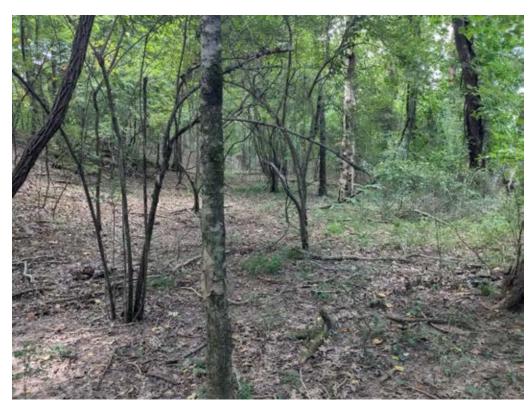
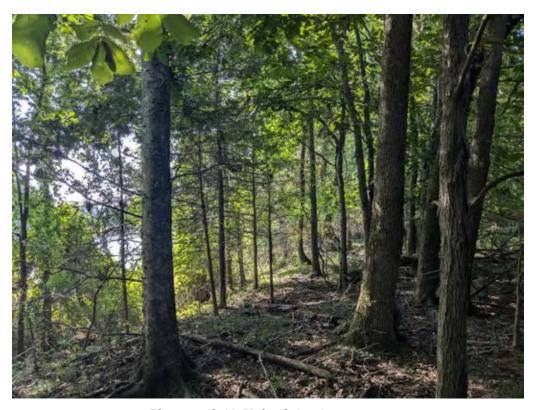
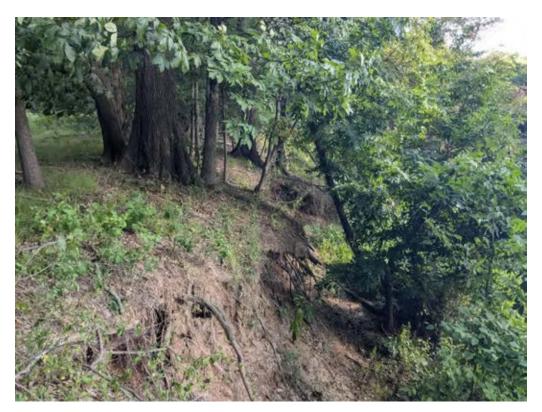
Photograph 18: Upper terrace, near S-07.

Photograph 19: Lower terrace, near S-08.

Photograph 20: Upland riparian terrace.

Photograph 21: Upland riparian terrace.

The forested, upland riparian, terrace community is located along Cadron Creek and the Arkansas River. Commonly observed dominant species in this community include shagbark hickory (*Carya ovata*), pecan (*Carya illinoinensis*), bitternut hickory (*Carya cordiformis*), Shumard oak (*Quercus shumardii*), sugarberry, eastern red cedar (*Juniperus virginiana*), common persimmon (*Diospyros virginiana*), sweet-gum (*Liquidambar styraciflua*), deciduous holly (*Ilex decidua*), poison ivy (*Toxicodendron radicans*), southern dewberry (*Rubus trivialis*), muscadine grape (*Vitis rotundifolia*), sawbrier (*Smilax bona-nox*), Virginia creeper (*Parthenocissus quinquefolia*), etc. (Attachment B, Photo 18-21).

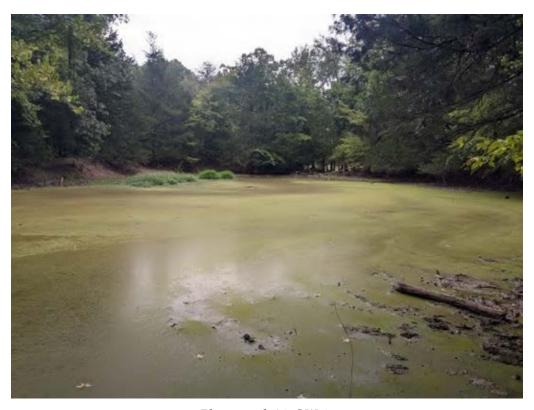
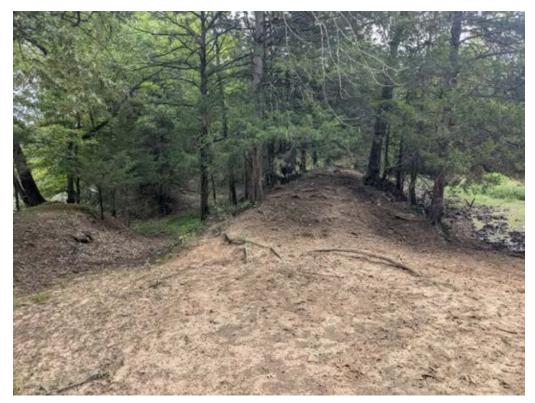
Photograph 24: OW-1.

Photograph 25: OW-1 overflow area.

Onsite observations revealed the presence of one man-made open water pond (OW-1) and one non-relatively permanent water (non-RPW) ephemeral drainage channel (EPH-1). OW-1 is a man-made pond with no obvious direct flow inlet or outlet (Attachment B, Photo 24). A pipe was observed through the southern edge of the pond embankment, but no defined drainage channel was observed south of the pipe. There is what visually appears to be a slightly lower portion of the berm along the northern edge of the pond embankment which may serve as a periodic overflow point (Attachment B, Photo 25). From this overflow point there is an undefined drainageway via a cut or eroded area in the stream terrace, leading to Cadron Creek. OW-1 is approximately 0.33 acre in size. EPH-1 is a small non-RPW drainageway that appears to periodically convey flow from WET-C to the point of confluence of WET-D and Cadron Creek. EPH-1 extends approximately 86 linear feet (Attachment B, Photo 26).

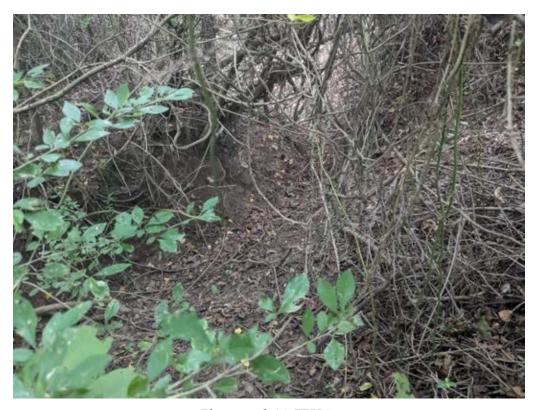
Photograph 26: EPH-1.
