# PUBLIC NOTICE

**Application Number: SWL-2025-00025**

## Butler County Wetland Mitigation Bank

## **Butler County Wetland Mitigation Site Plan**

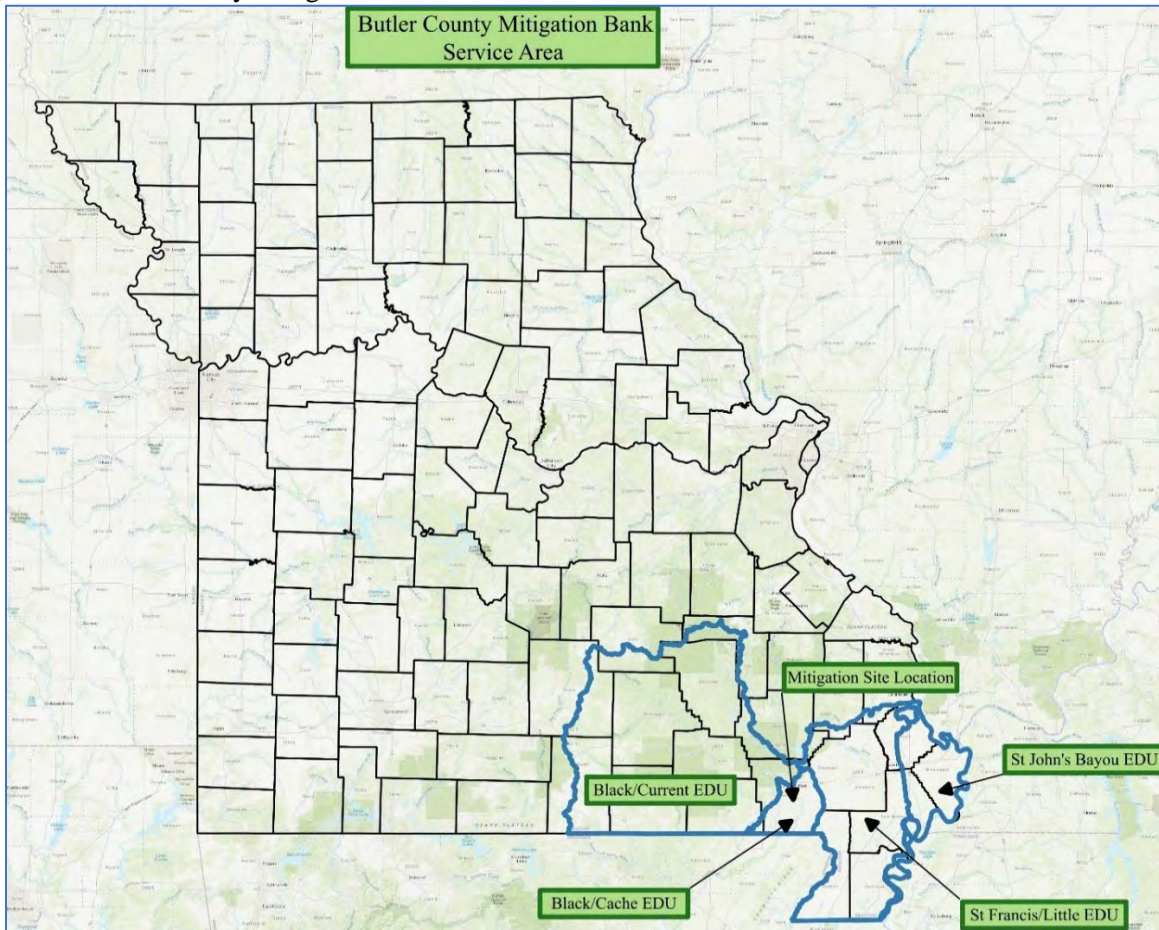
**Figure 1.** Butler County Mitigation Bank Service Area

This service area was selected because the watersheds within the service area are generally hydrologically and ecologically similar to the Black/Cache EDU, which contains the proposed mitigation site, and mitigation options in this region of Missouri are limited. A RIBITS search in November 2024 showed no active mitigation banks in Missouri within the proposed service area. Mitigation banks can help meet the needs of developers, including municipalities and state agencies, without temporal lag that could result in losses of aquatic resources.

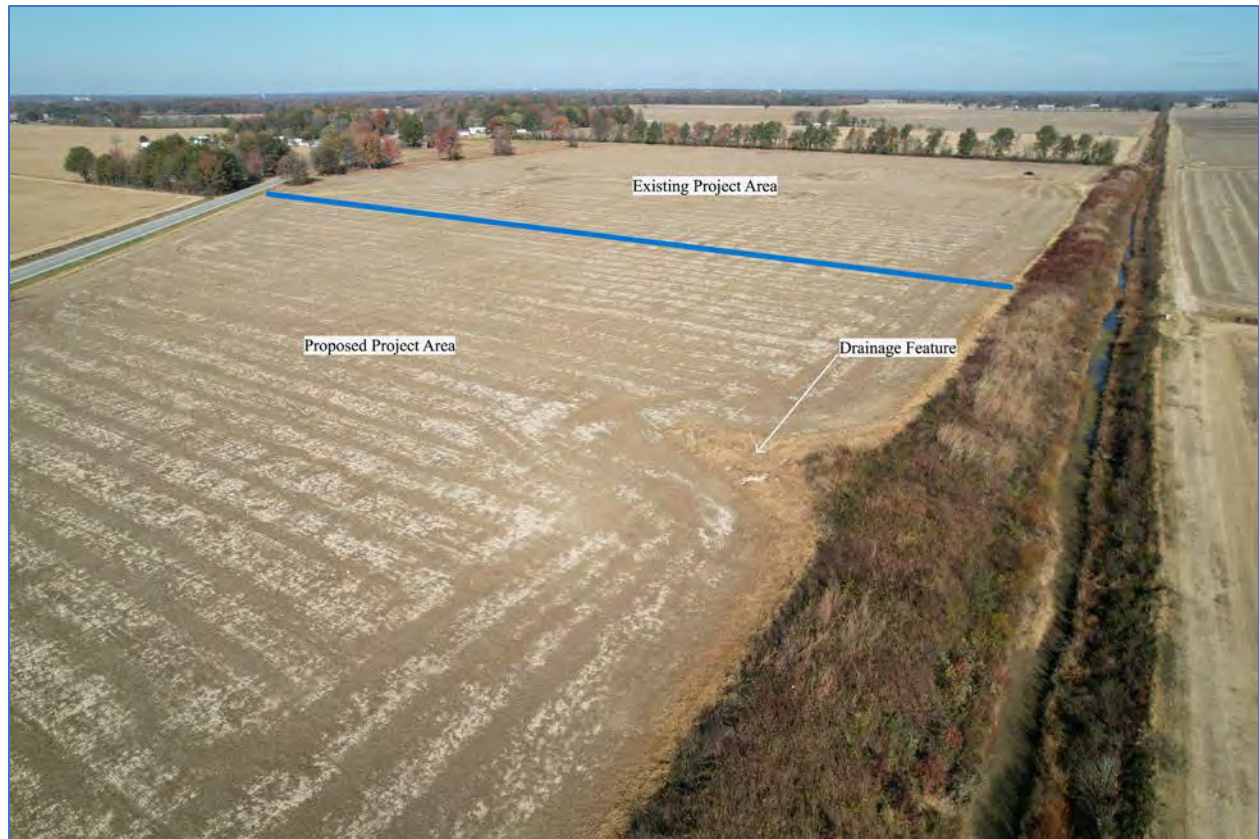
1 – Aerial overview of proposed project area and erosion feature draining the site to the adjacent intermittent stream. Facing northwest.

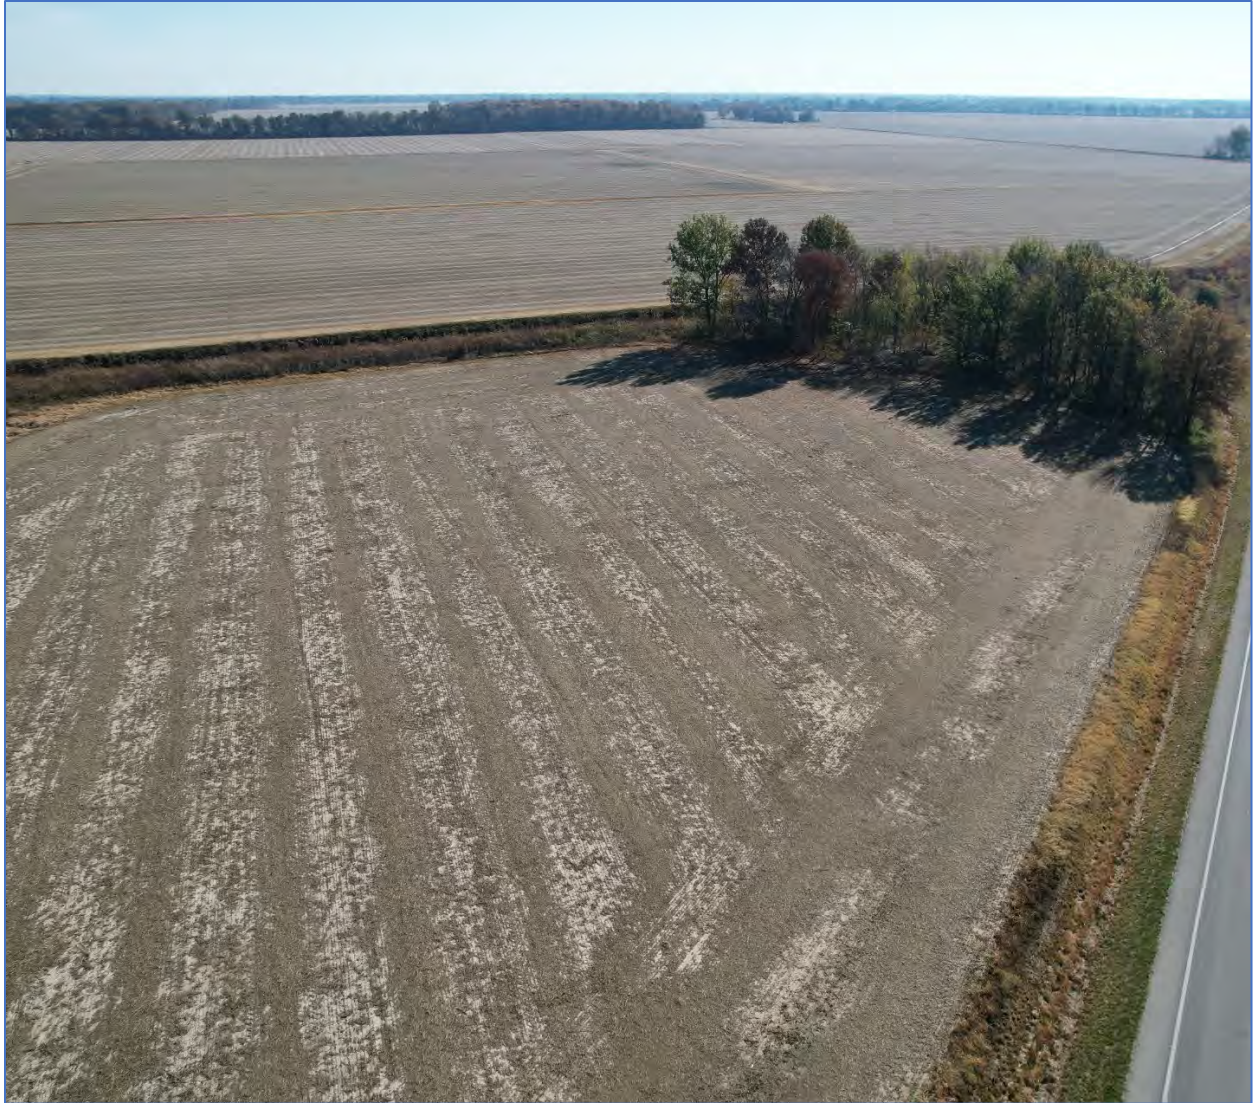
2 – Aerial overview of the proposed project area facing southeast.

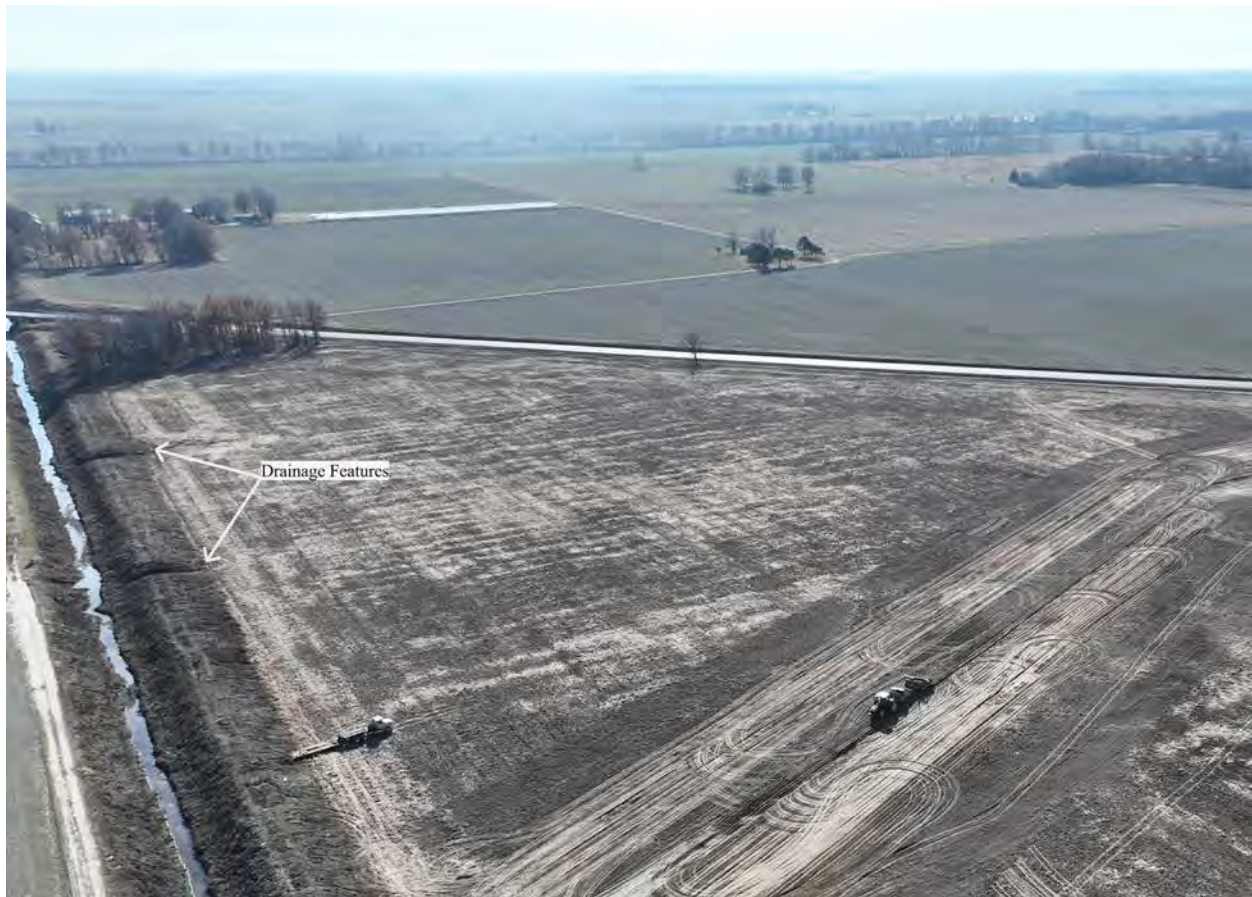
3 – Aerial overview of proposed project area and erosion feature draining the site to the adjacent intermittent stream. Facing southwest.

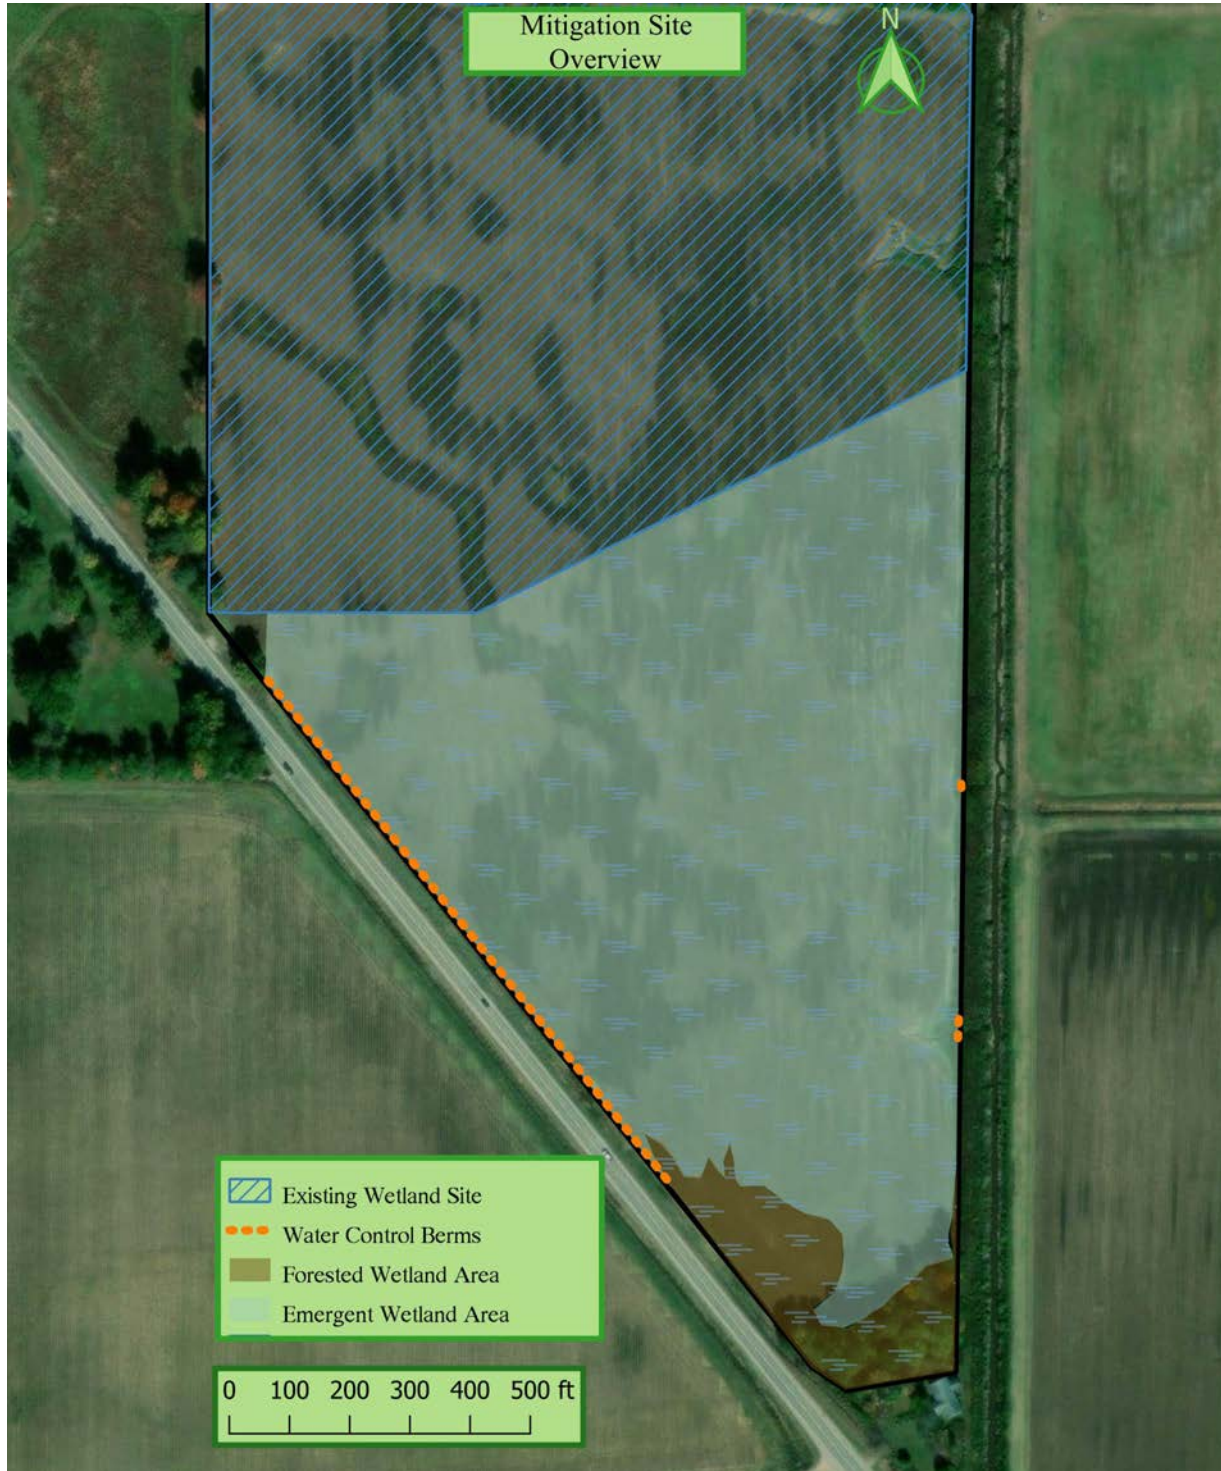
**Figure 3.** Butler County Wetland Mitigation Site Overview

In addition to the berms described above to retain hydrology, a spillway will be placed within the berm separating this proposed site from the previously completed wetland mitigation site. Its elevation will be the same as the existing spillway to the unnamed tributary, allowing excess hydrology from the existing site to flow to the newly proposed site without impacting the existing wetland hydrology.

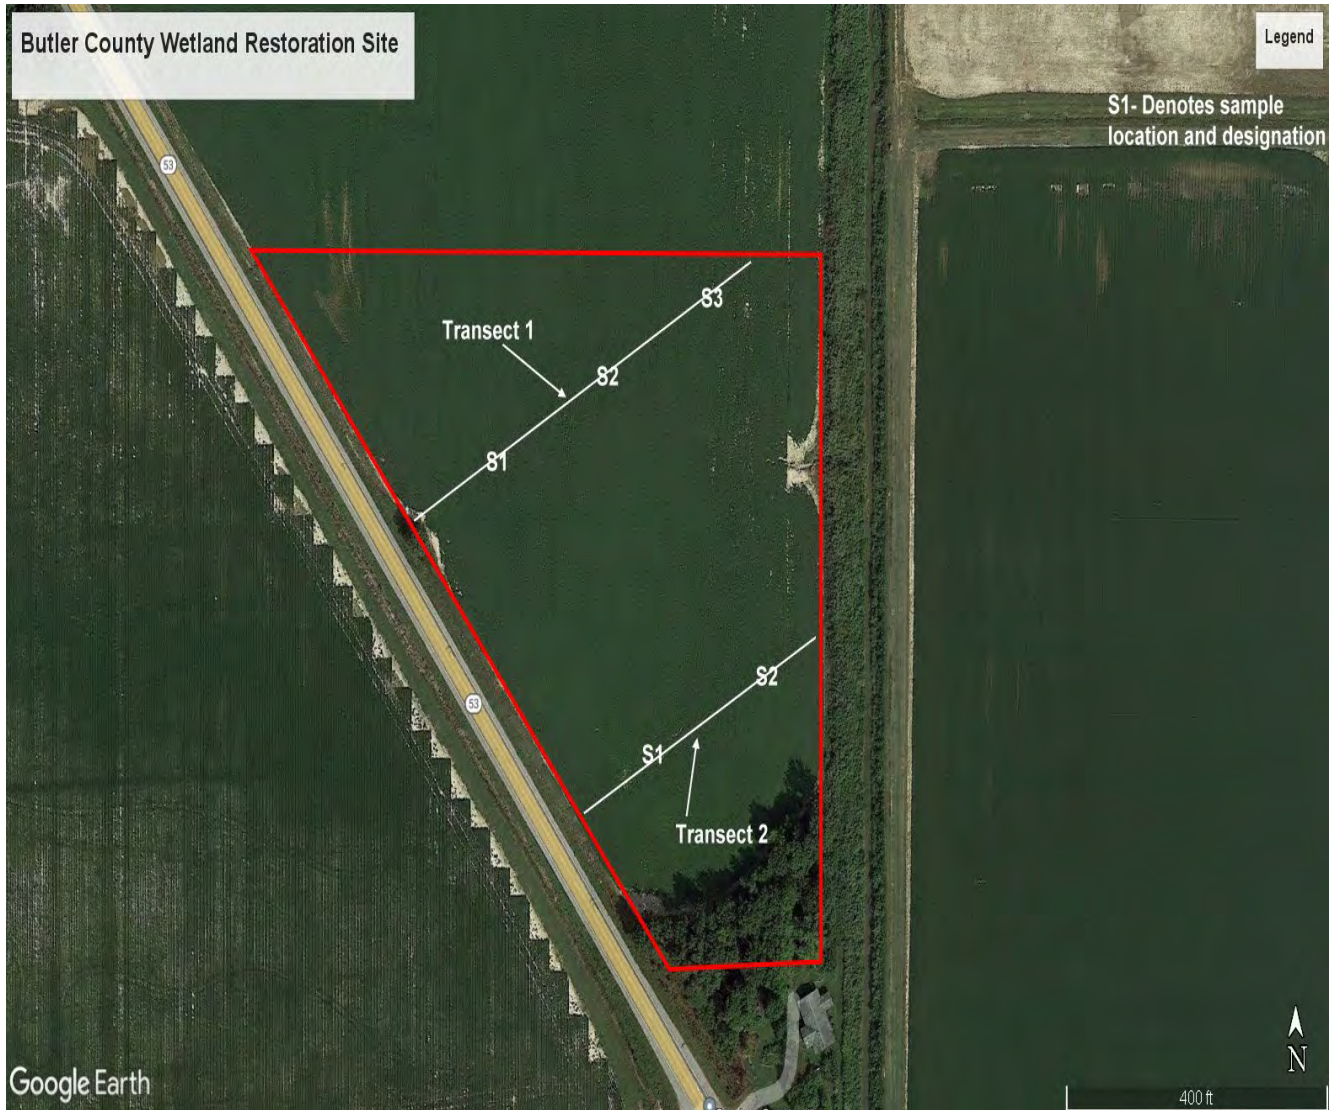
Since the site has been row cropped for many decades, the traditional wetland characteristics have been masked or altered. Due to row cropping, the vegetation has been altered from its natural state therefore our focus was on hydrology and soils. The site is adjacent to an existing drainage ditch that has been present since the early 1900's. A historic slide review was conducted to determine the frequency of saturation or inundation. Historic aerial photos were reviewed that covered years 1985 through 2020. During those years, there were areas that showed inundation during the growing season. Below is an aerial photo showing the location of the sample sites.
