**Prospectus**  
**West Fork White River Stream Mitigation Bank**  
**Washington County, Arkansas**

September 18, 2012

Prepared by:

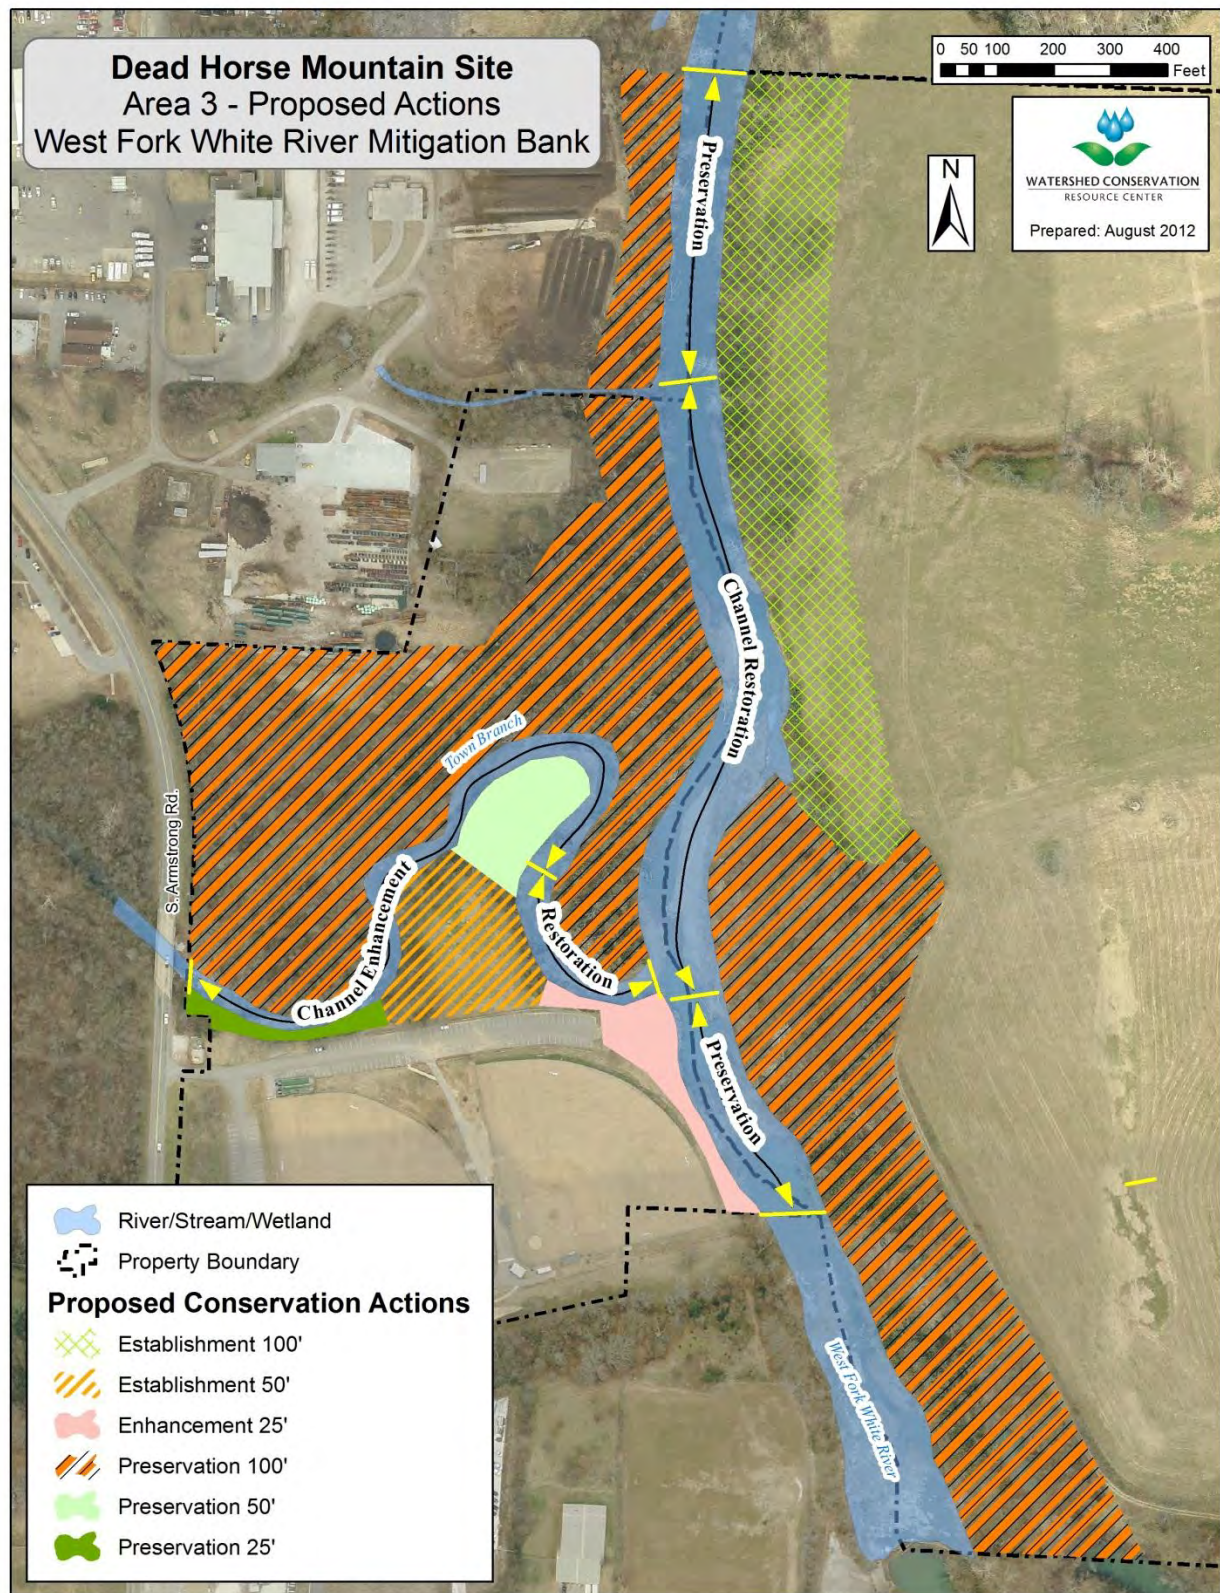
**Figure 7** Proposed conservation actions to be undertaken at Area 3 of the WFWR Mitigation Bank – Dead Horse Mountain Site

A map showing the proposed actions for each area is shown in Appendix A, Figures 5-7. The overall mitigation plan concept for this site is to design and implement river restoration on the West Fork White River that will 1) create and enhance aquatic habitat, 2) stabilize streambanks and eliminate them as a source of contaminants that

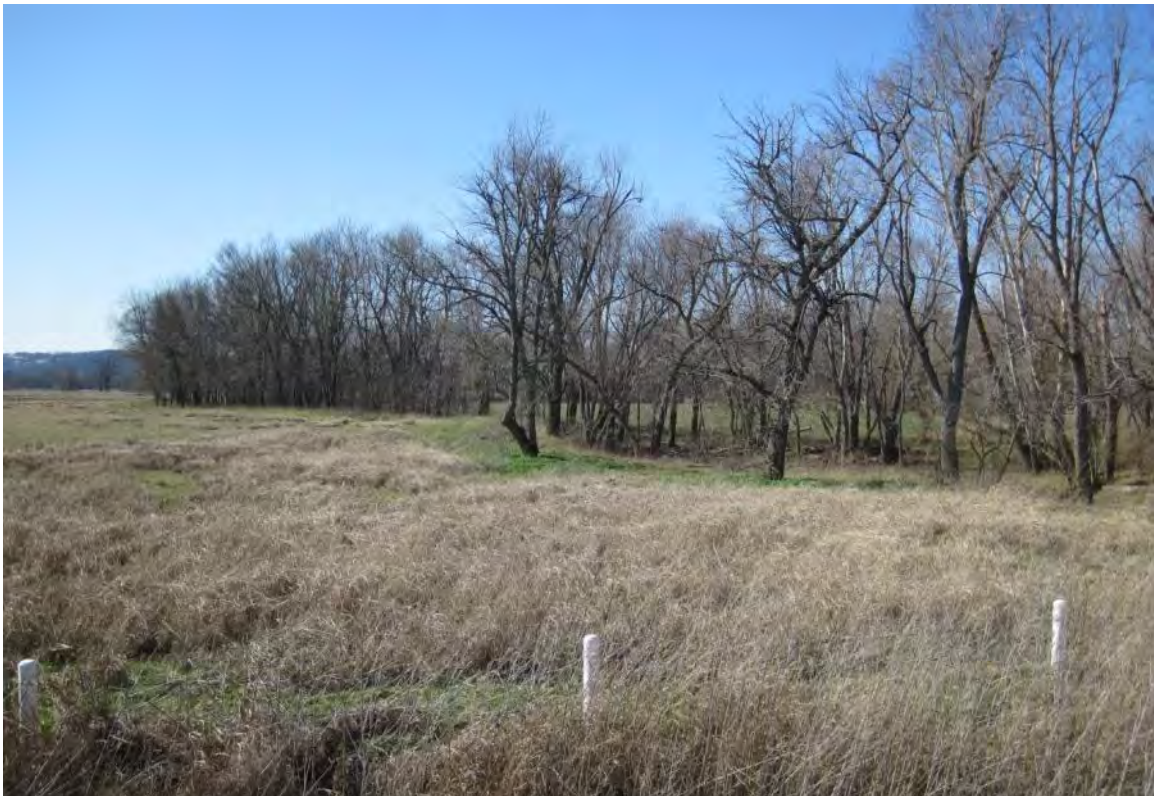
**Photo 1** – Area 1 looking west from Dead Horse Mountain Rd. towards old channel meander scars, associated wetlands and forested area. Grassed area in foreground will be converted to forest.

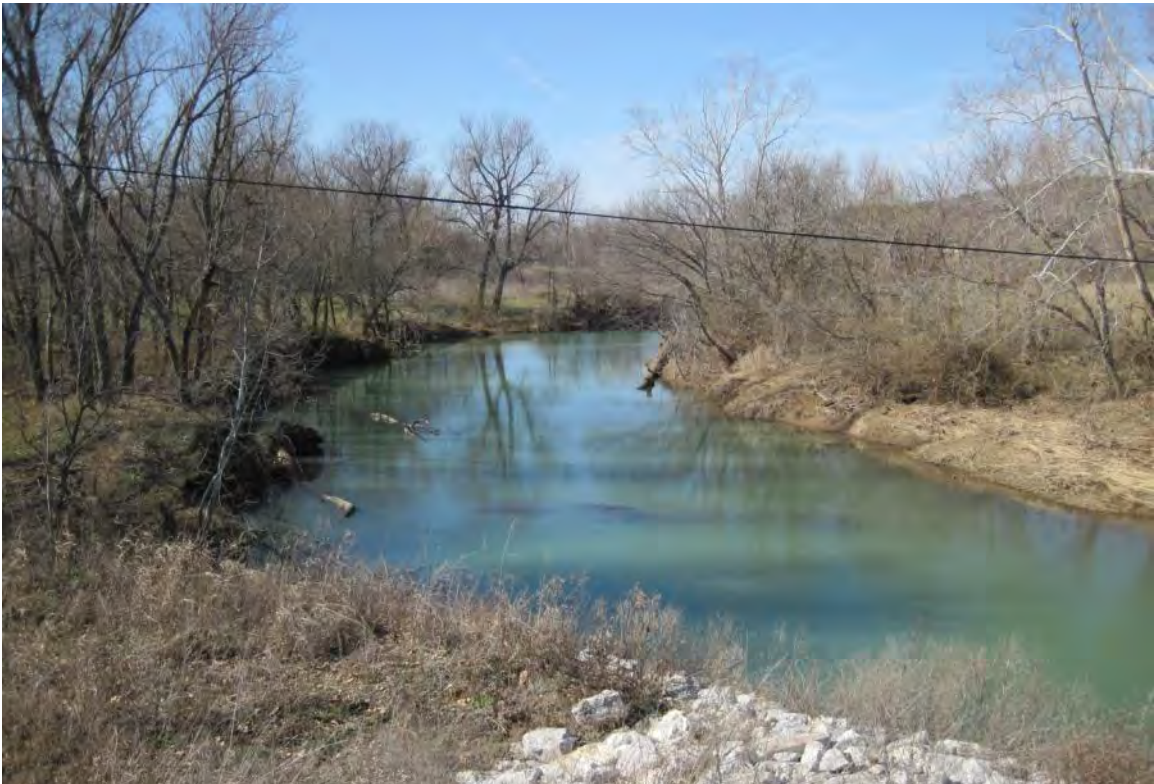
**Photo 2** Area 1 looking west from Dead Horse Mountain Rd. The eroding bank on the left of the picture will be stabilized as part of the river restoration component of the established bank site.

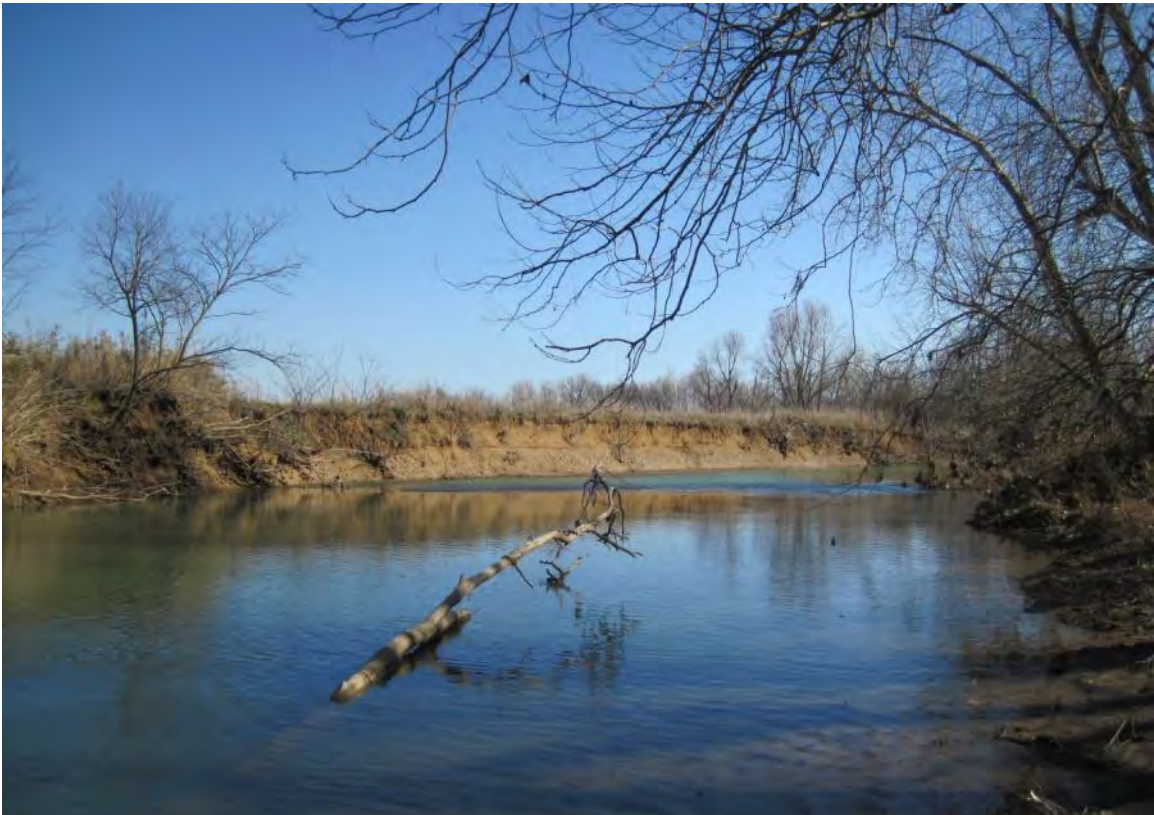
**Photo 3** Area 1 looking east-northeast towards eroding riverbank that will be restored

The WFWR is a perennial stream and the proposed mitigation site has 2,500 feet of highly erodible cut-banks that are 10 to 14 feet high (Appendix B, Photos 3 and 8). A combination of channel incision, low radius of curvature to bankfull width ratios, erodible bank materials, and lack of a forested riparian area is resulting in accelerated streambank erosion causing land loss, vegetation loss, and poor aquatic habitat. There are several ephemeral tributaries that are moderately stable and flow to the WFWR. There are also several side channels and riverine wetlands that will be included in the mitigation bank. Forested riparian areas can be found periodically throughout the site.

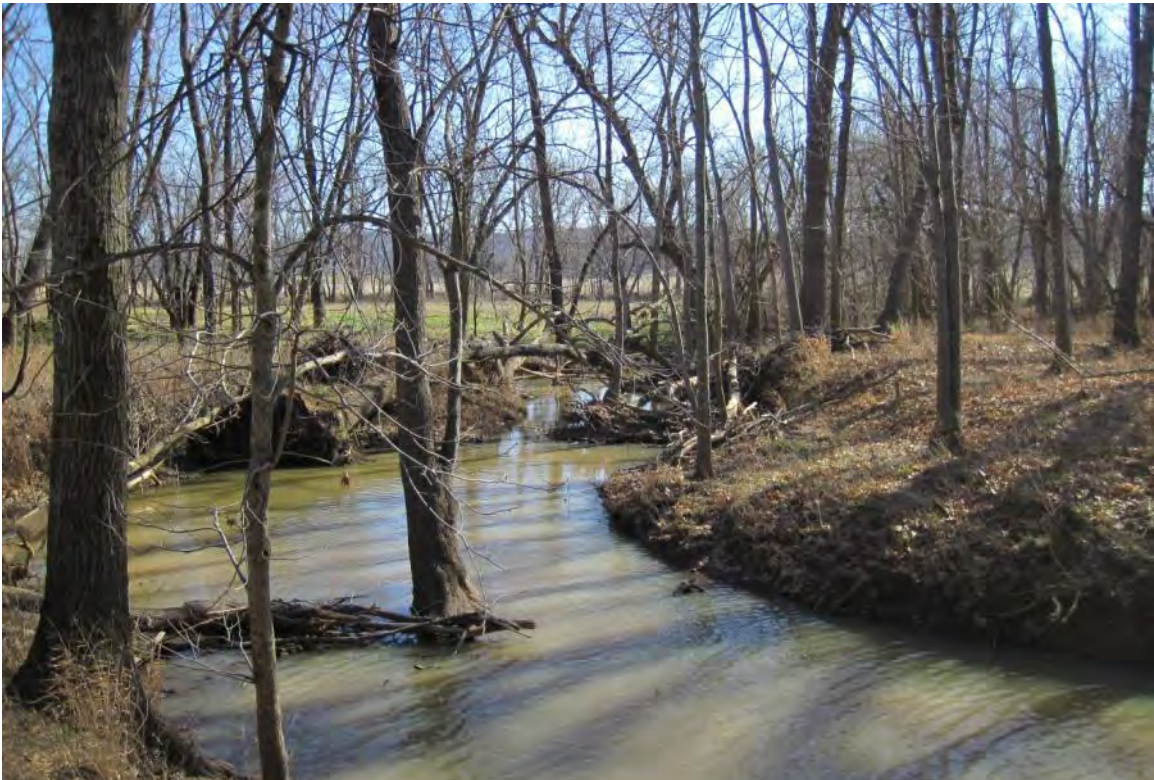
**Photo 4** Area 1 looking southeast at old river meander scars that serve as riverine wetlands. This area will be preserved as part of the established bank area.

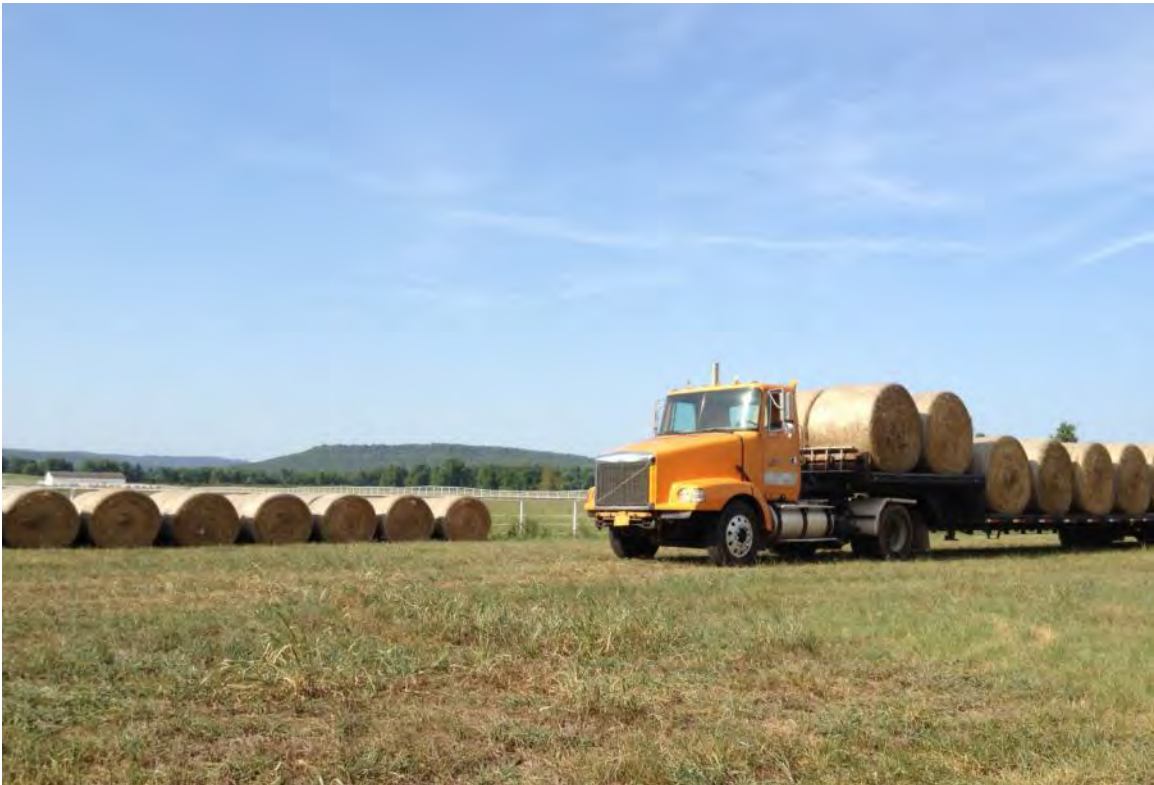
**Photo 5** Area 1: Pastures adjacent to the mitigation area are managed for hay production. Portions of the mitigation area will be converted from pasture to forested riparian.

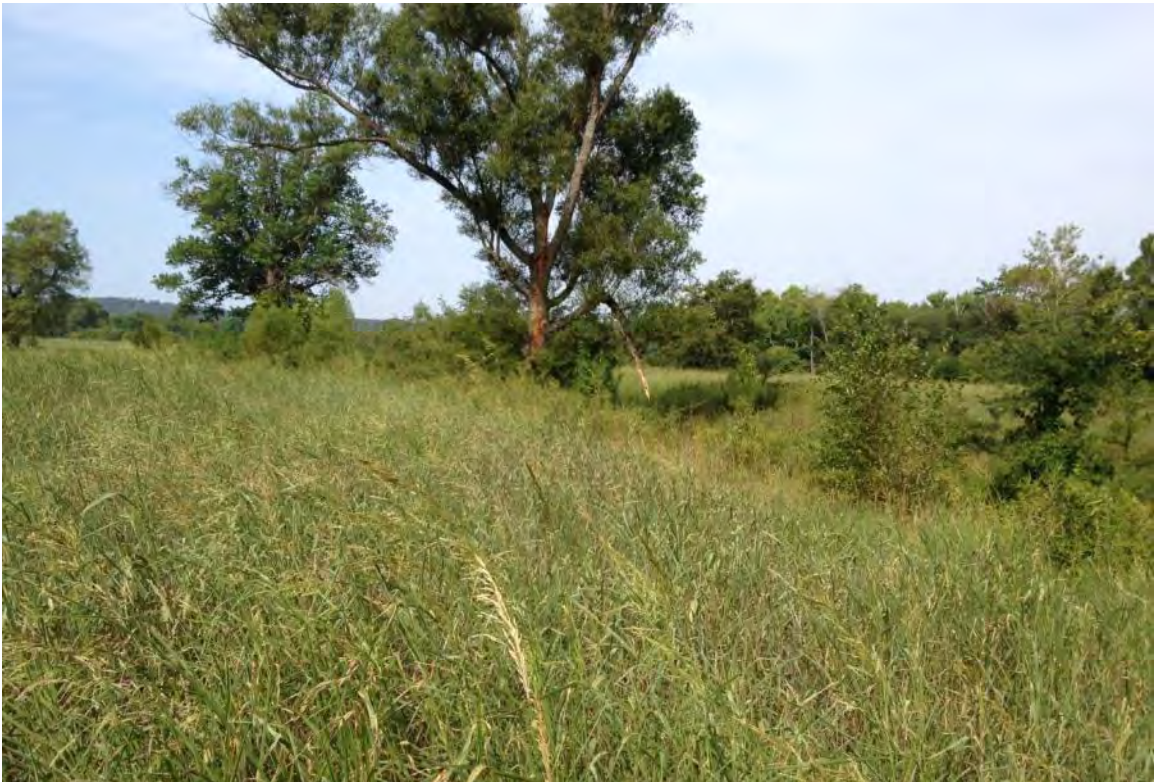
**Photo 6** Area 1 looking west along ephemeral tributary. A forested riparian area will be established and the stream channel will be enhanced where appropriate

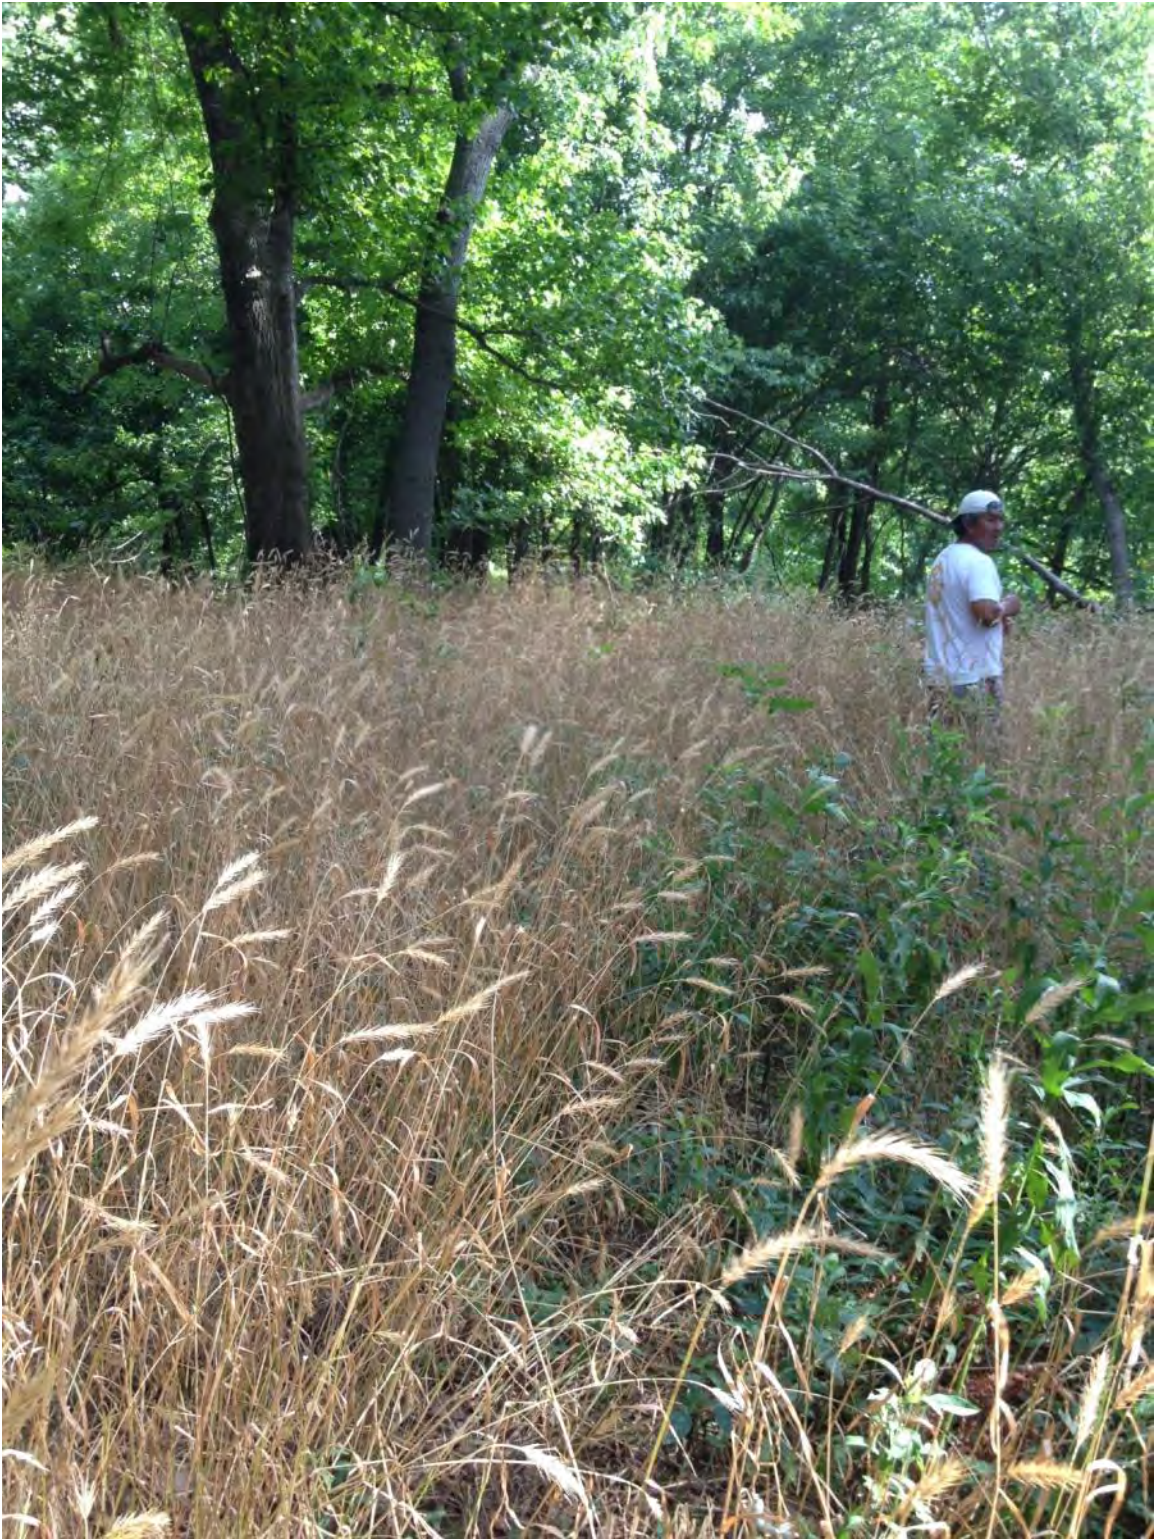
**Photo 7** Area 1 looking east at Virginia wild rye understory in a forested riparian that will be preserved

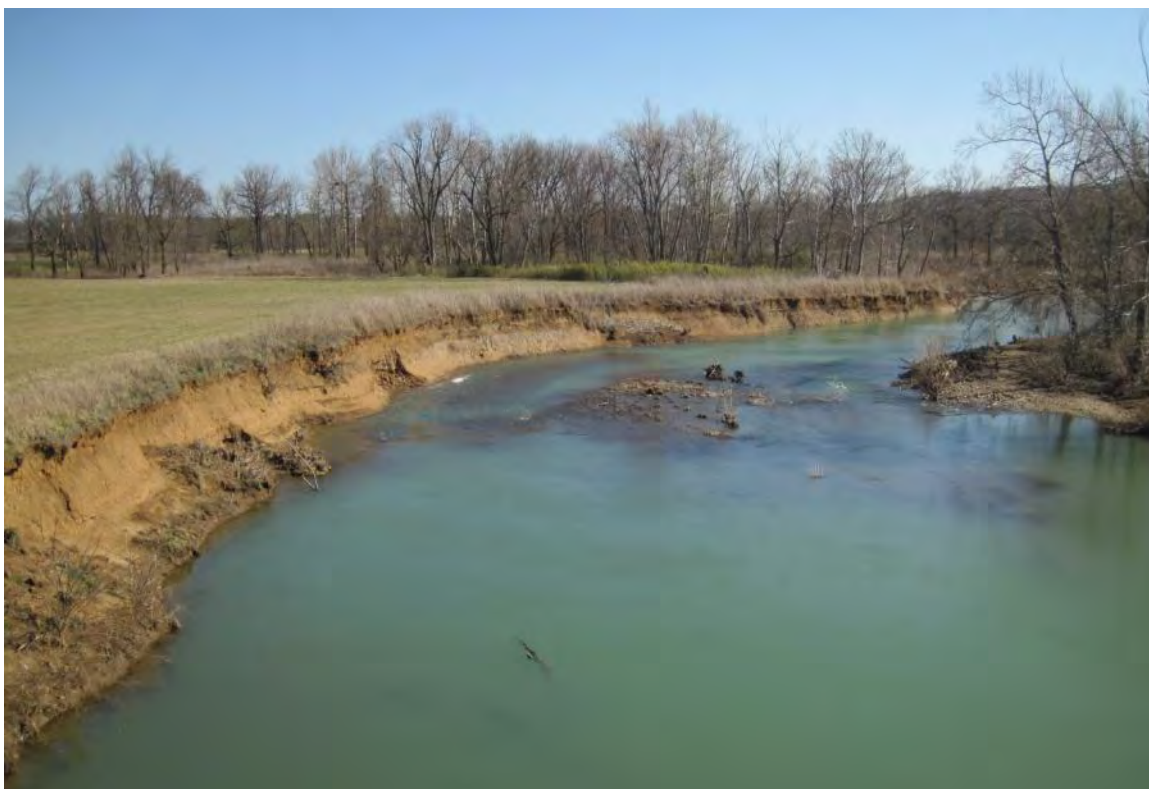
**Photo 8** Area 2 looking east from Dead Horse Mountain Rd. at eroding riverbank. The 14 ft. high cut-bank will be stabilized using a toe wood bench. A riparian forest will be established on the floodplain adjacent to the restored river bank

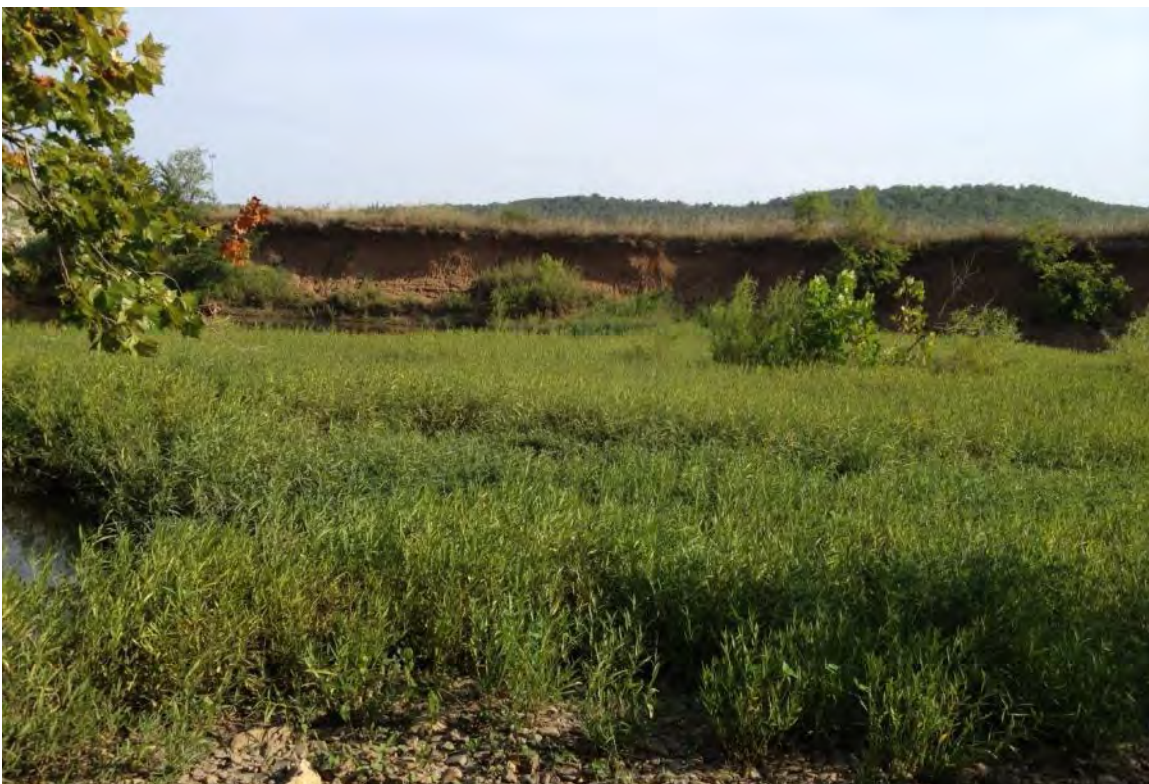
**Photo 9** Area 2 looking north towards eroding riverbank. The dimensions of the channel will be adjusted during restoration to reduce the width to depth ratio.

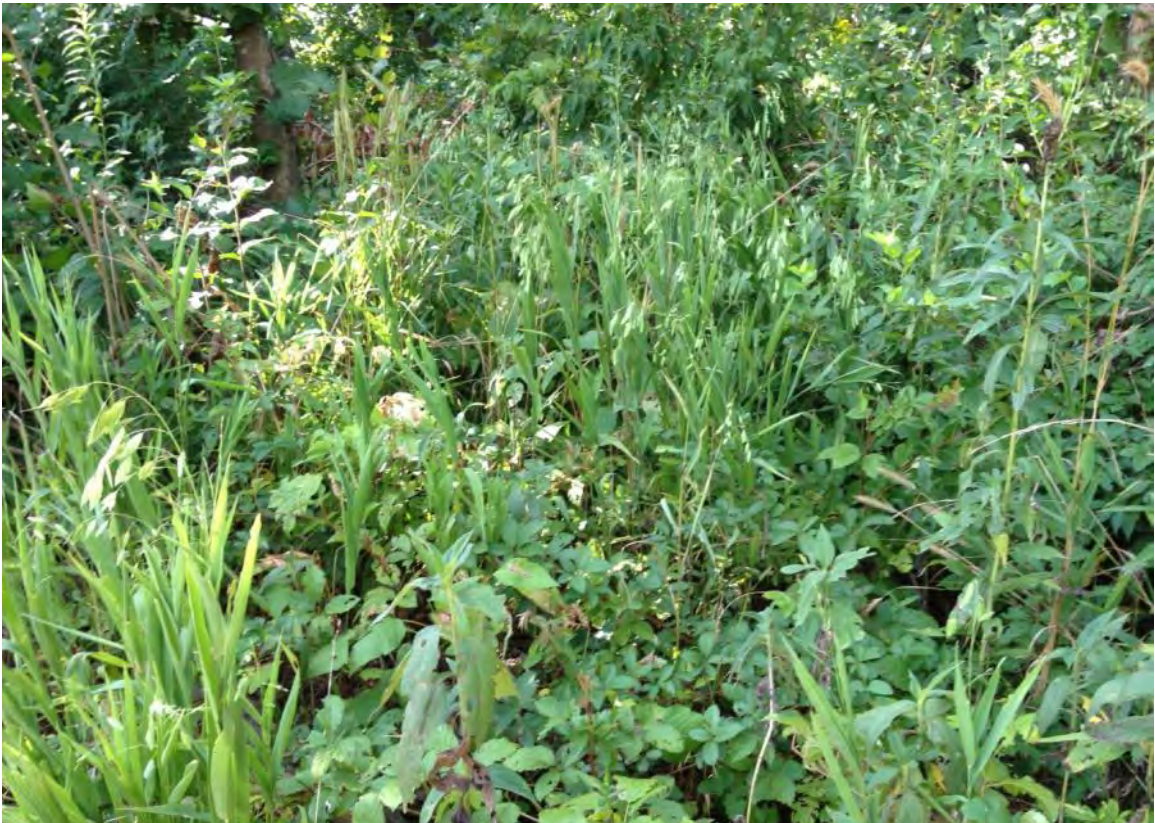
**Photo 10** Area 2: Typical near-channel vegetative community near stable sections of the river that will be preserved

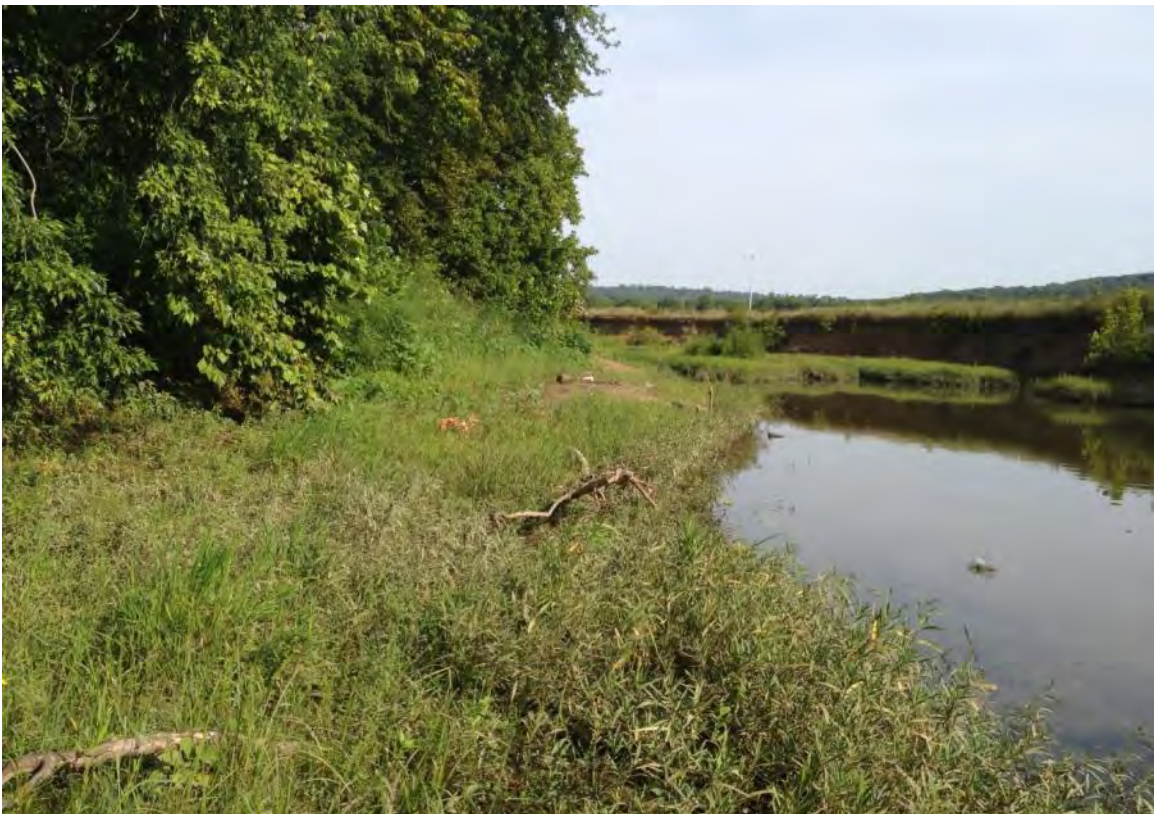
**Photo 11** Area 2 looking northwest towards eroding riverbank

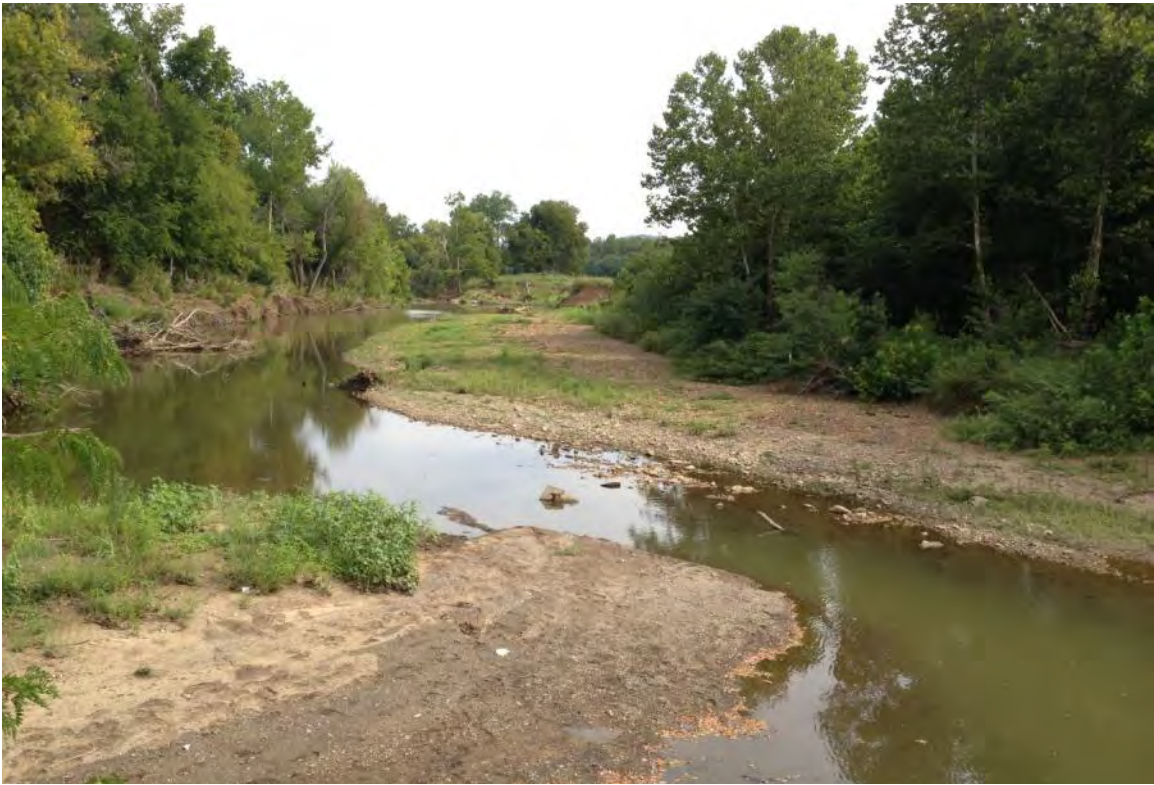
**Photo 12** Area 3 looking north-east towards alternating eroding riverbanks on the WFWR. The channel will be restored and the banks stabilized.

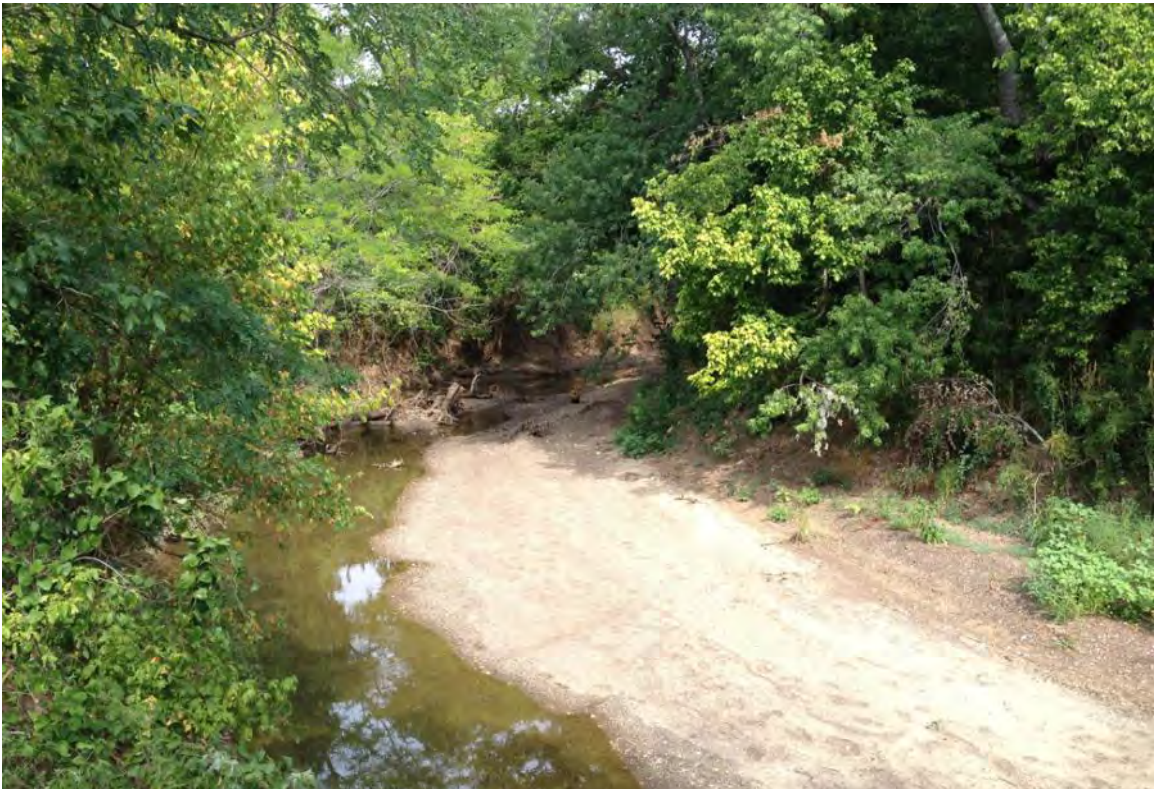
**Photo 13** Area 3 looking north-northwest up Town Branch tributary to the WFWR. The riverbank on the left of the photo frame is eroding and will be restored as part of the implementation phase for Area 3.

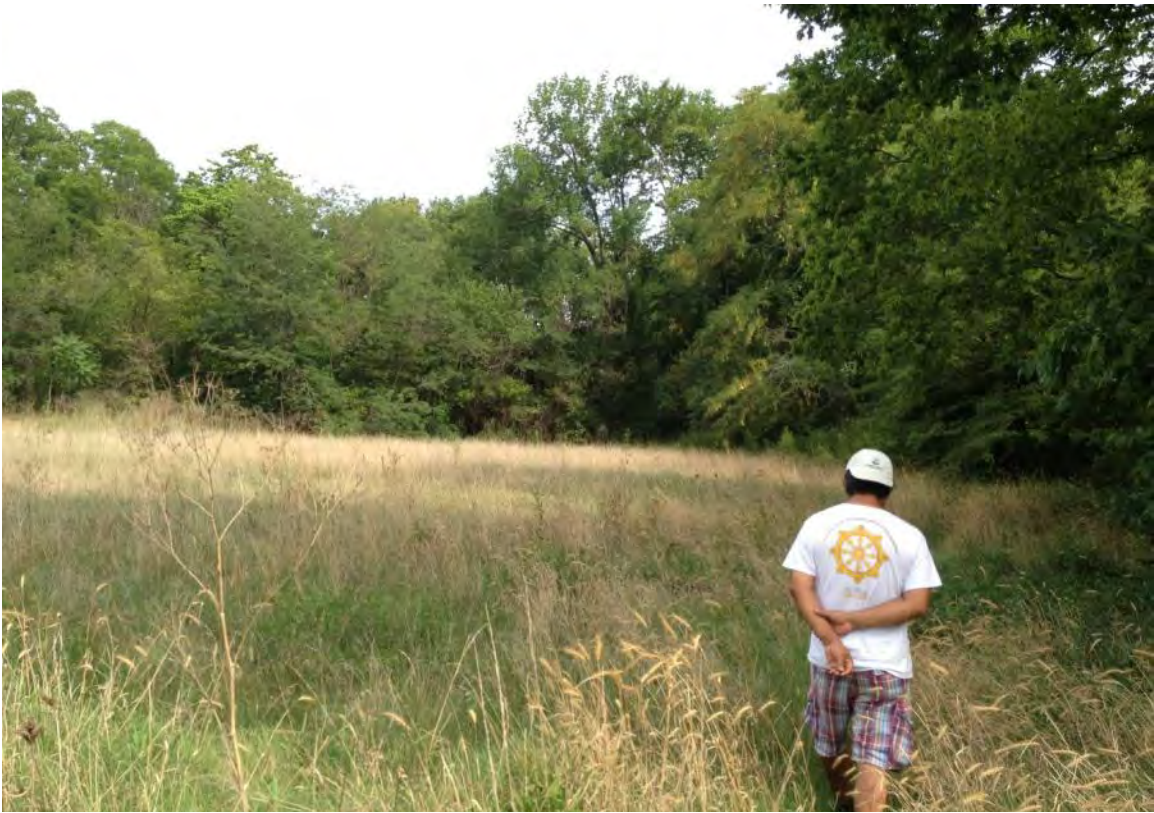
**Photo 14** Area 3 looking north towards field that where a forested riparian area will be established.

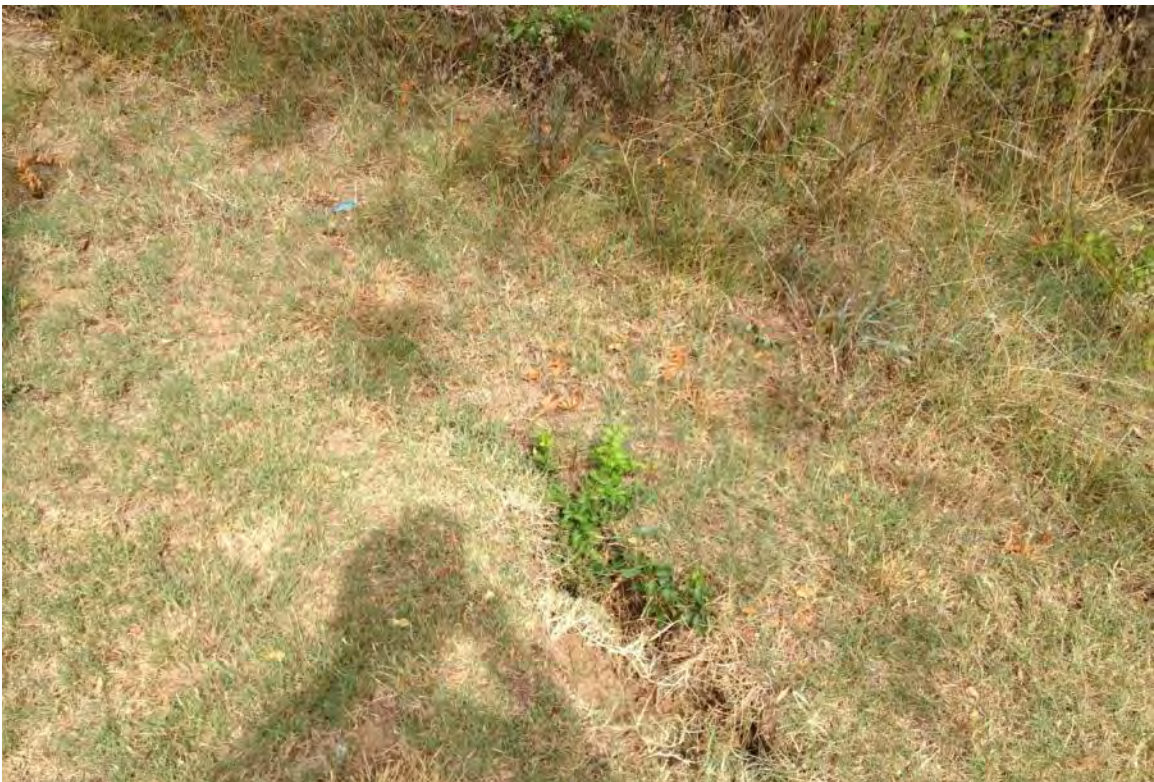
**Photo 15** Area 3: Tension cracks are visible (center of frame) along a length of the eroding streambank on Town Branch. The cracks are located approximately 10 feet from the edge of the streambank.
