**US Army Corps
of Engineers**

Beaver Lake

Final
U.S. Army Environmental Condition of
Property Report
Priority Area 1

August 30, 2021

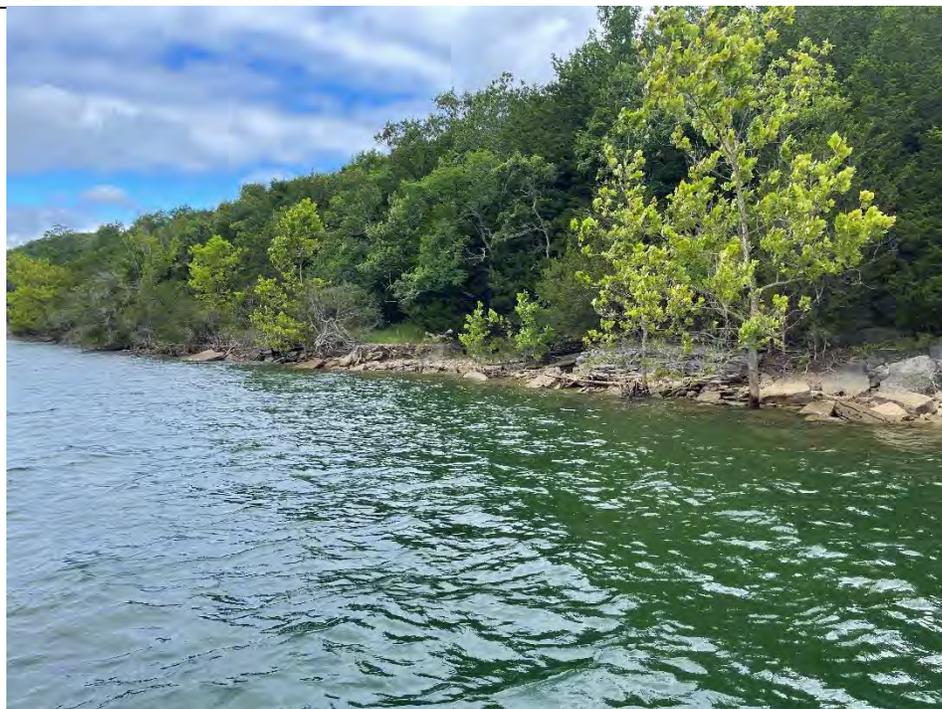
Priority Area 1A.1 – Minor debris visible

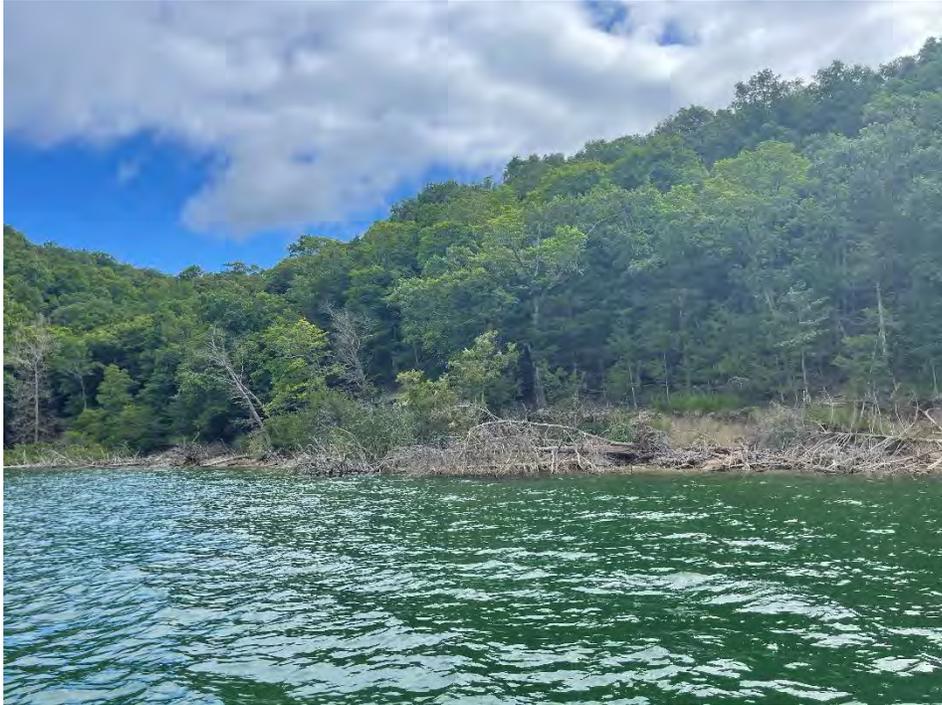
Priority Area 1A.1 – Shoreline view erosion visible

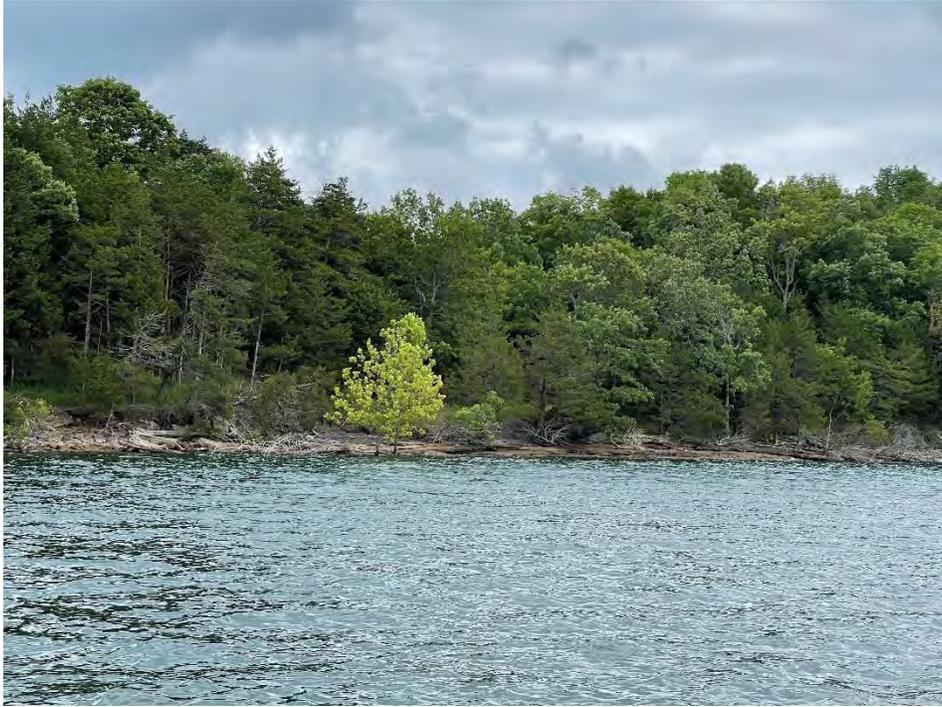
Priority Area 1A.1 – Shoreline view enclosed foam

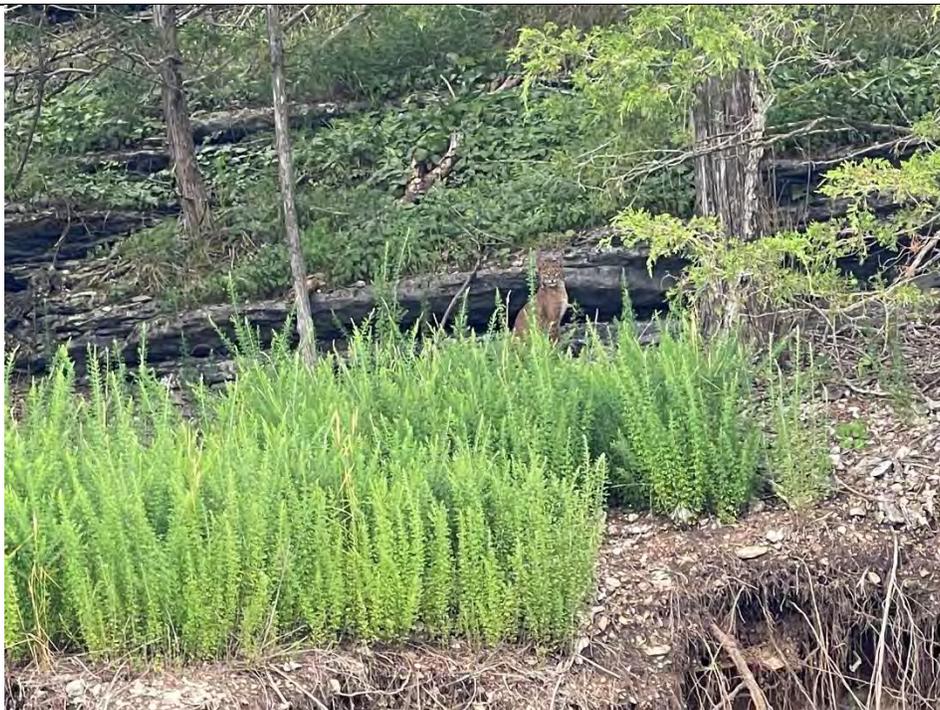
Priority Area 1A.2 – Shoreline view some erosion visible

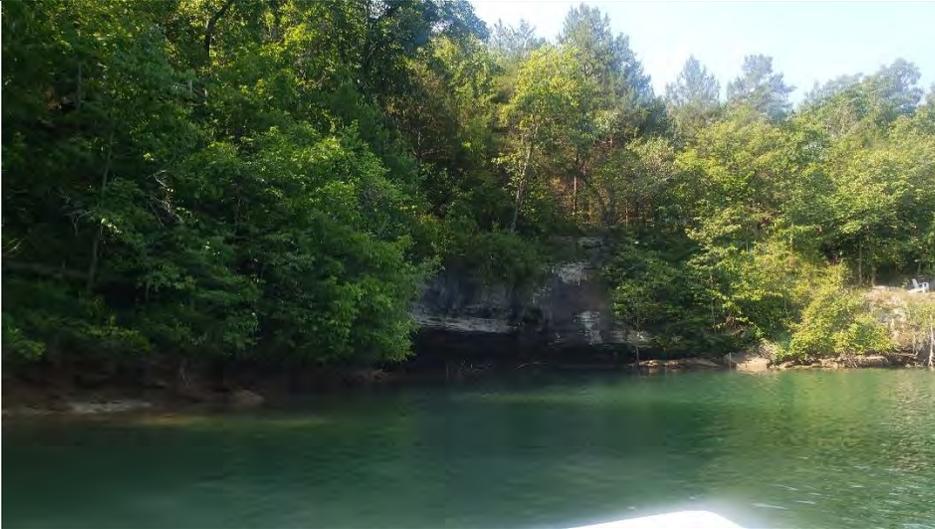
Priority Area 2 – Overhanging ledge

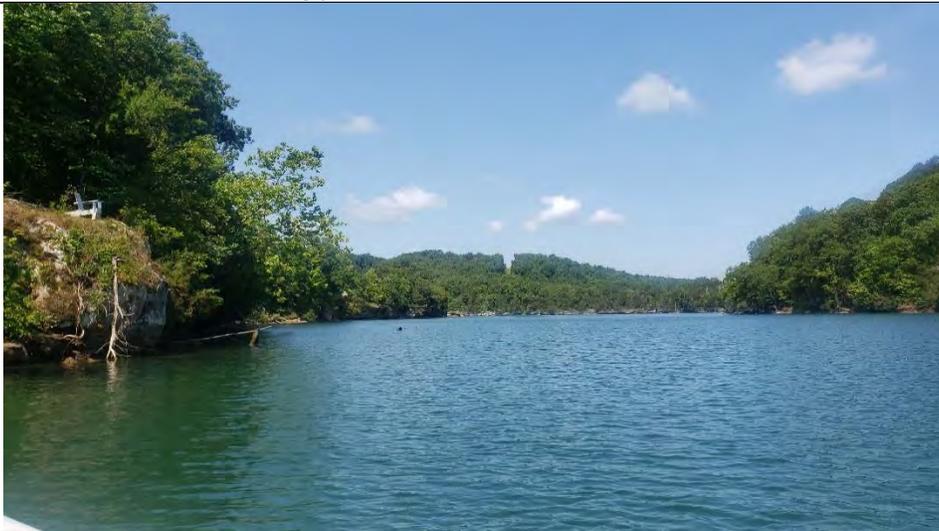
Priority Area 2 – Some woody debris

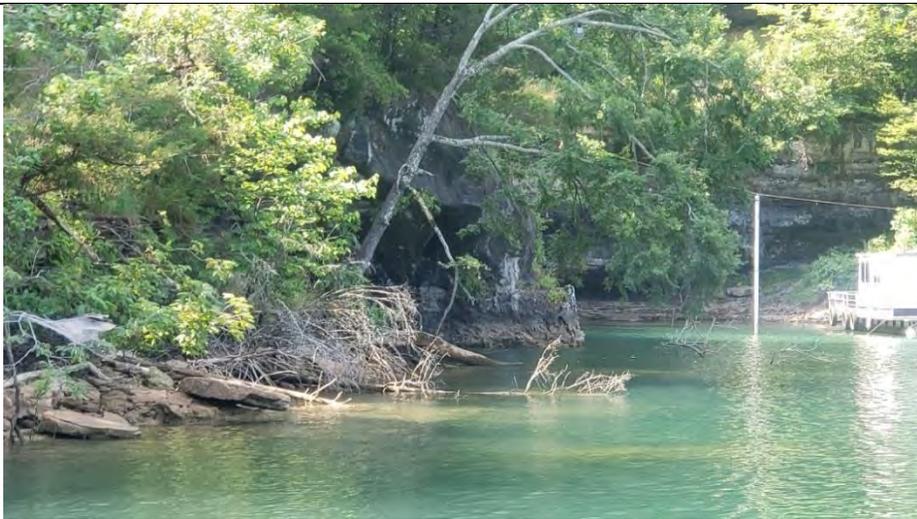
Priority Area 3.1 – Woody debris

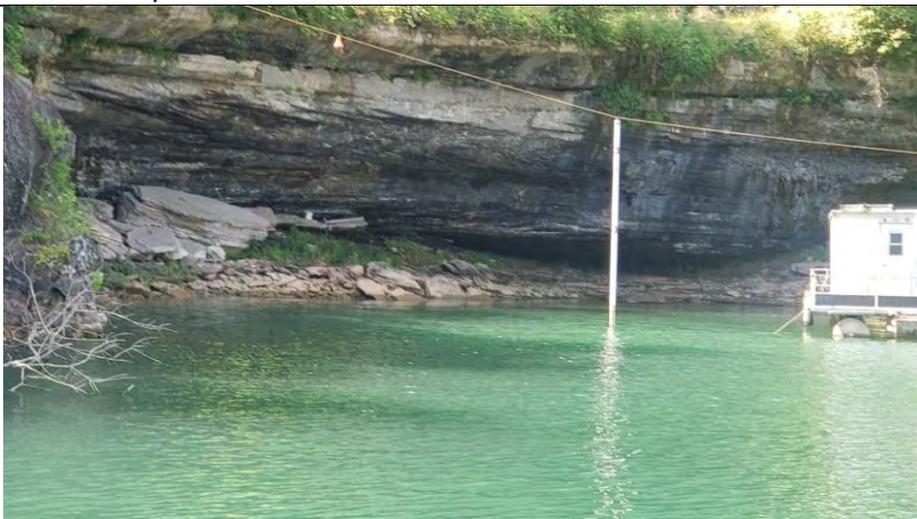
Priority Area 3.1 – Overhanging ledge

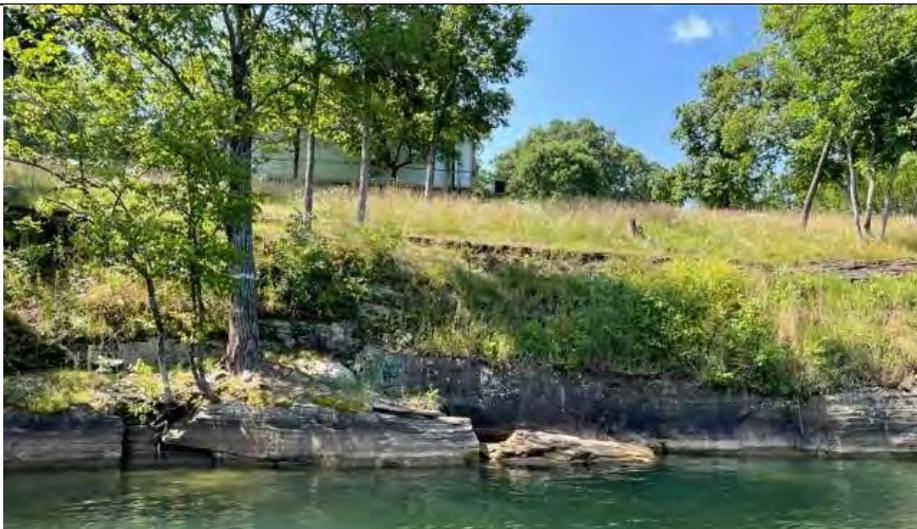
Priority Area 3.2 – Some Erosion along shoreline

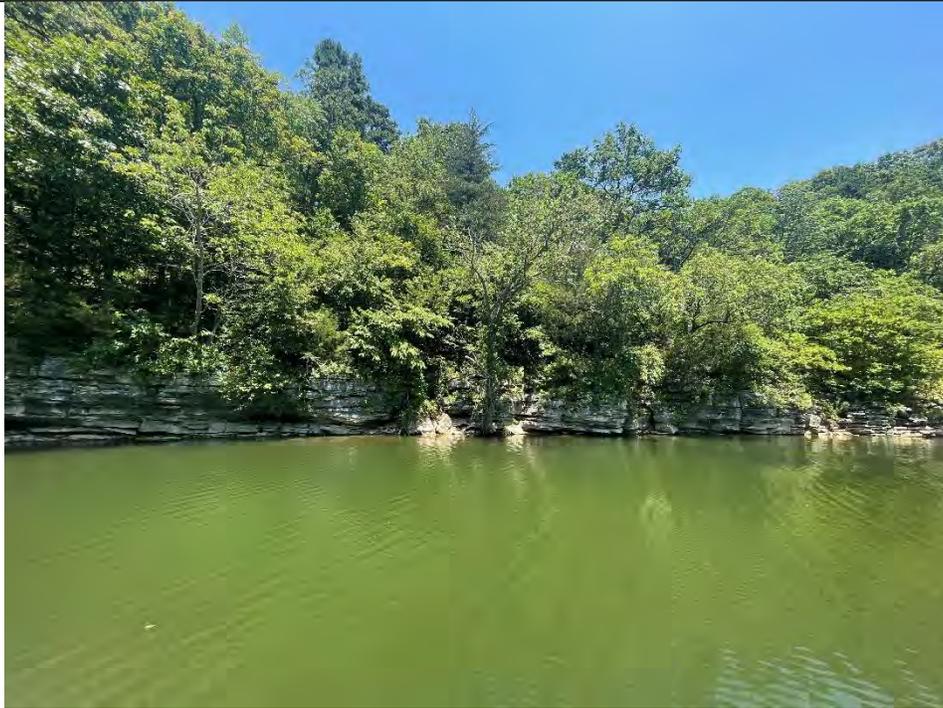
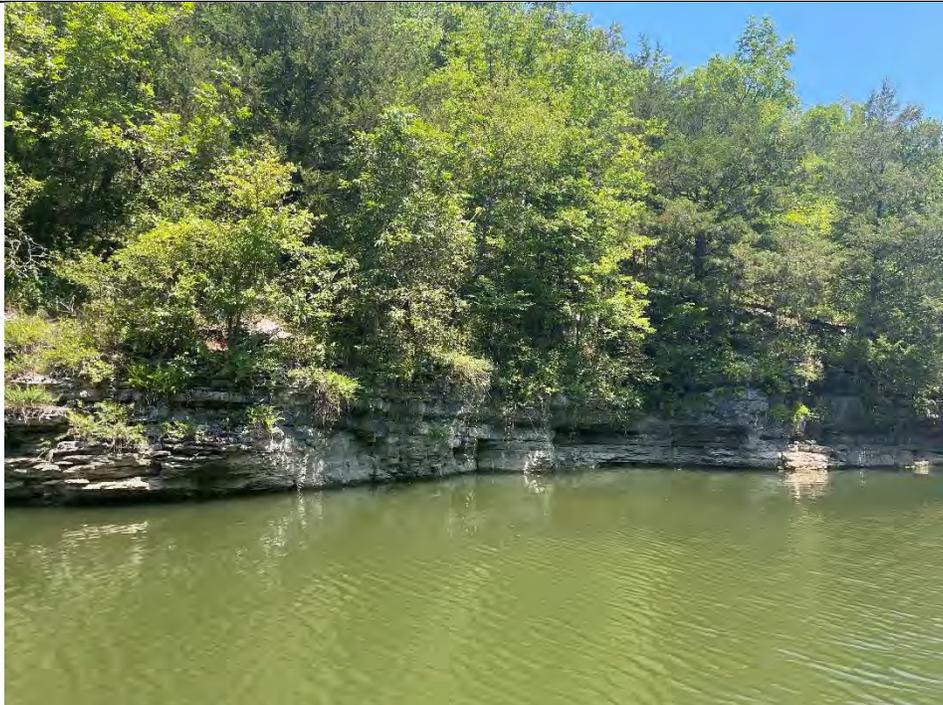
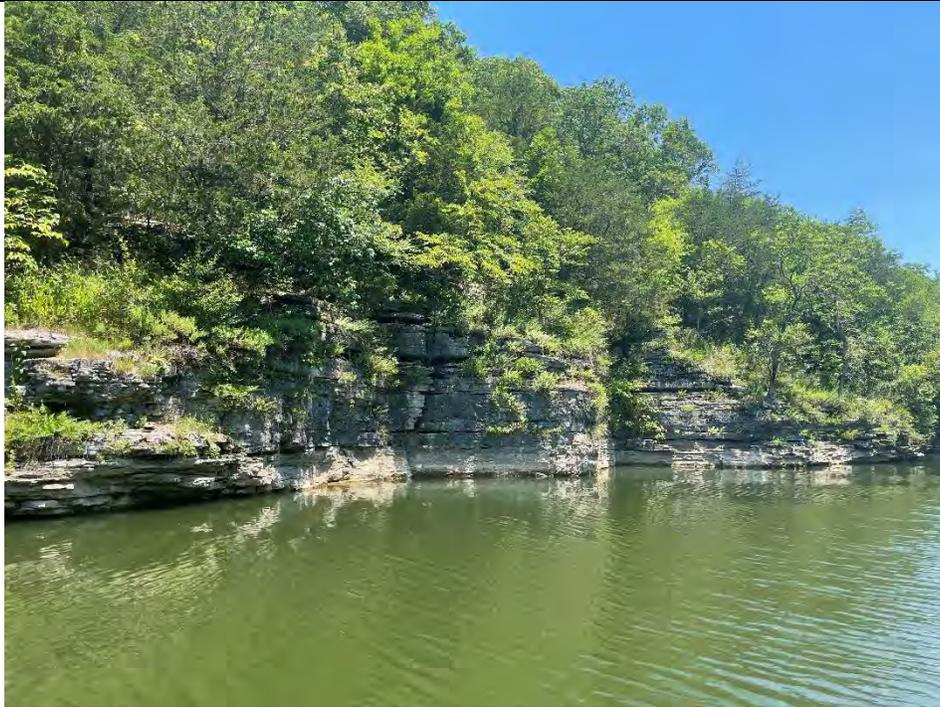
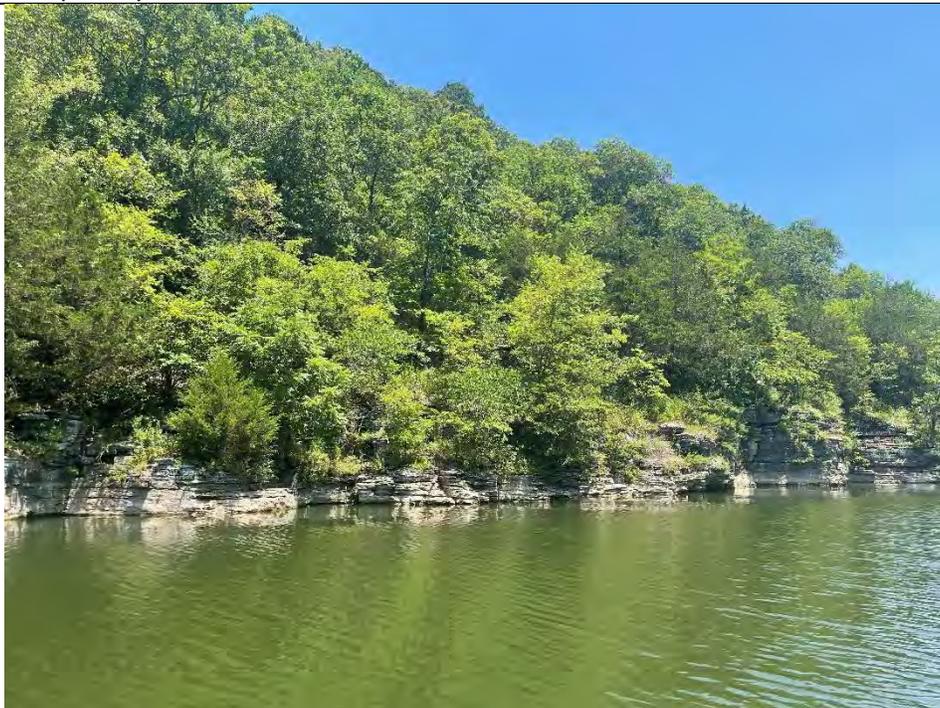
Site 4 – View of priority area from watercraft rockface shoreline visible

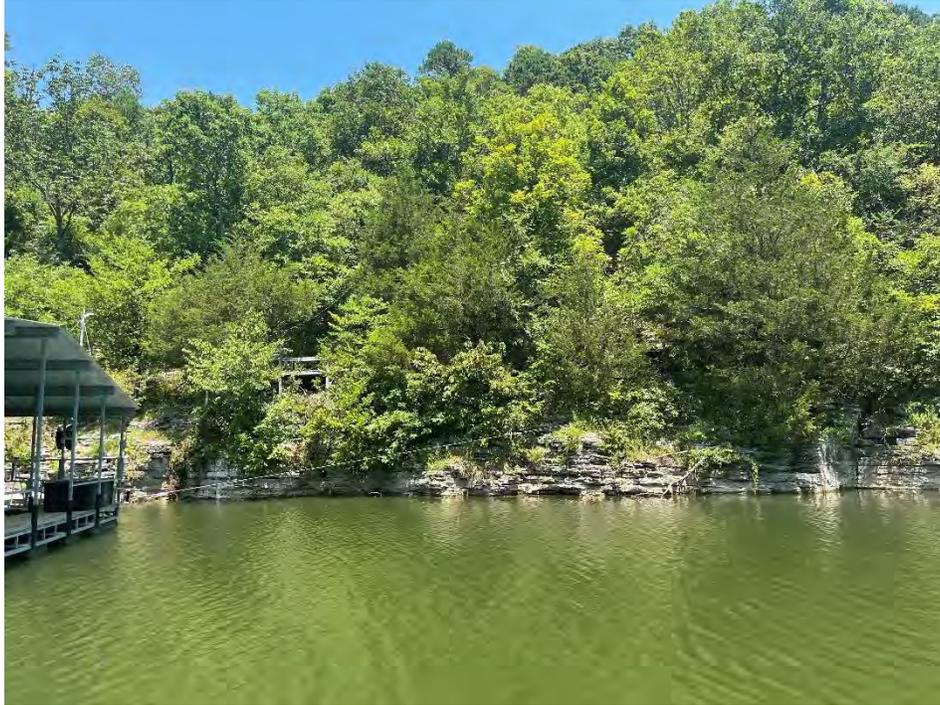
Site 4 – Priority area shoreline and covered boat dock

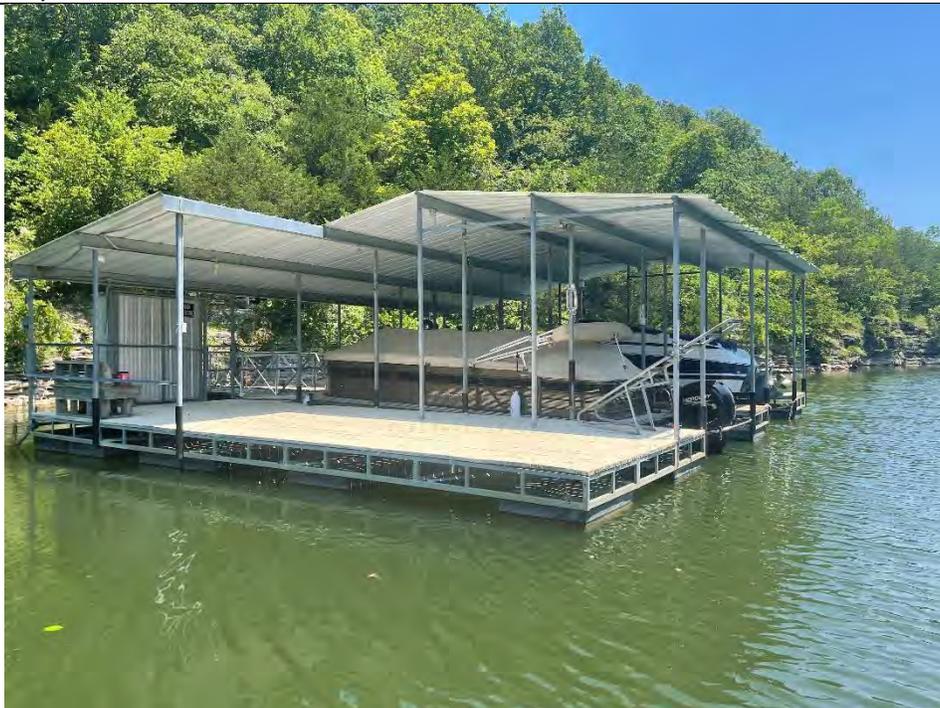
Site 4 – Priority area with covered boat dock

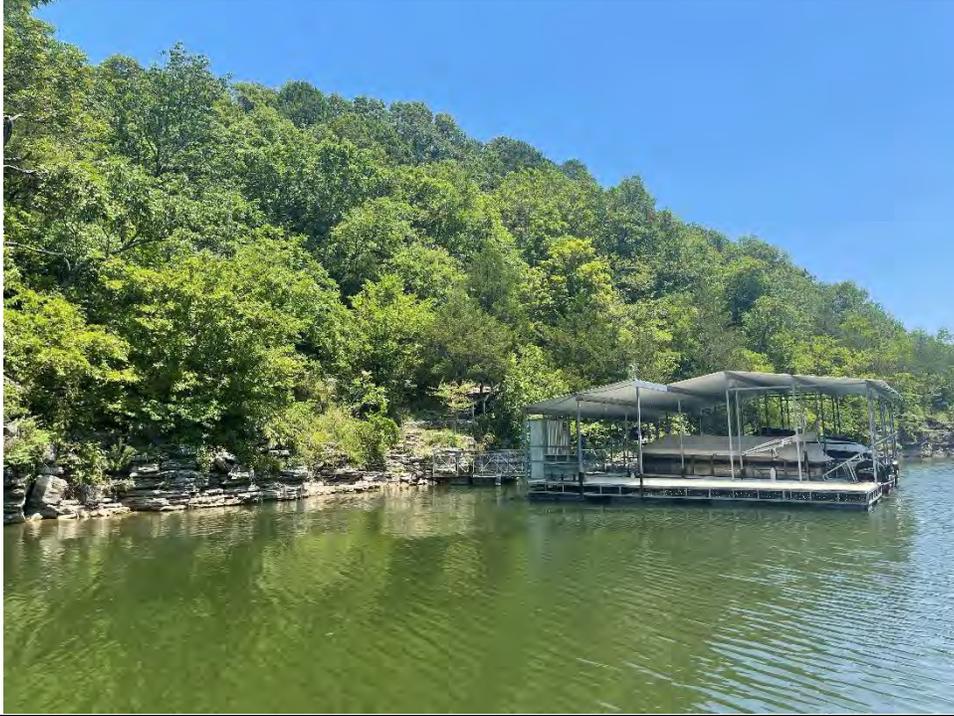
Site 4 – Priority area shoreline and covered boat dock

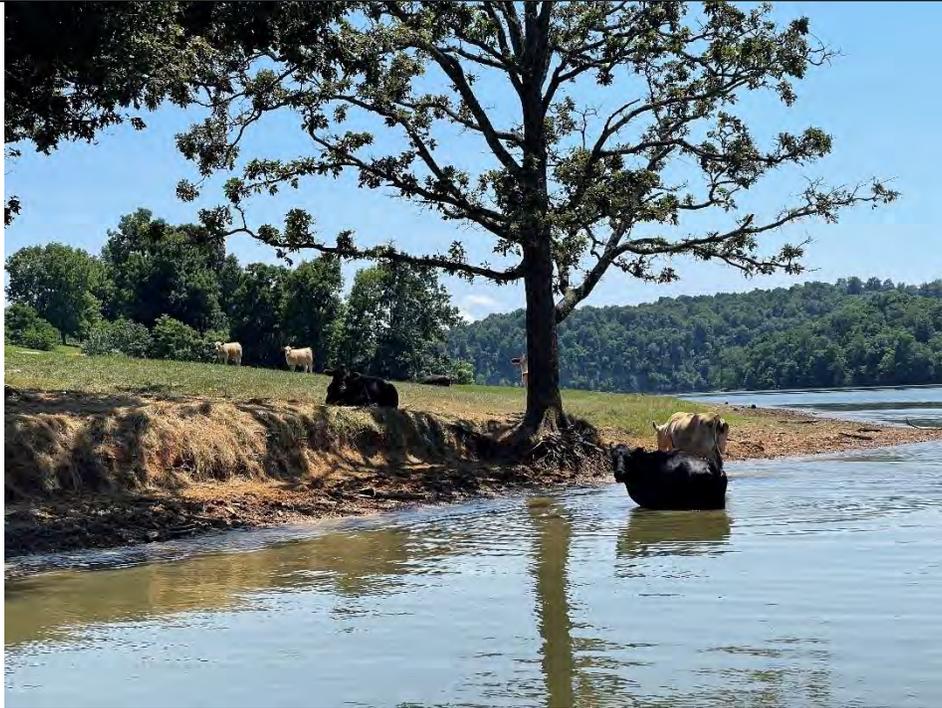
Priority Area 5 – Livestock present at priority area

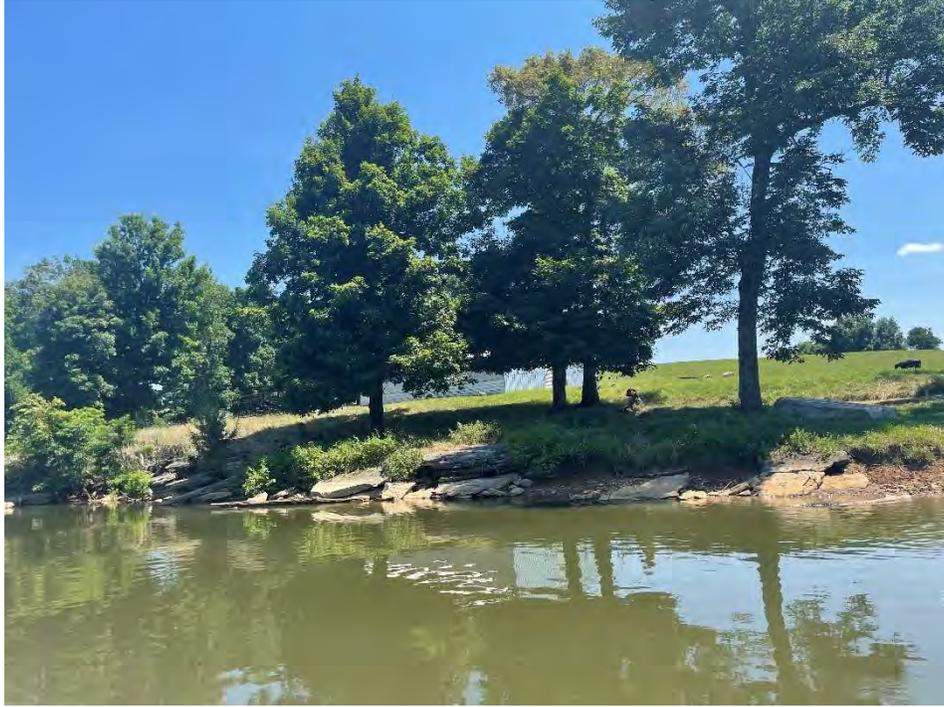
Priority Area 5 – Portion of adjacent structure can be seen

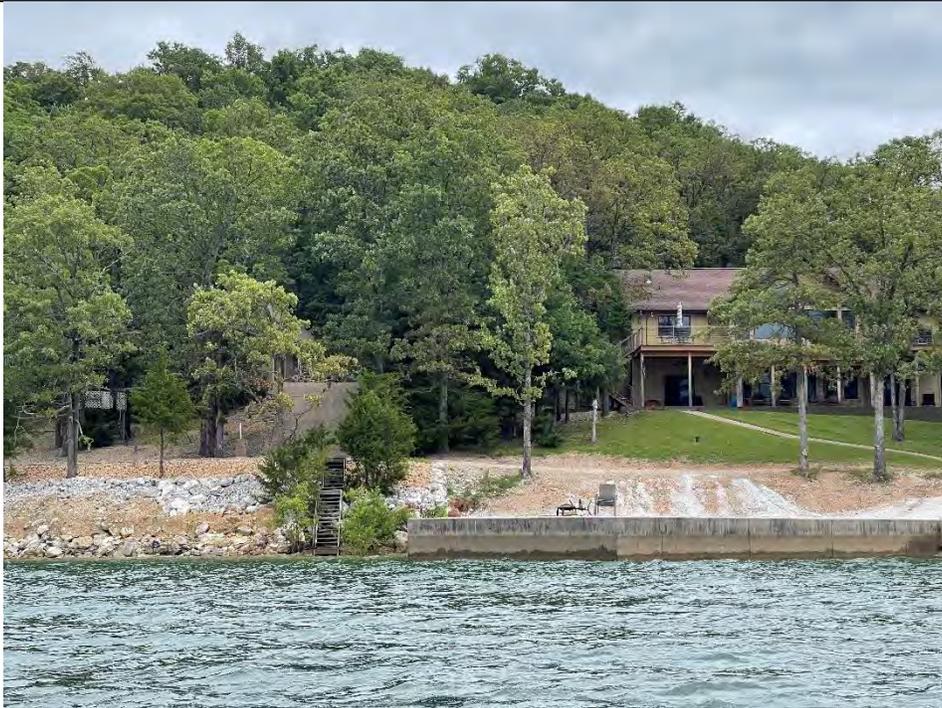
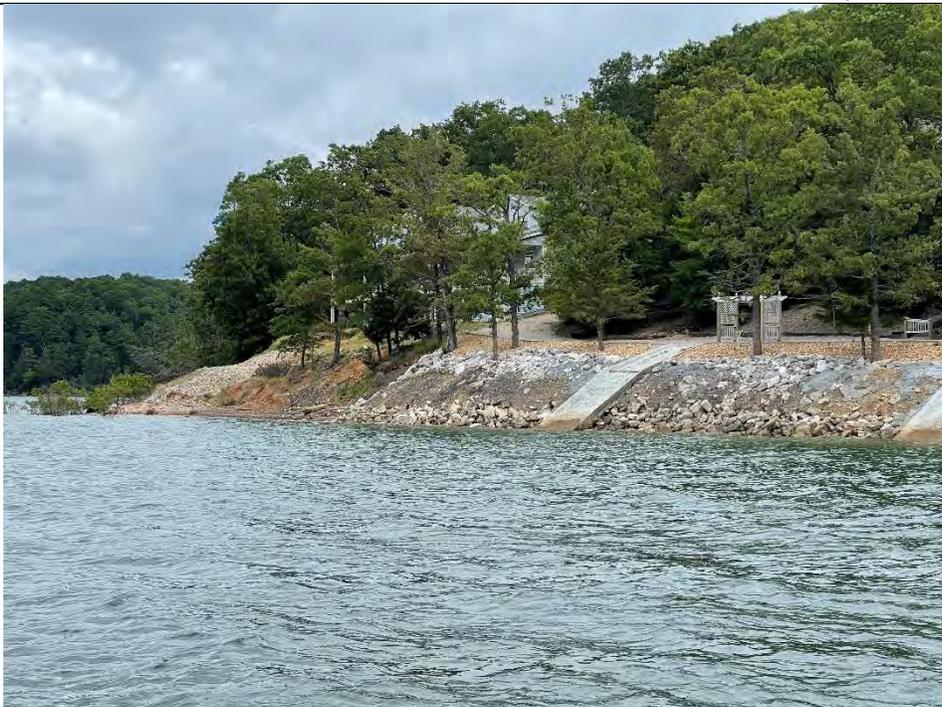
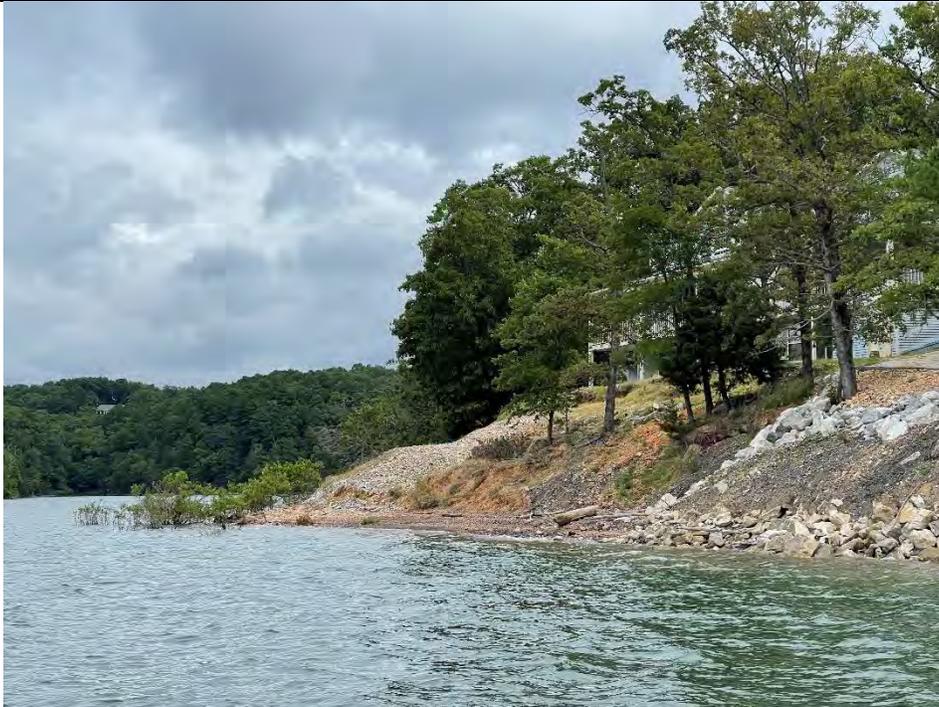
Priority Area 6 – Bank stabilization can be seen, USACE Beaver Lake Office erosion permit

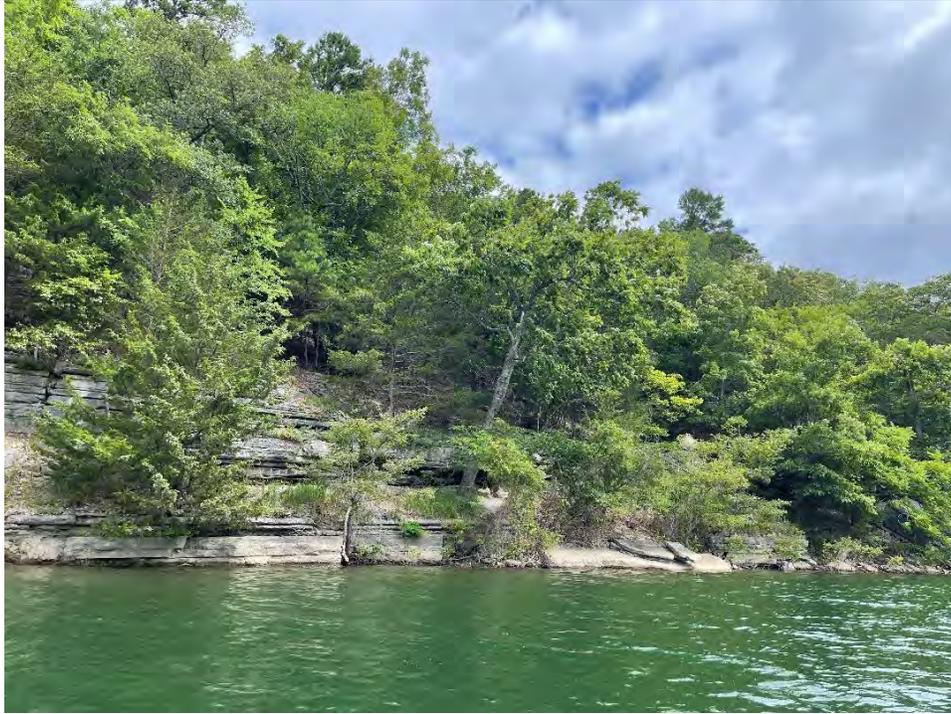
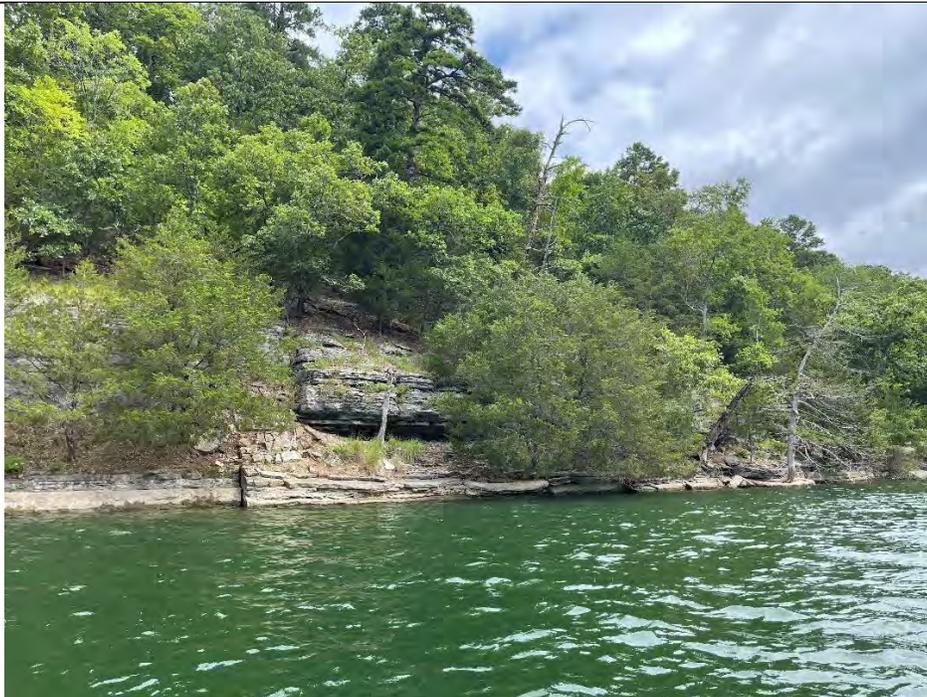
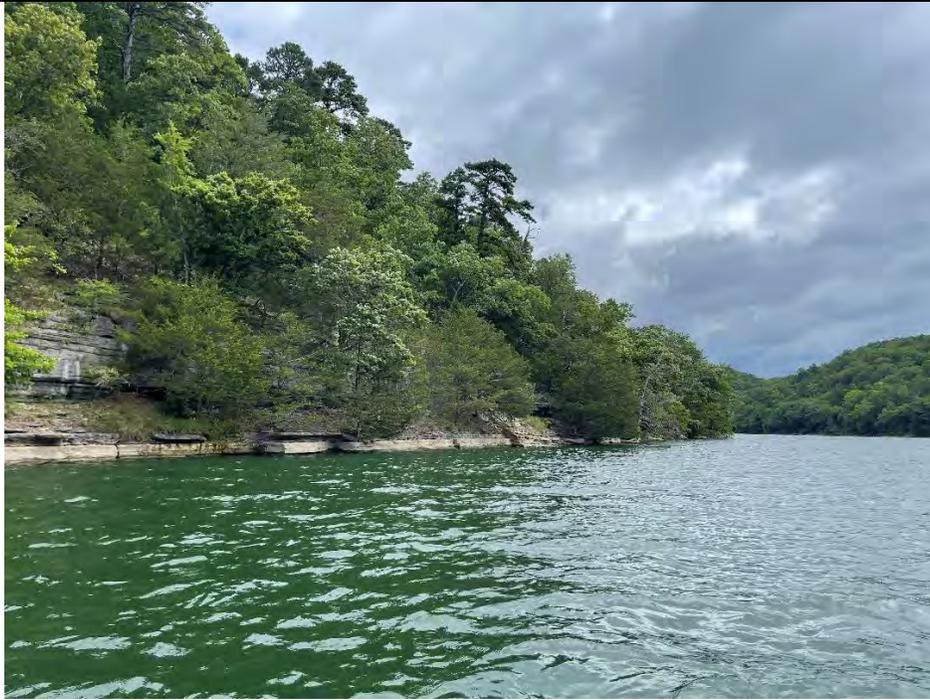
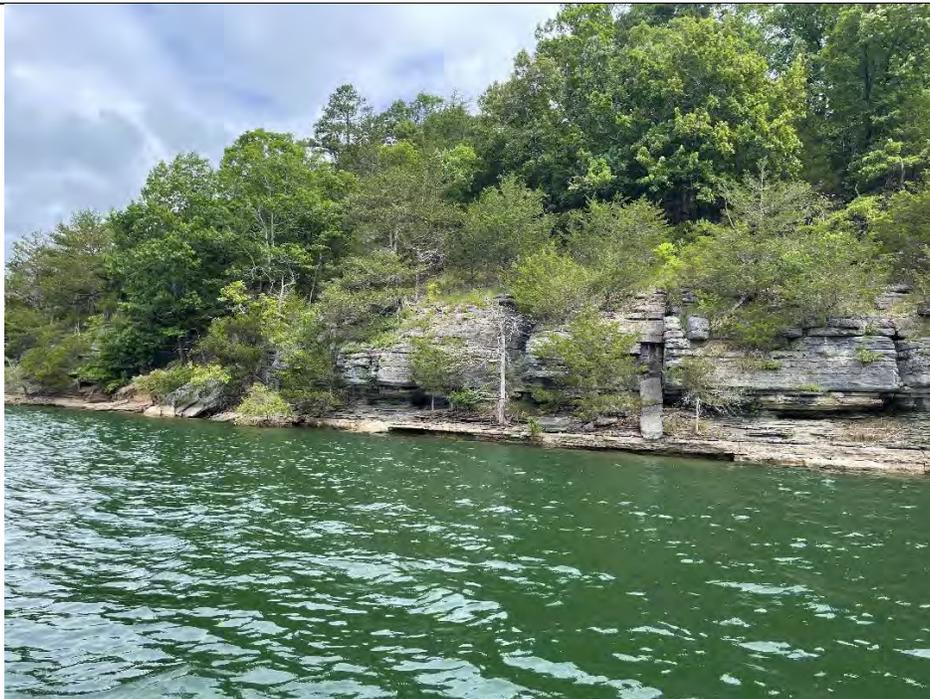
Priority Area 7 – Rocky bluff view from watercraft

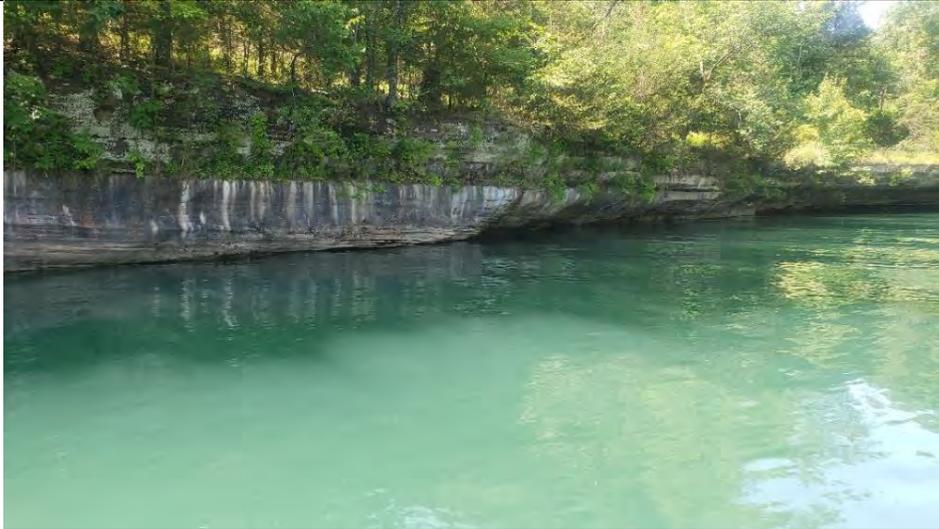
Priority Area 8 – Shoreline view

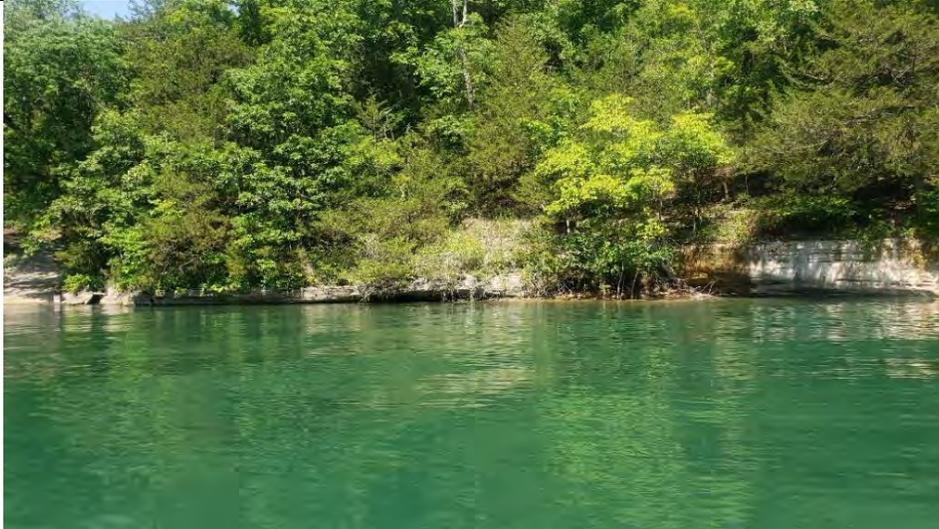
Priority Area 8 – Some erosion of rocky banks, woody debris

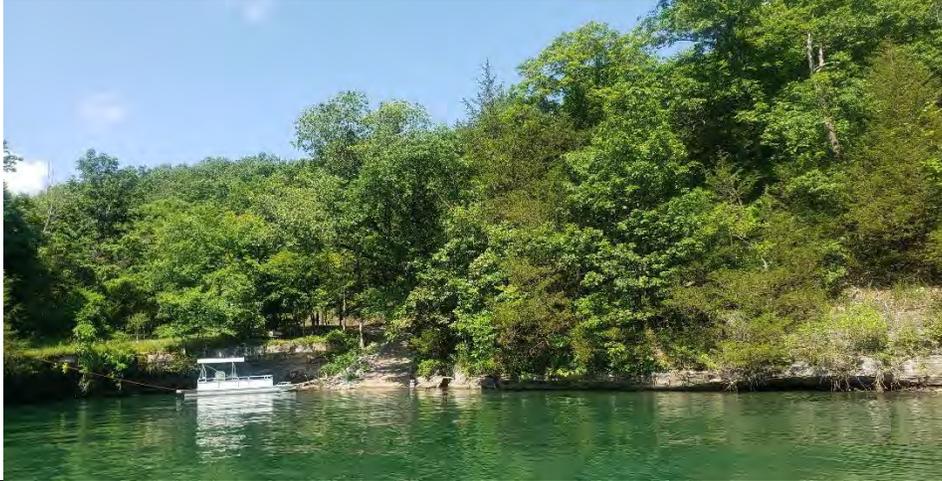
Priority Area 8 – Private residential use and boat ramp

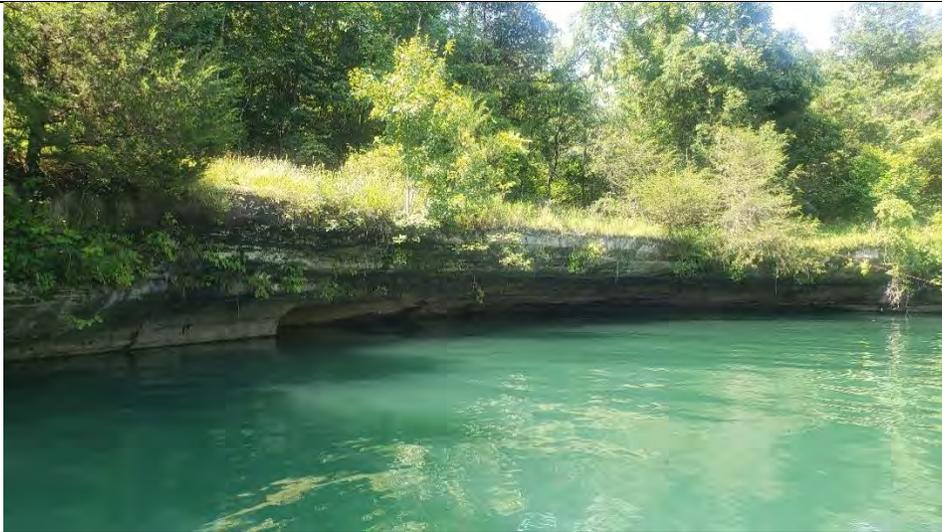
Priority Area 8 – Overhanging, vegetated ledge

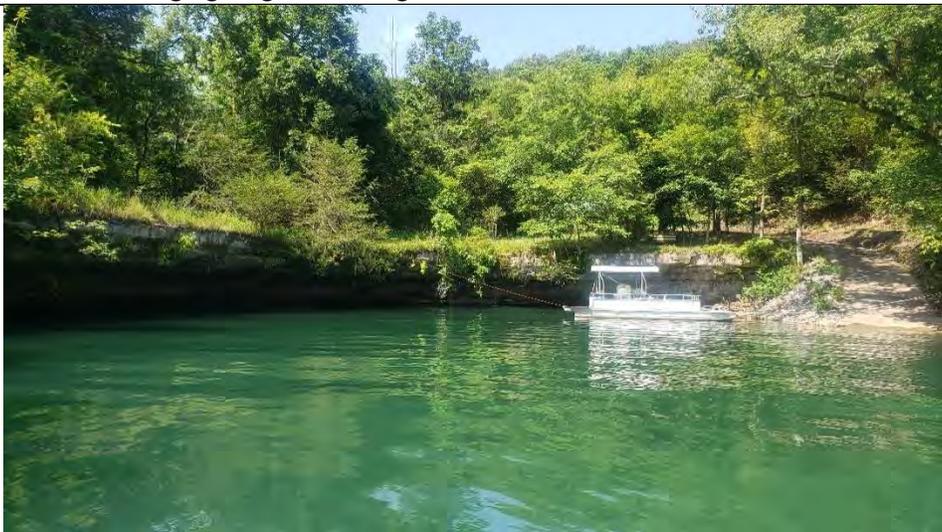
Priority Area 8 – Line running across cove

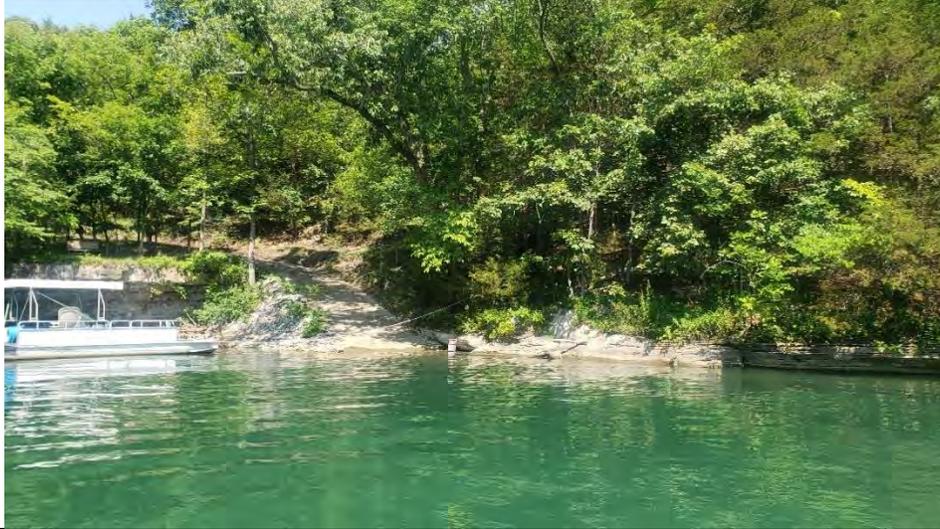
Priority Area 8 – Paved boat ramp

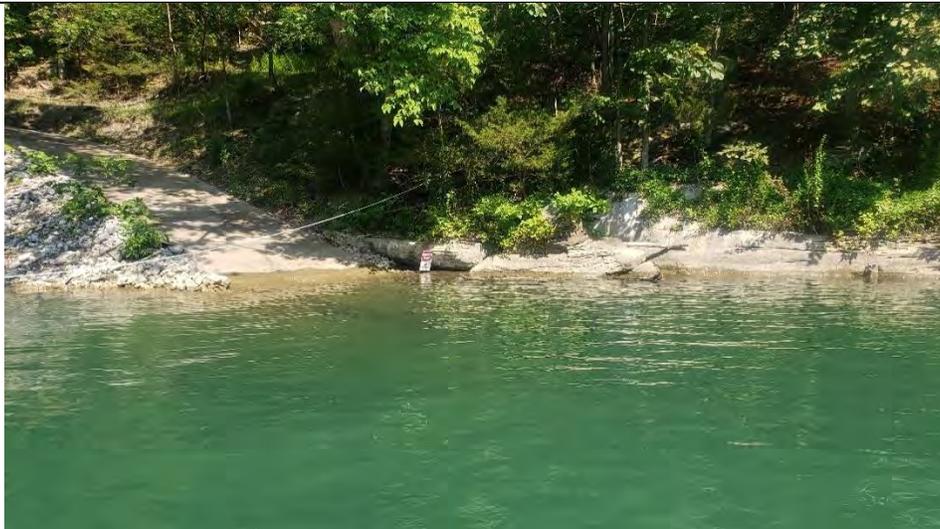
Priority Area 8 – Private property signs

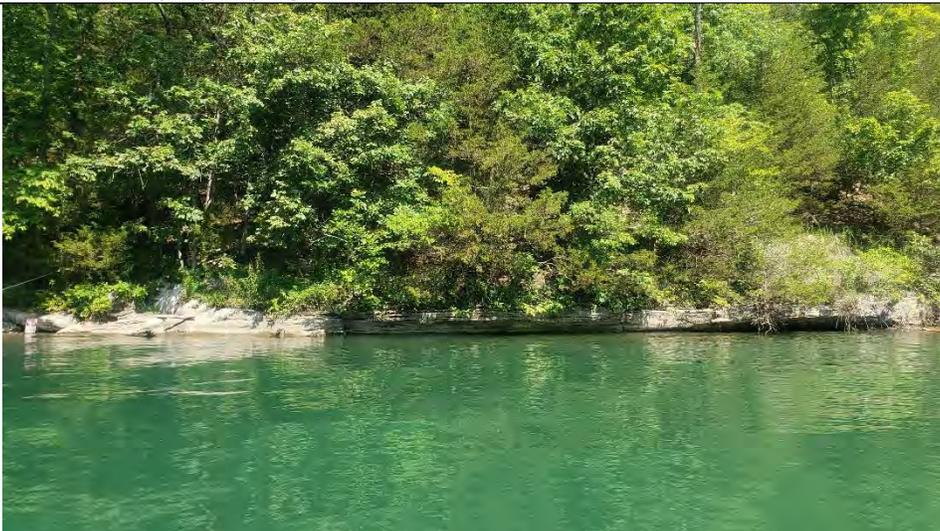
Priority Area 8 – Vegetated shoreline

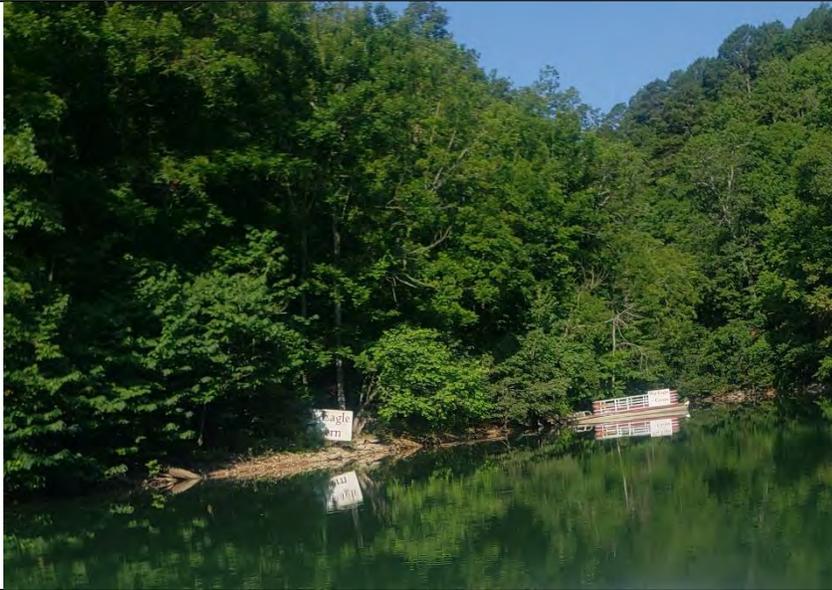
Priority Area 9 – Shoreline view

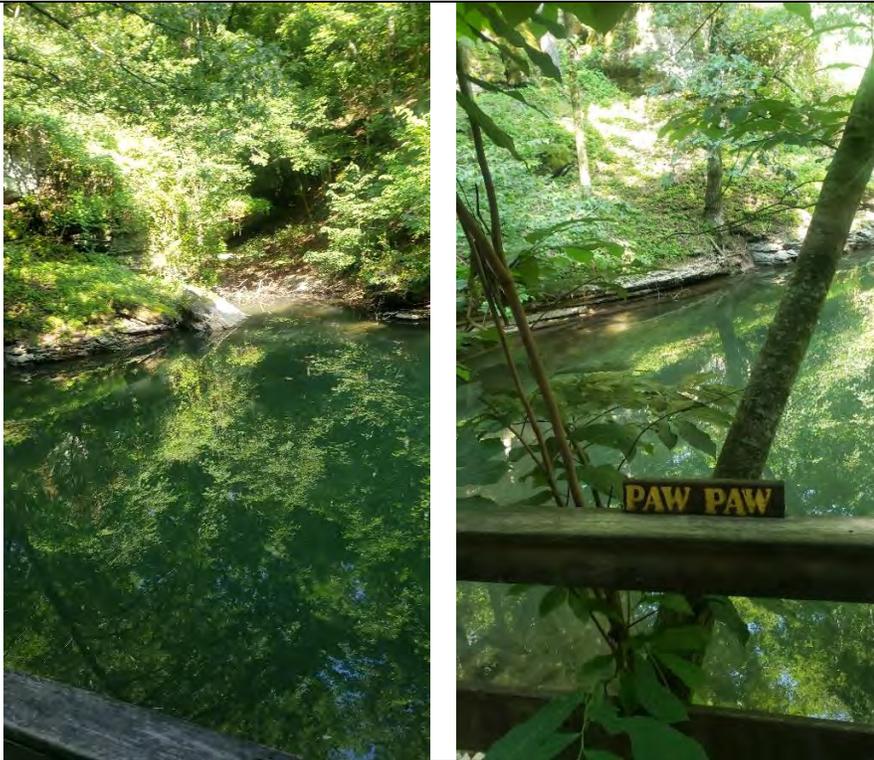
Priority Area 9 – Images of vegetated banks

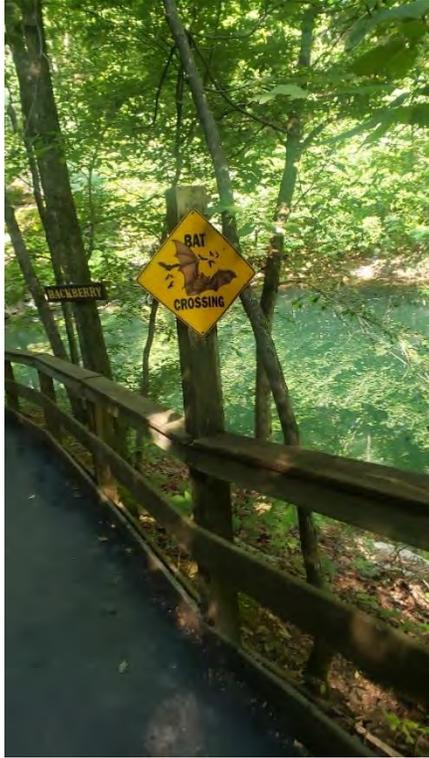
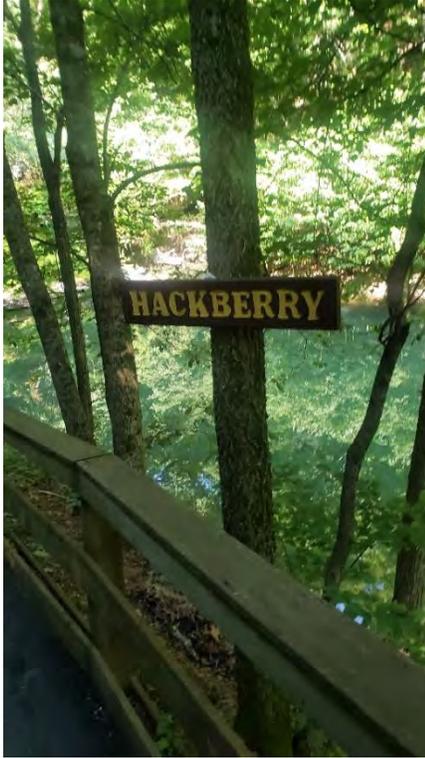
Priority Area 9 – Images of walkway along banks

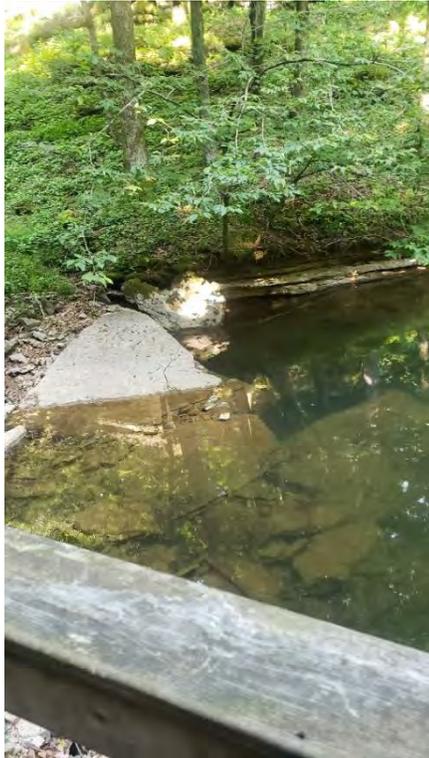
Priority Area 9 – Images near the mouth of the cavern

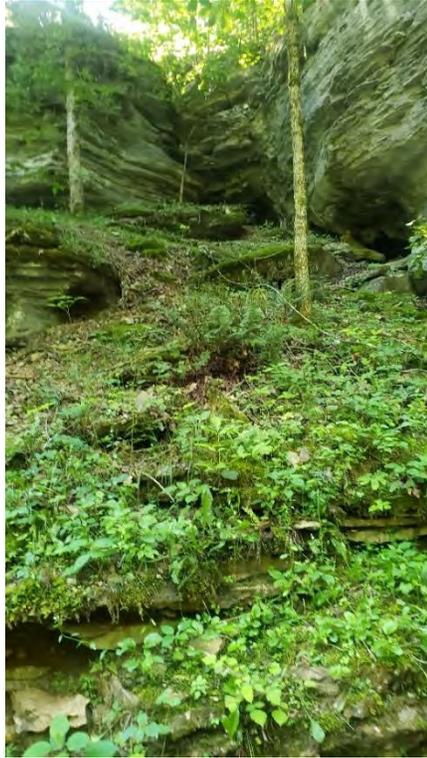
Priority Area 9 – Images of vegetated banks and limestone

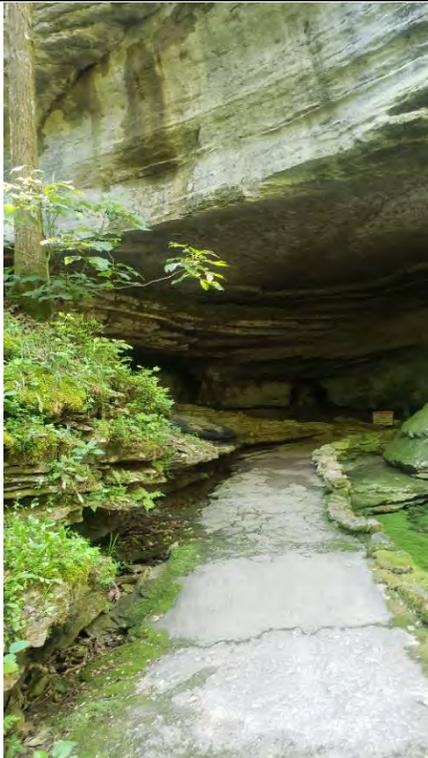
Priority Area 9 – Images near mouth of cavern
