**US Army Corps
of Engineers**

Beaver Lake

Final
U.S. Army Environmental Condition of
Property Report
Priority Area 1

August 30, 2021

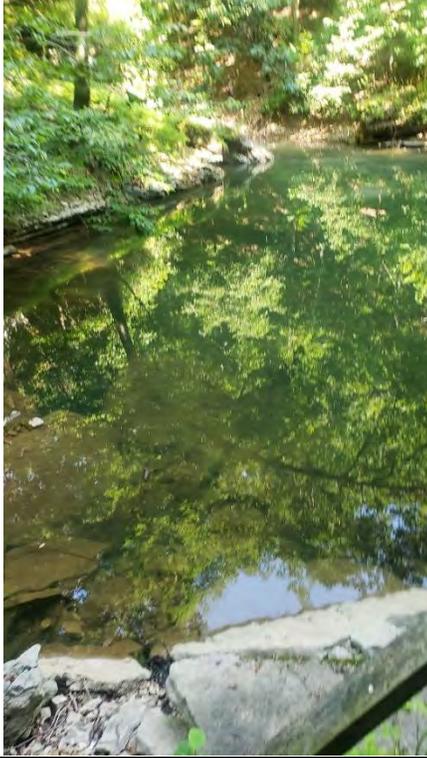
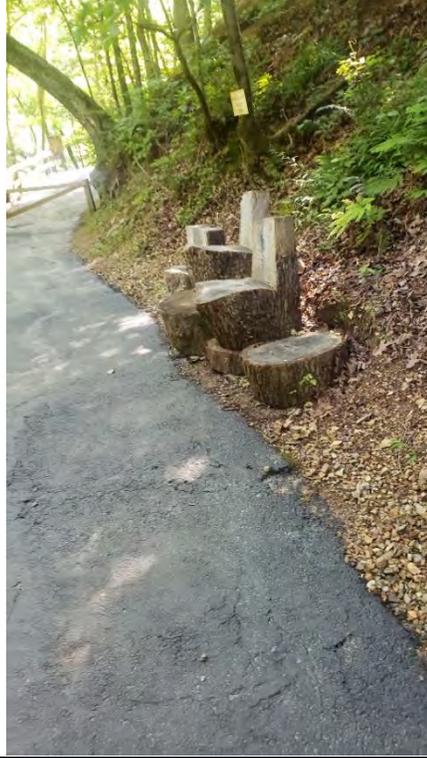
Priority Area 9 – (left) Image showing water quality (right) Image of walkway along bank

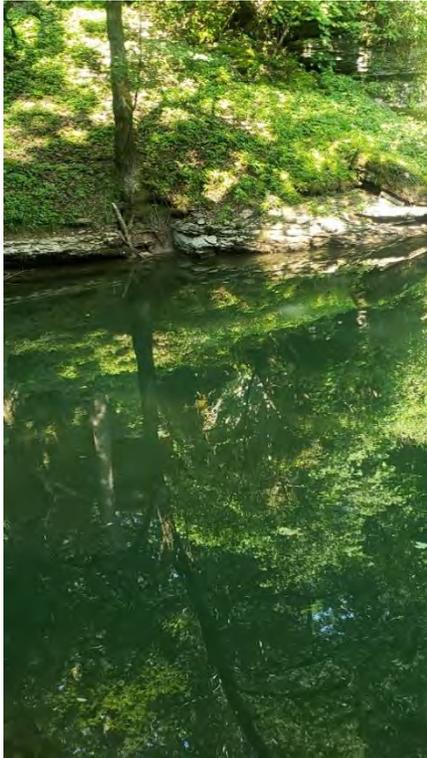
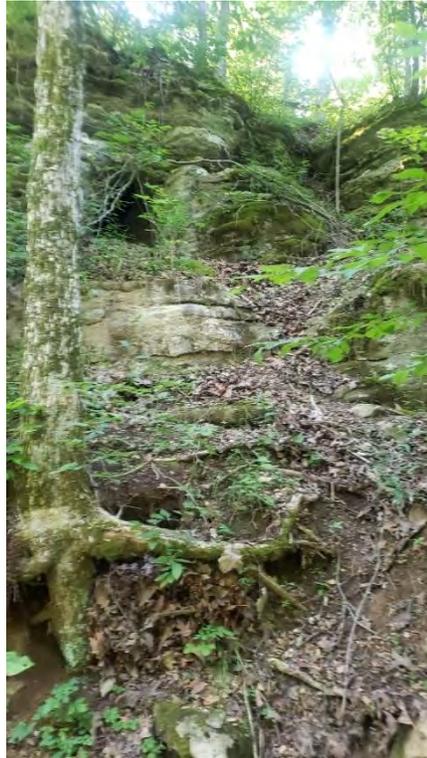
Priority Area 9 – (left) Healthy vegetation above rocky bank overhang (right) Vegetated banks

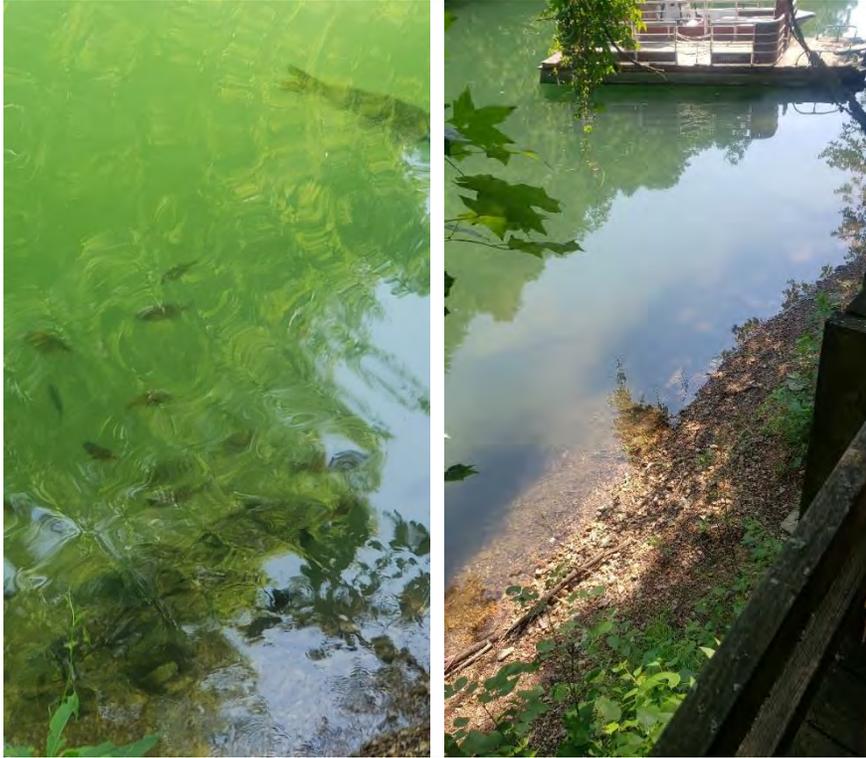
Priority Area 9 – Healthy water and habitat quality

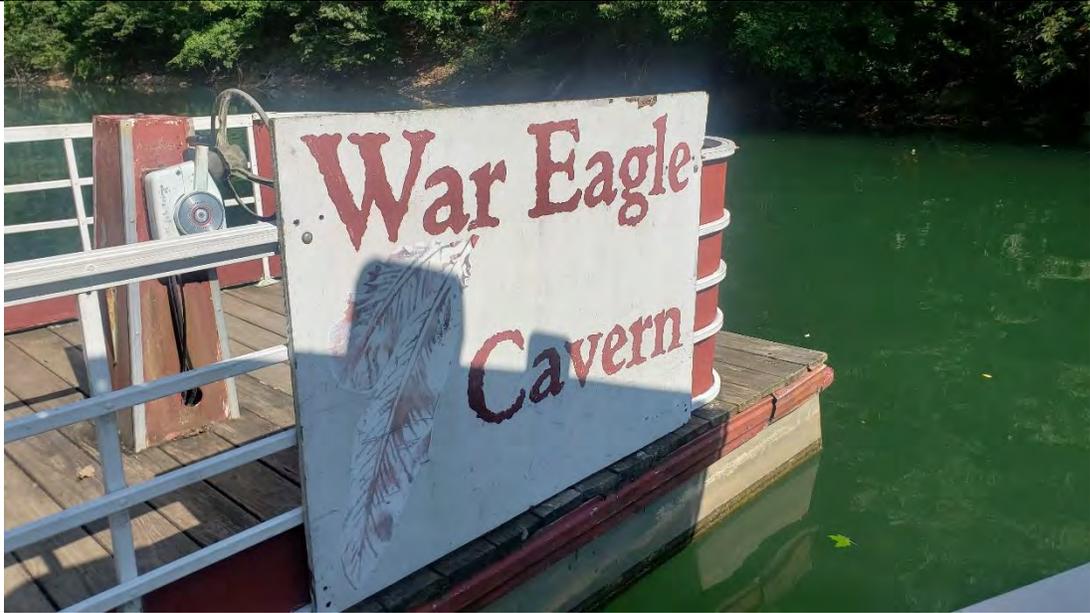
Priority Area 9 – Signage for establishment

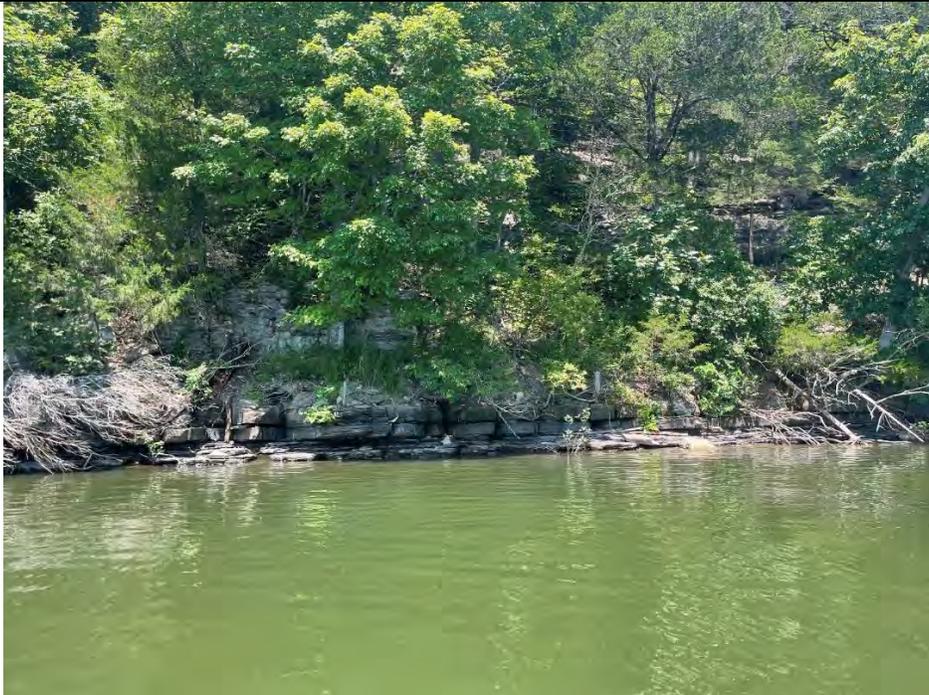
Priority Area 10 – Portions of the priority area have rocky bluffs leading into the lake

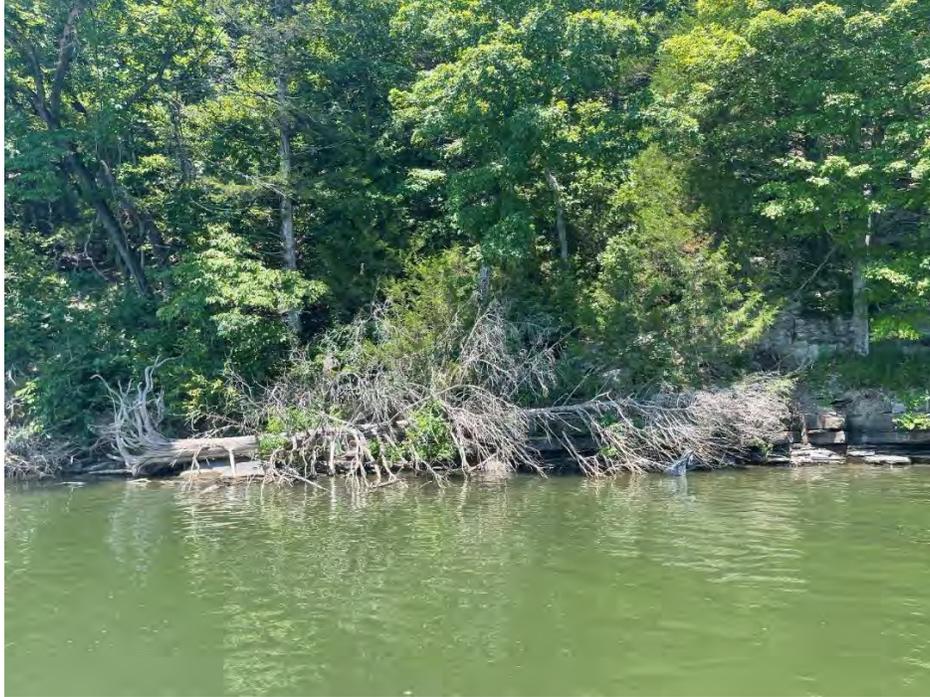
Priority Area 10 – Fallen trees on priority area

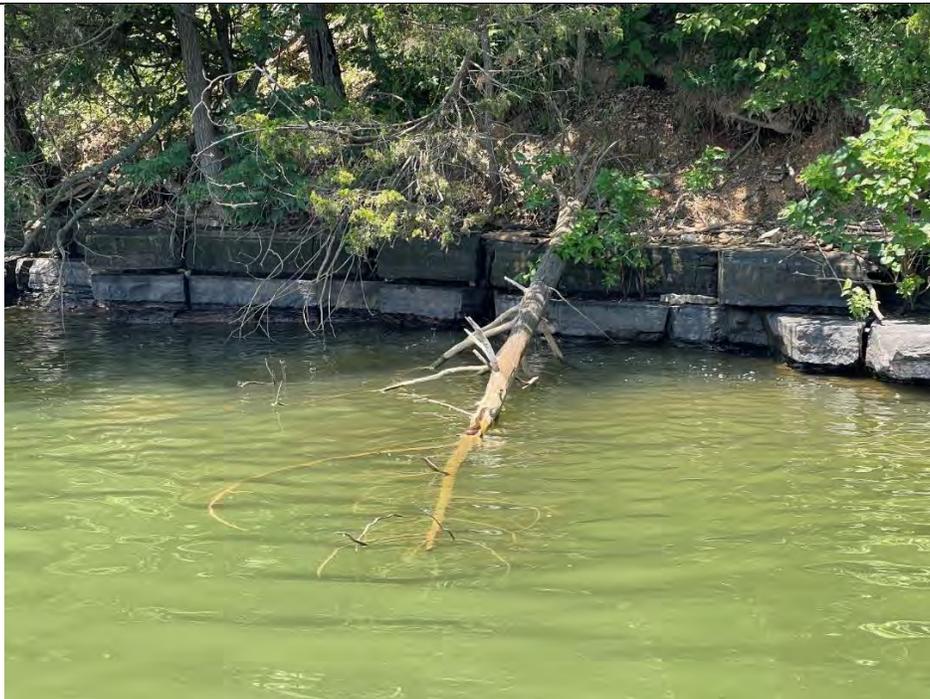
Priority Area 10 – Rock strata on priority area edge

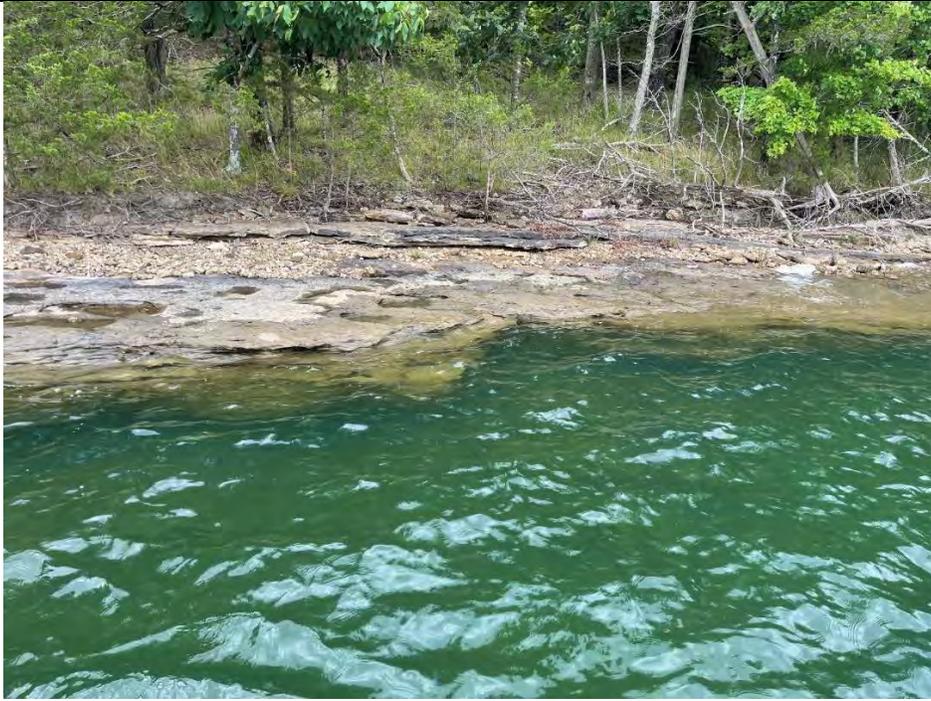
Priority Area 11 – Good water clarity near priority area

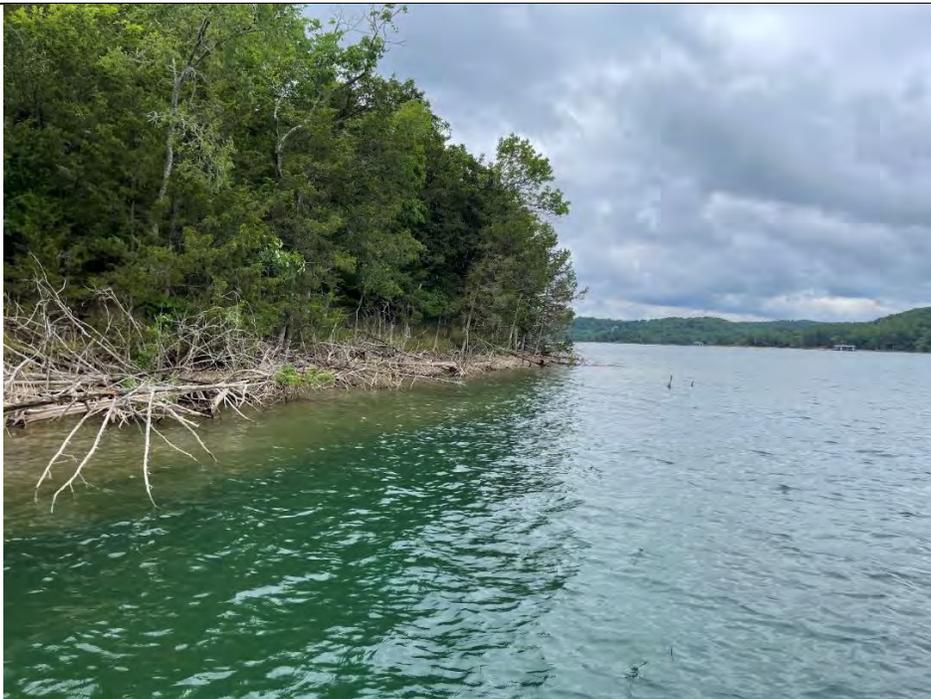
Priority Area 11 – Fallen trees on priority area

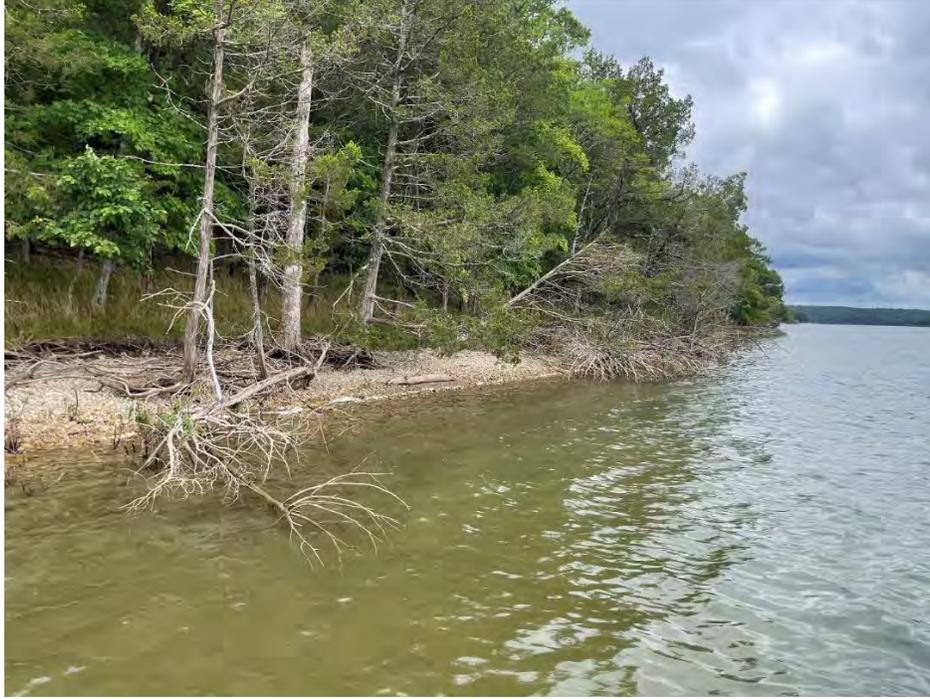
Priority Area 11 – Fallen trees on priority area

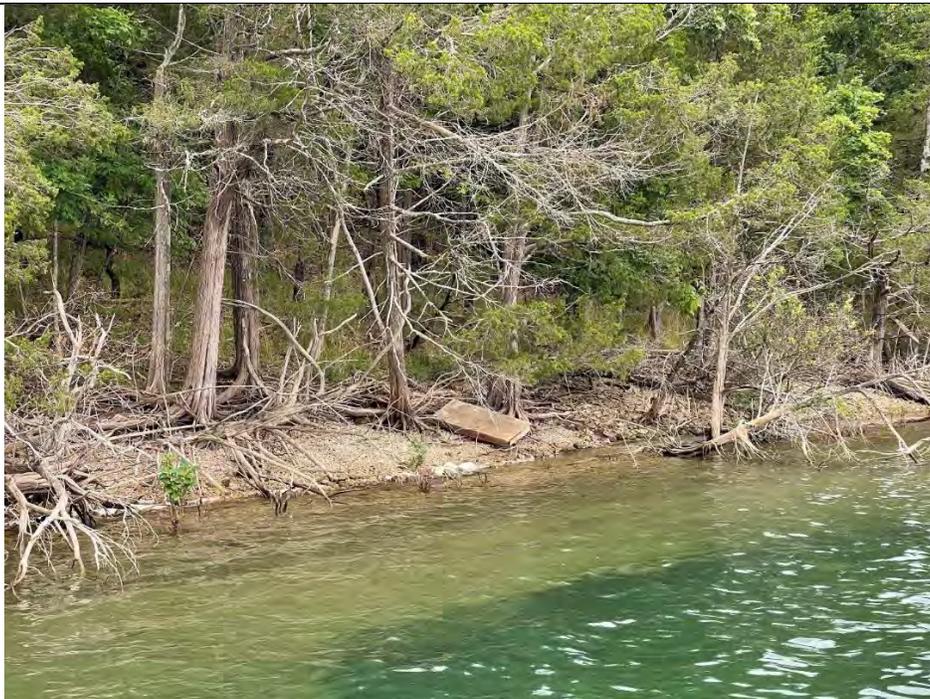
Priority Area 11 – Debris seen at priority area

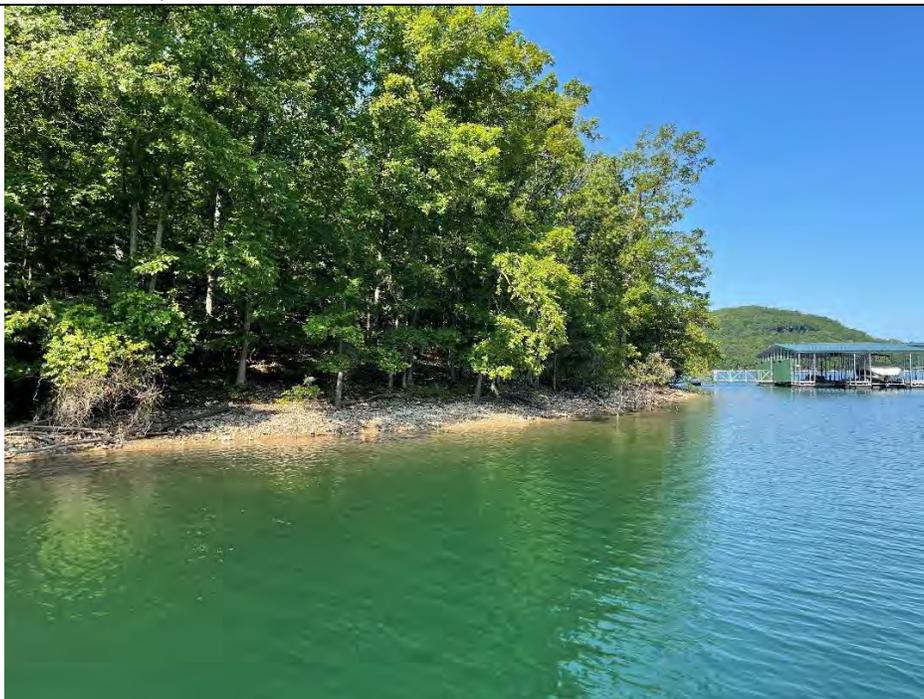
Priority Area 15 – Boat dock at priority area

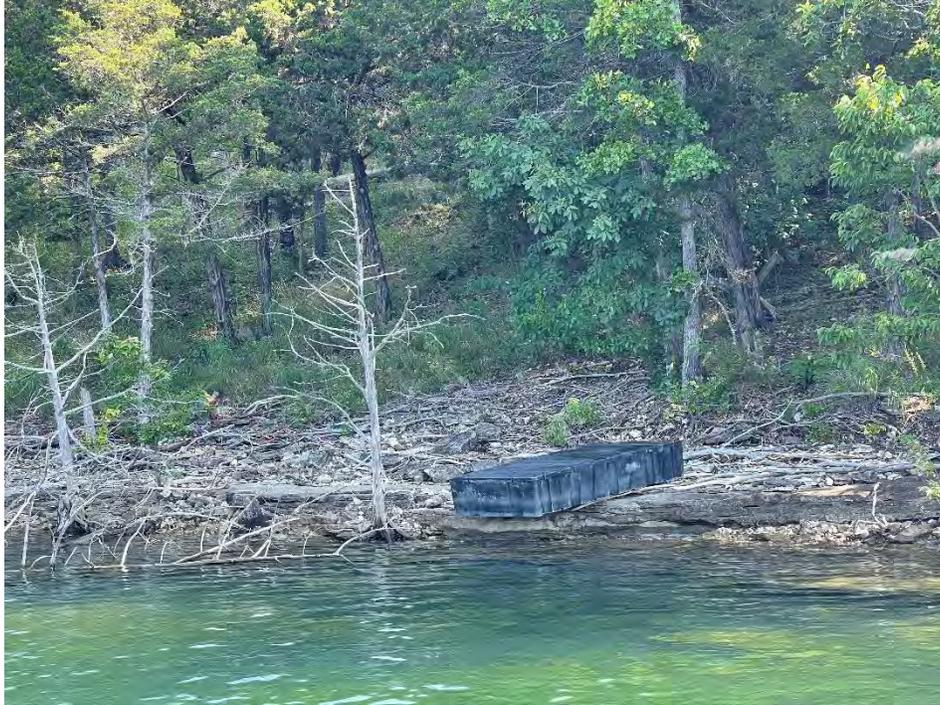
Priority Area 16 – View of the priority area from the watercraft, encapsulated foam can be seen

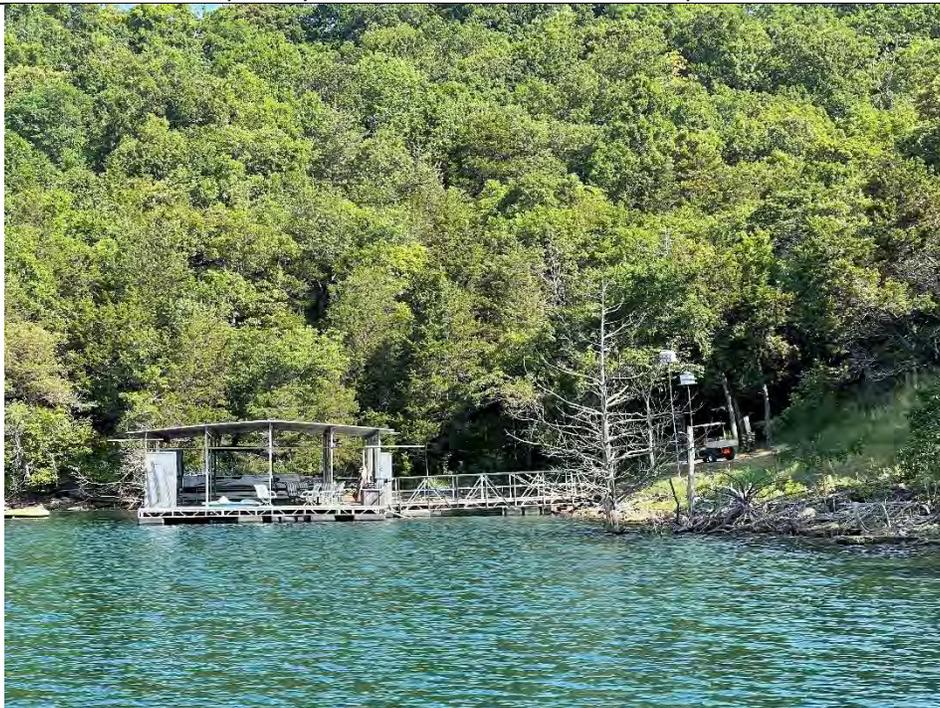
Priority Area 16 – Larger boat dock located on at the priority area
